**Docket No. 272 – Development and Management Plan Inspection**

**Segment 3 Underground Line**

**Date:** April 17, 2008

**Location:** East Devon Substation to the Housatonic River Crossing

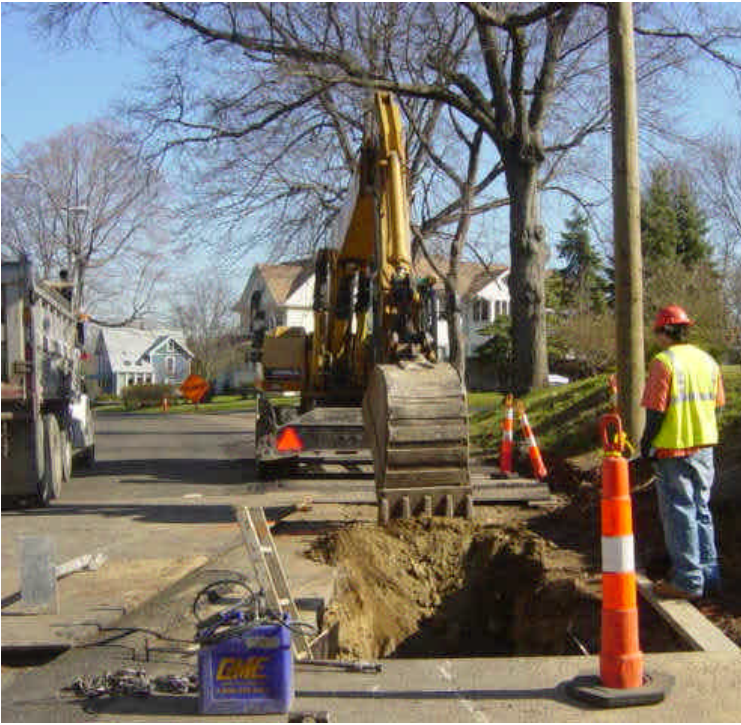
**Trenching continues along Naugatuck Avenue near sta. #1042-1044.**

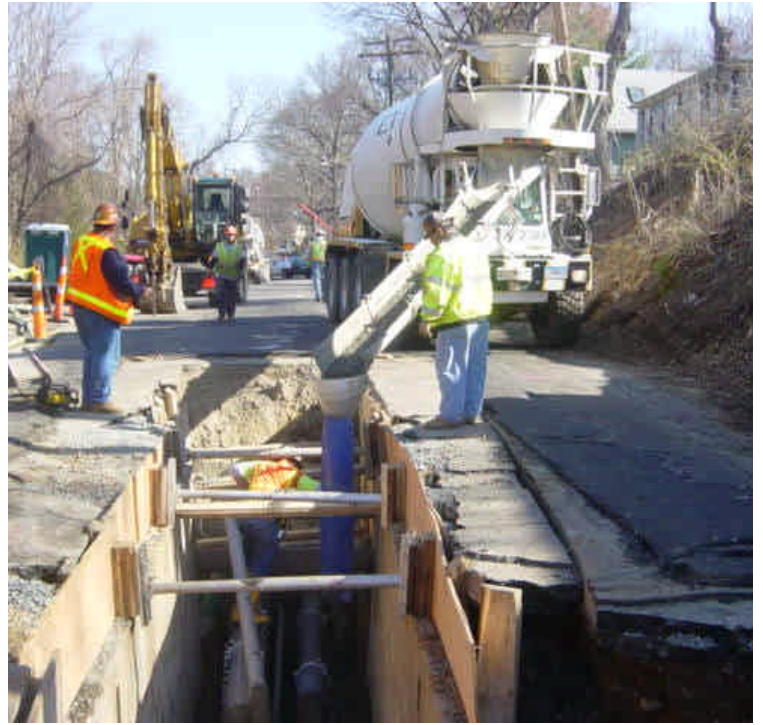
**Backfilling was underway near sta. #1031-1032.**

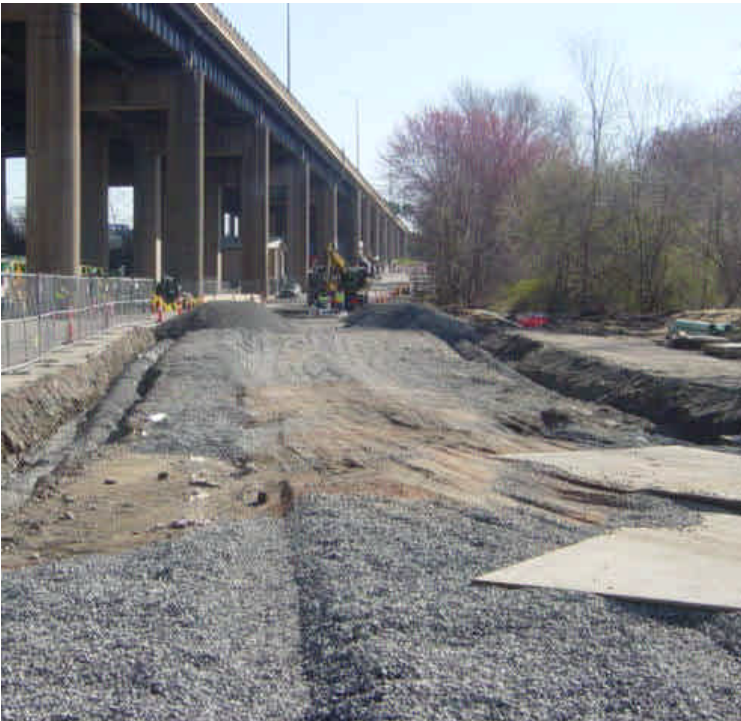
**Tie-ins between the HDD work the vault near sta. #1015 are complete and the area has been partially backfilled. Handholes were being set at the time of the inspection.**

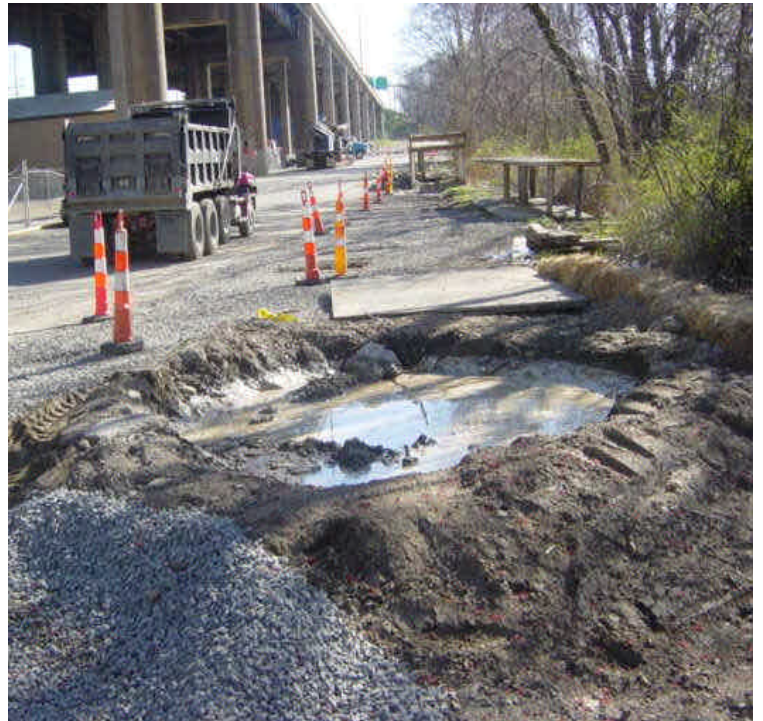
**A designated concrete washout area remains in place near sta. #1018. Watch available capacity and controls here and remove material when feasible.**

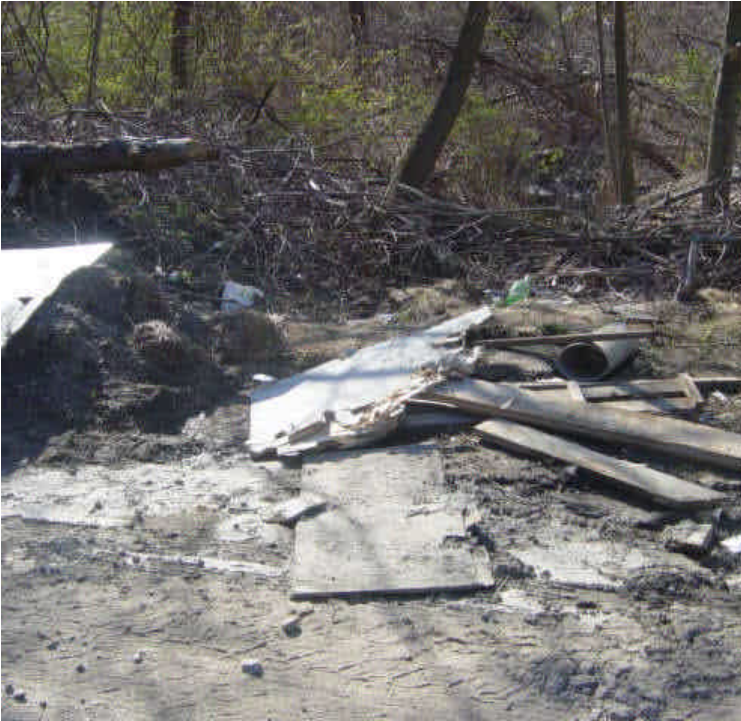
**Debris material has been placed near the drainage swale along the south side of the staging area. The haybales are deteriorating and a resource area is adjacent. This area should be cleaned up as soon as feasible and controls should be evaluated.**

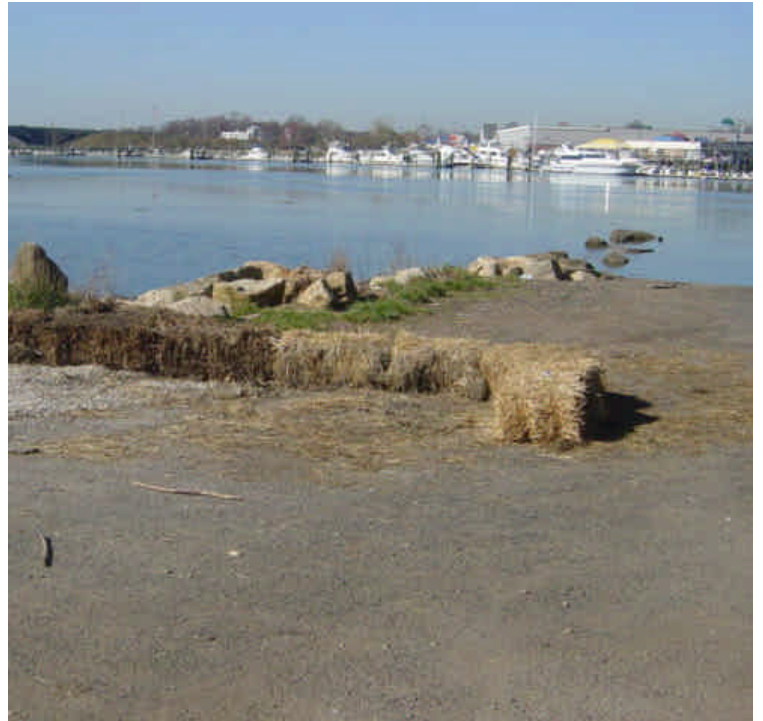
**Deteriorated haybales along the bank of the Housatonic River have been replaced and reset.**

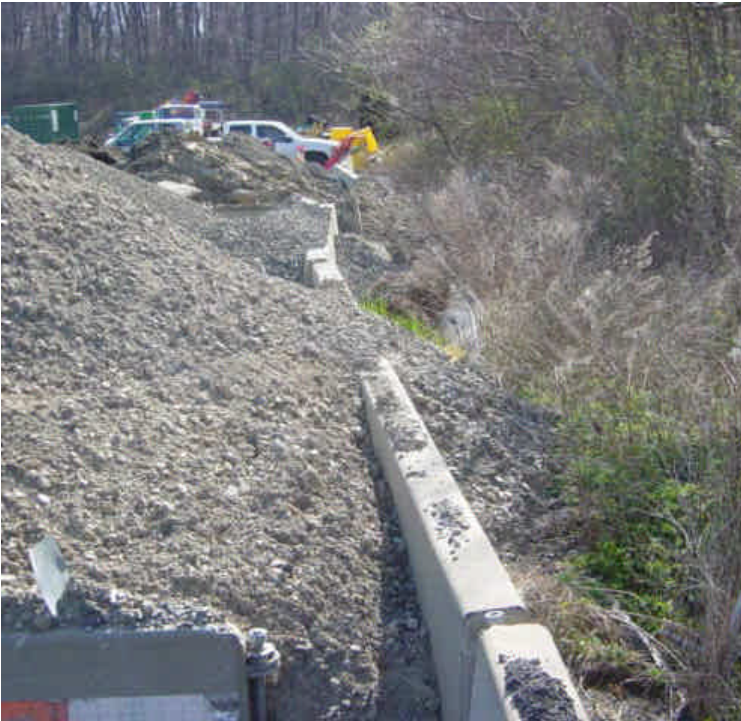
**Stockpiled material has overtopped the established storage bins at the Shelland Street yard, but material remains at the perimeter controls.**

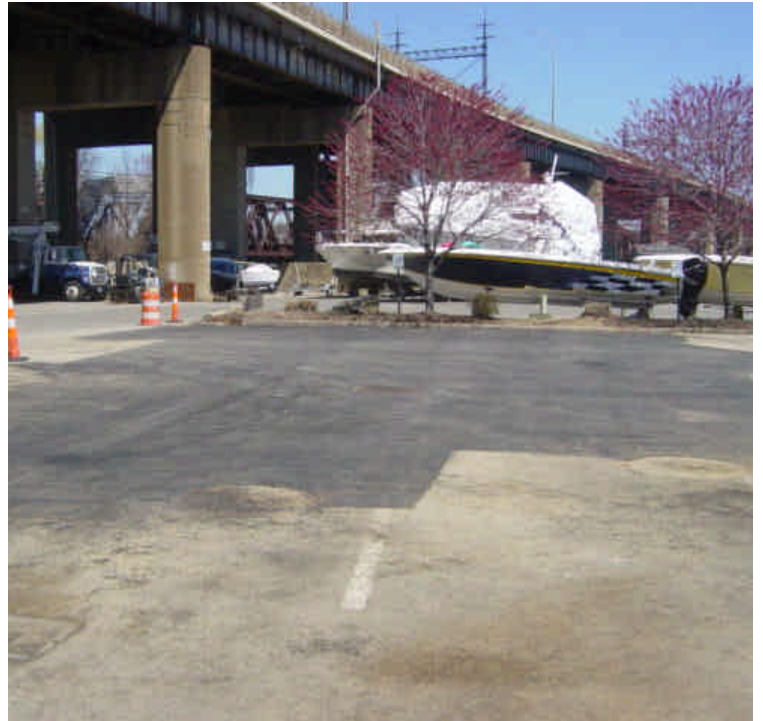
**Staging area on the west side of the Housatonic River near sta. #999 has been paved. A minor amount of remnant sediment remains on the surface.**
