**Docket No. 272 – Development and Management Plan Inspection**

**Segment 3 Underground Line**

**Date:** April 24, 2008

**Location:** East Devon Substation to the Housatonic River Crossing

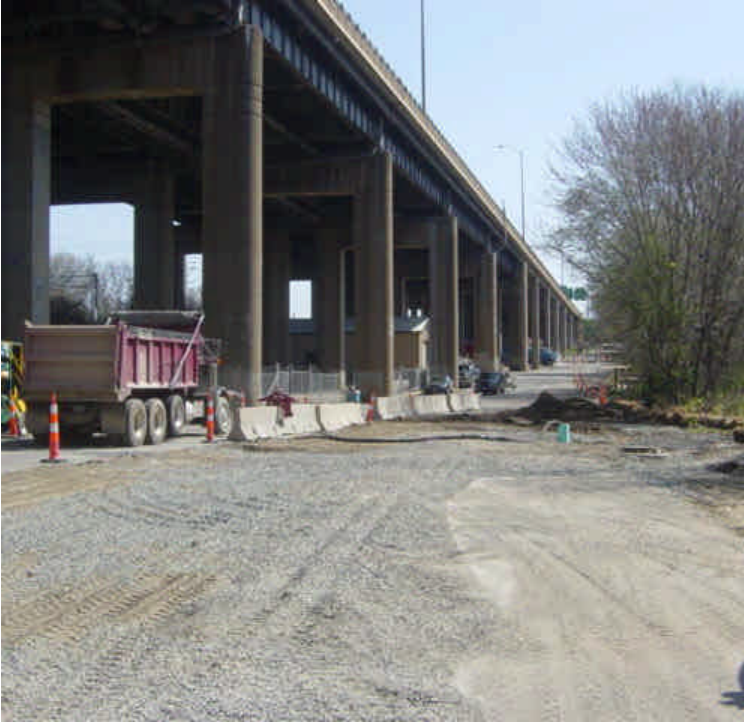
**HDD work has been tied-in to the vault near sta. #1015 and the area was being backfilled with crushed stone and process material in preparation for paving.**

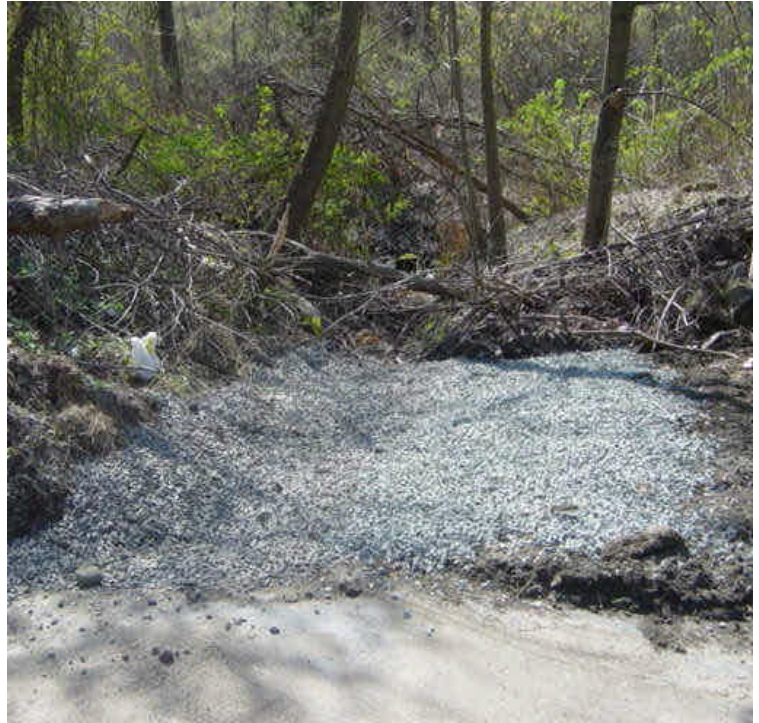
**Deteriorating hay bales have been removed from the drainage swale near sta. #1017. Crushed stone has been installed to limit Sedimentation. Continue to monitor and determine if this is effective.**

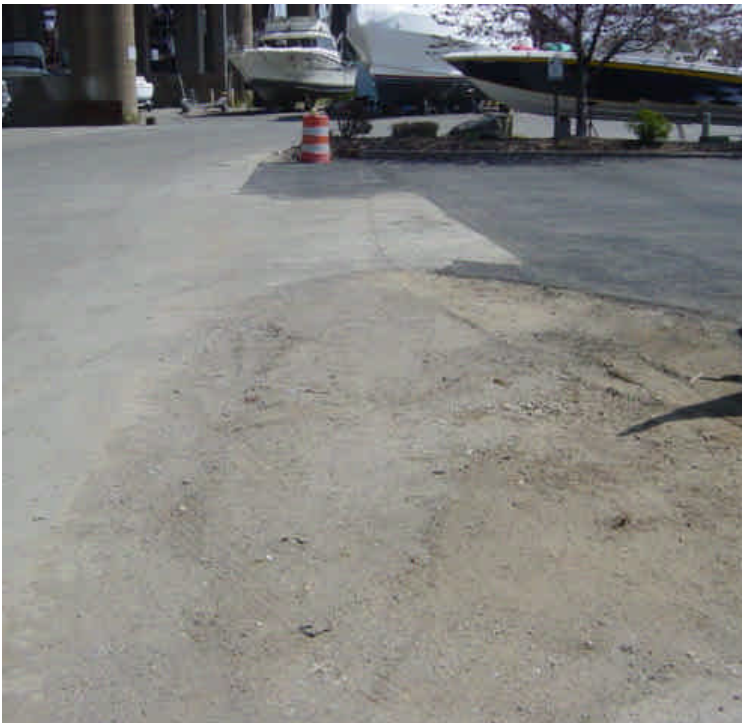
**Tie-in work has been completed on the west side of the Housatonic River near sta. #999 and the area has been paved. A small section remains backfilled with soil/ processed material.**

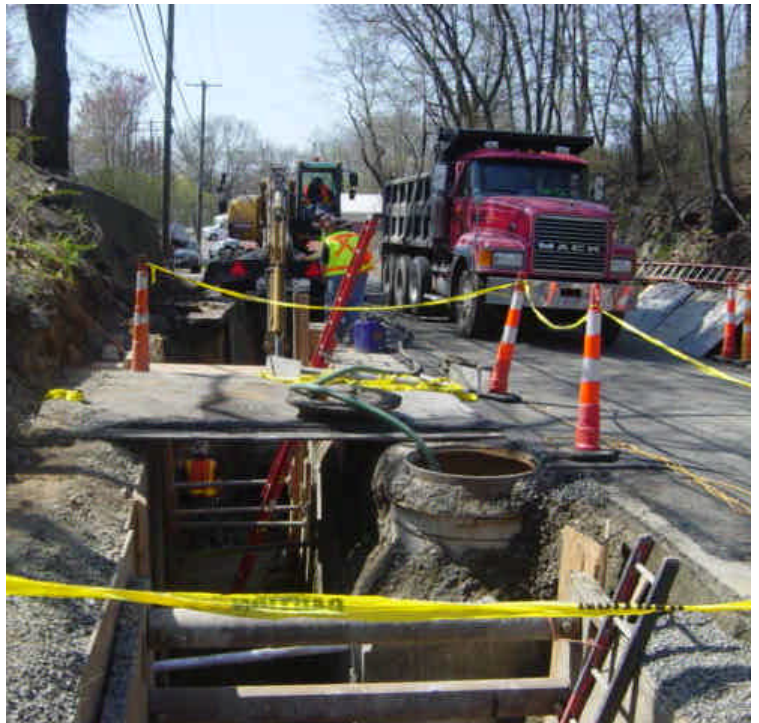
**Trenching continues along Naugatuck Avenue near sta. 1030-1032.**
