Docket No. 272 – Development and Management Plan Inspection

Segment 3 Underground Line

Date: May 22, 2008

Location: East Devon Substation to the Housatonic River Crossing

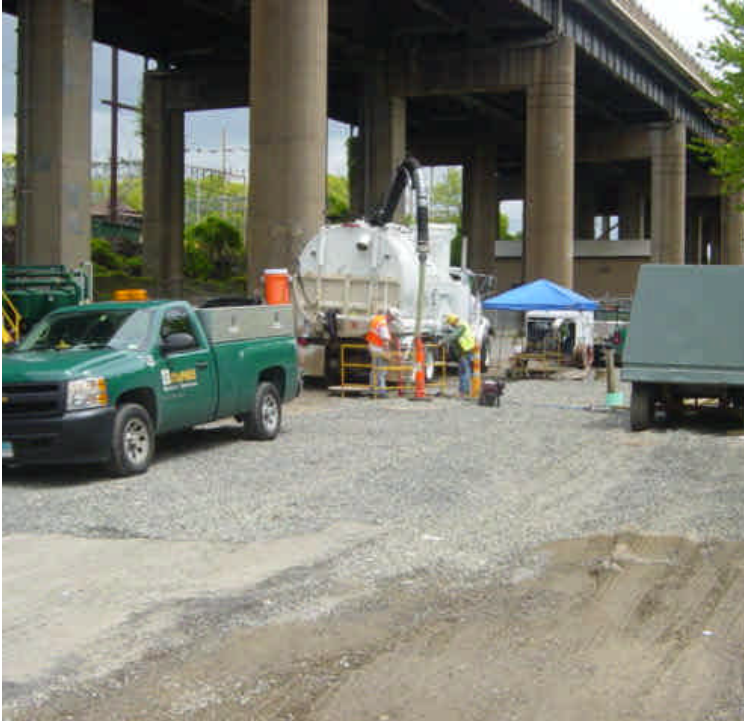
Electrical contractors were on site proofing the lines at vault #1.

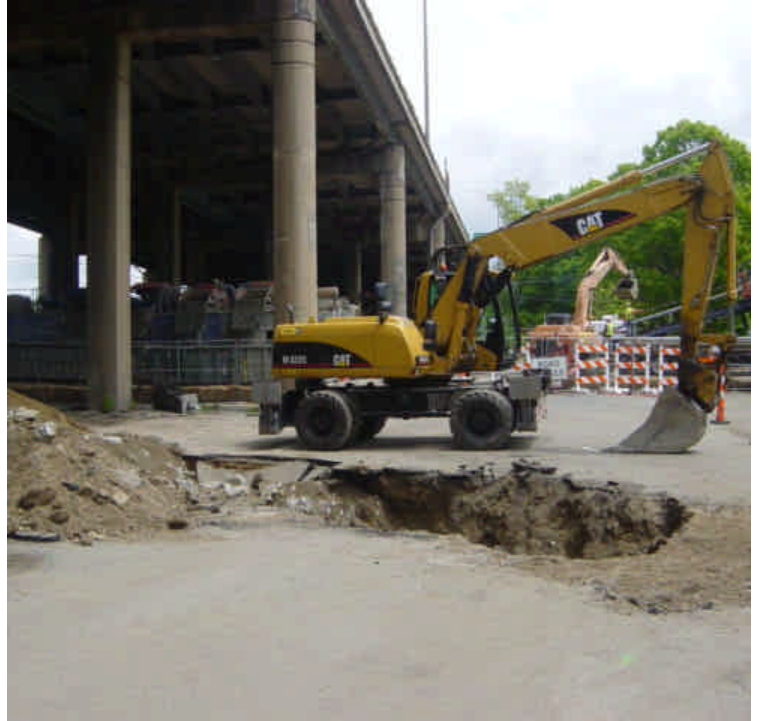
Area near sta. #1020 was being excavated to expose the conduit bank and tie-in with the HDD work.

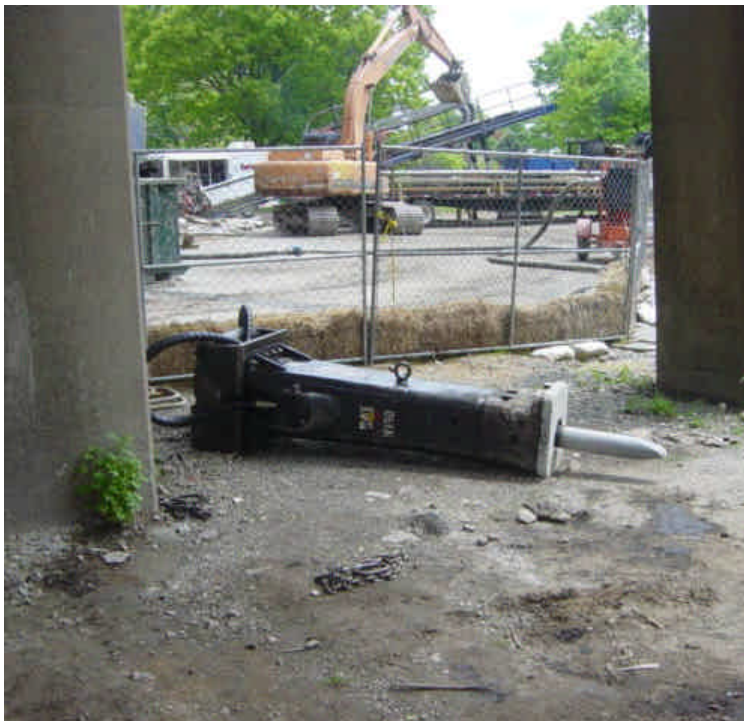
Areas of Inspection	Observation	Recommended Action	Corrected Action
	A hydraulic jacking hammer was temporarily stored along the access drive near sta. #1020 without proactive secondary containment. 5/22/08	When equipment containing hydraulic fluid needs to be temporarily stored on site, provide secondary containment, proactively. 5/22/08	Needs proactive attention.
Additional Observations	None. 5/22/08	None. 5/22/08

Hydraulic jacking hammer was temporarily stored along the access drive near sta. #1020 without secondary containment.

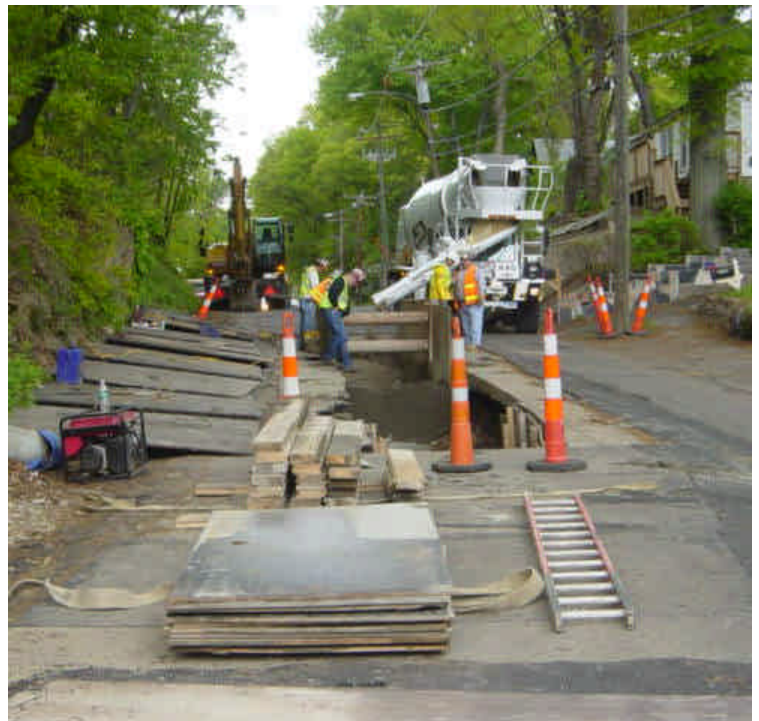
Backfilling was ongoing near sta. #1030-1031.
