Docket No. 272 – Development and Management Plan Inspection

Segment 3 Underground Line

Date: June 12, 2008

Location: East Devon Substation to the Housatonic River Crossing

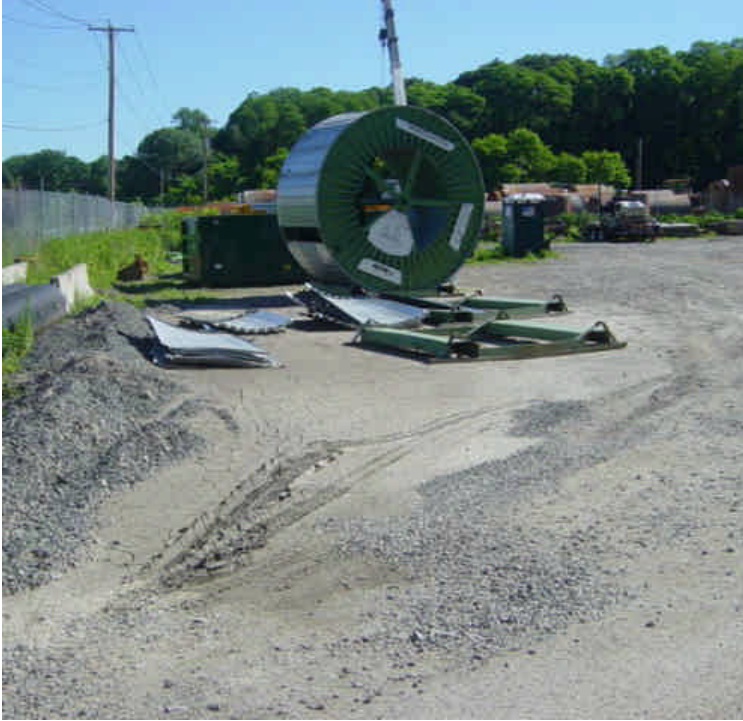
Areas of Inspection	Observation	Recommended Action	Corrected Action
	<p>with the Shelland Street yard near the storage bins to accommodate frac tank washout water. The excavated material was stockpiled along the side of the pit to create a containment berm. A breach occurred within the yard. 6/12/08</p>	<p>material within excavated area. Adjust controls as necessary. Remain aware of capacity issues, especially since the pit is near the perimeter of the yard. See Erosion and Sediment Control section for more details. 6/12/08</p>	
<p>Soils</p>	<p>During active work, soils are exposed as part of the excavation for trench, vault, and utility work. 6/12/08</p>	<p>Soils appear to have been handled appropriately. Ensure any material stockpiles are contained. 6/12/08</p>	<p>NA</p>
<p>State species of concern, threatened and endangered species.</p>	<p>According to the D&M plan, state-listed species are not located in this work area. 6/12/08</p>	<p>None. 6/12/08</p>	<p>NA</p>

Frac tanks have been emptied out at the Shelland Street lay-down yard. Some of the material had overtopped the berm and spilled over the surface of the yard. It was contained by the stone check dam near the entrance to the yard.

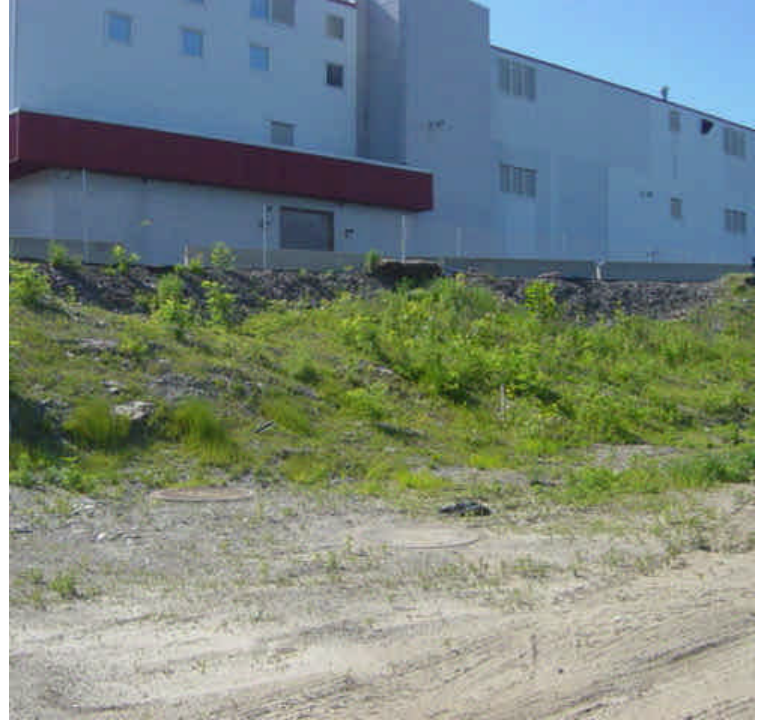
<p>Vegetative clearing (including trees to save or danger trees noted) or stabilization</p>	<p>The sapling remain at sta. #1049 (vault #3) in an effort to restore pre-construction conditions. Adjacent areas remain backfilled with processed material. 6/12/08</p> <p>The exposed soil along the slope near sta. #1080 has naturally vegetated (approximately 90% coverage). 6/12/08</p> <p>Some vegetative cover is in place over the exposed soils located outside of the Milford lay-down yard. The stone berm remains in place. 6/12/08</p>	<p>Continue to monitor and permanently stabilize the area when feasible. Work out an appropriate restoration plan. See erosion control section for more details. 6/12/08</p> <p>Coordinate final restoration/planting plans with the landowner as stated last year. 6/12/08</p> <p>Continue to monitor until exposed soils are permanently stabilized. 6/12/08</p>	<p>NA at this time</p> <p>Area is stable but final restoration plan is still needed.</p> <p>Continue to monitor.</p>

The exposed soil along the slope near sta. #1080 has naturally vegetated (approximately 90% coverage). Coordinate final restoration/planting plans with the landowner.

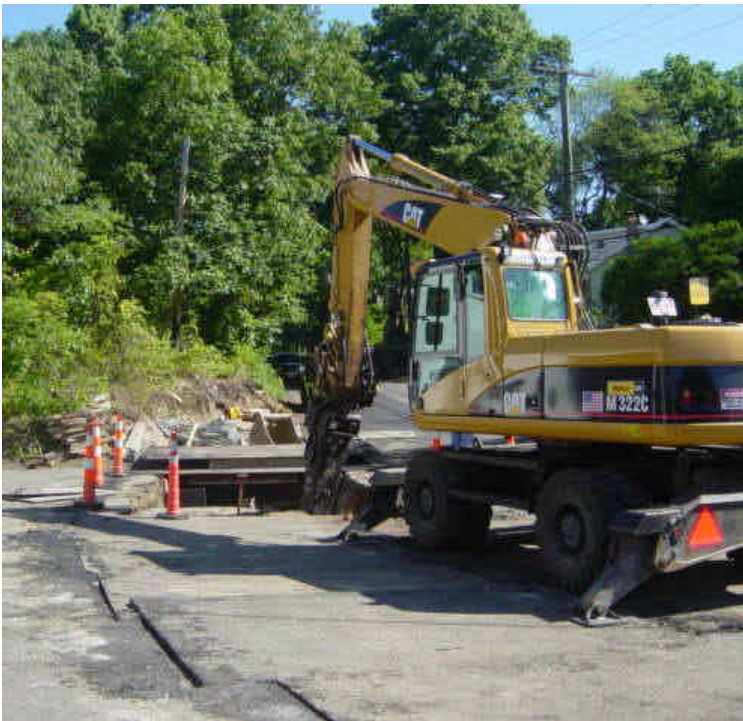
Trenching continues near sta. #1030 to connect with the HDD work. One of the circuits has already been connected.

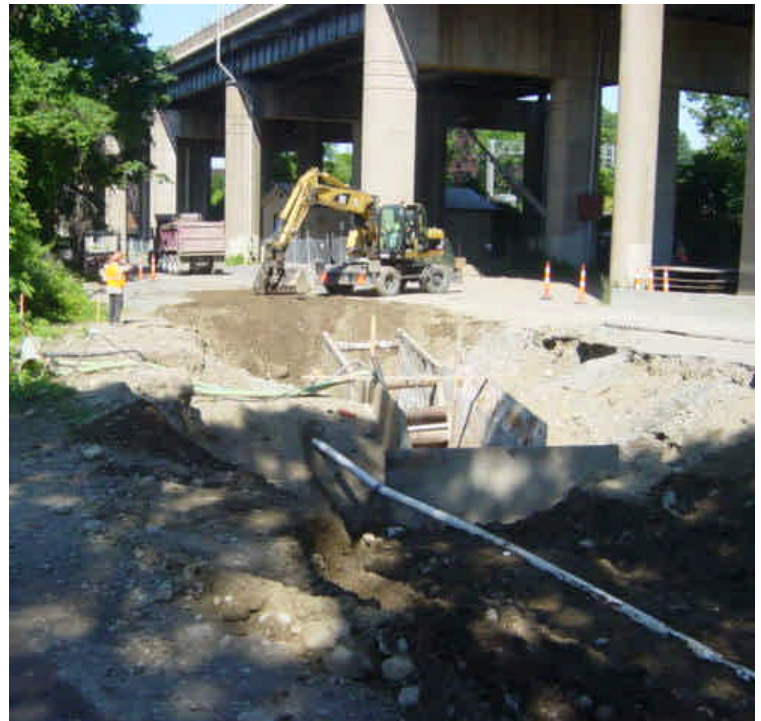
<p>Dewatering</p>	<p>A dewatering was ongoing near sta. #1020. Several of the frac tanks have been removed from the area and were cleaned and emptied at the Shelland Street Yard. 6/12/08</p>	<p>None. Continue to ensure dewatering discharge is contained appropriately and filtered as per the D&M plan. 6/12/08</p>	<p>NA</p>
<p>Blasting</p>	<p>No blasting has been</p>	<p>None 6/12/08</p>	<p>NA</p>

Trenching continues near sta. #1020 to connect with the HDD work. The trench was being dewatered at the time of the inspection.
