Docket No. 272 – Development and Management Plan Inspection

Segment 3 Underground Line

Date: June 20, 2008

Location: East Devon Substation to the Housatonic River Crossing

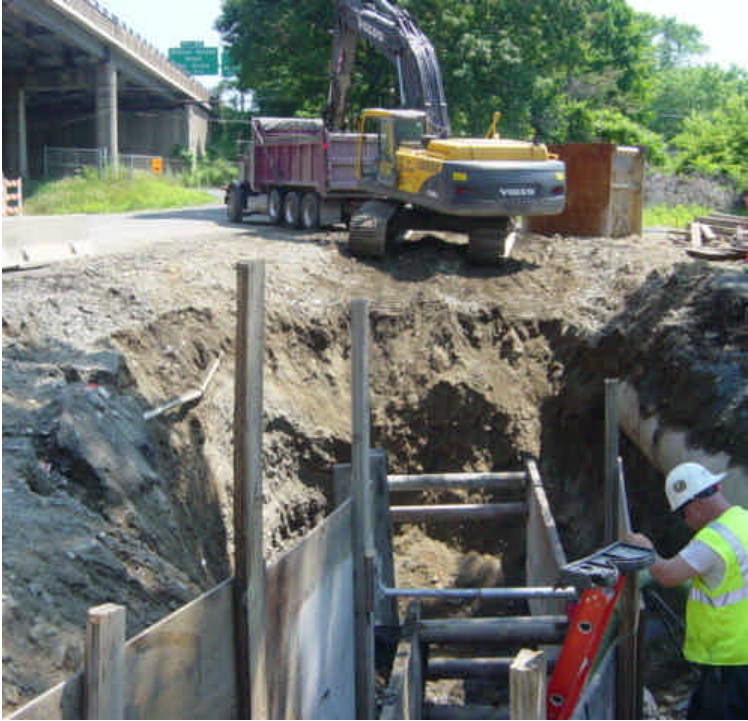
Trenching continues near sta. #1020 to tie-in to the adjacent HDD work.

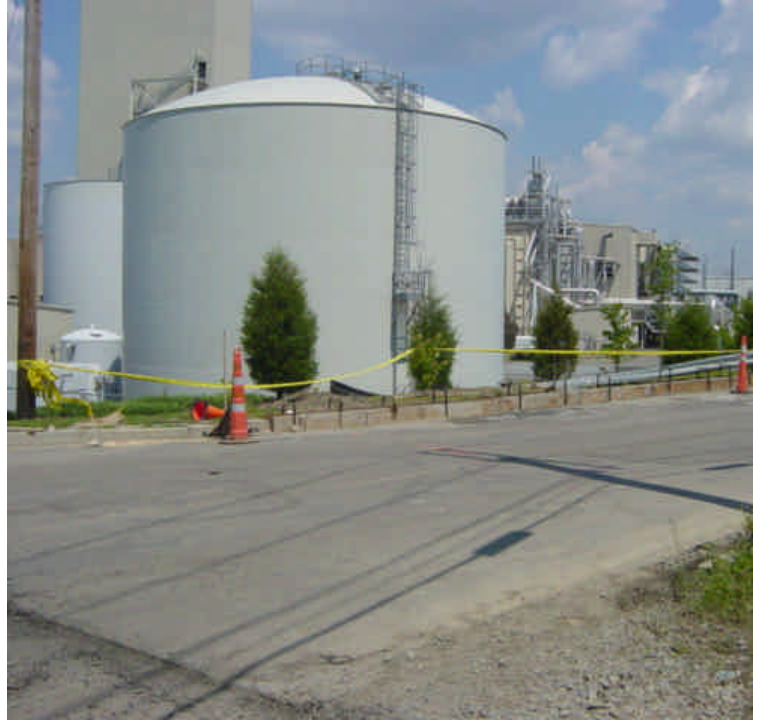
Additional Observations	Concrete curbing was being restored near sta #1095. 6/20/08	None. 6/20/08	NA

Formwork has been constructed near sta. #1095 in preparation to restore concrete curb.

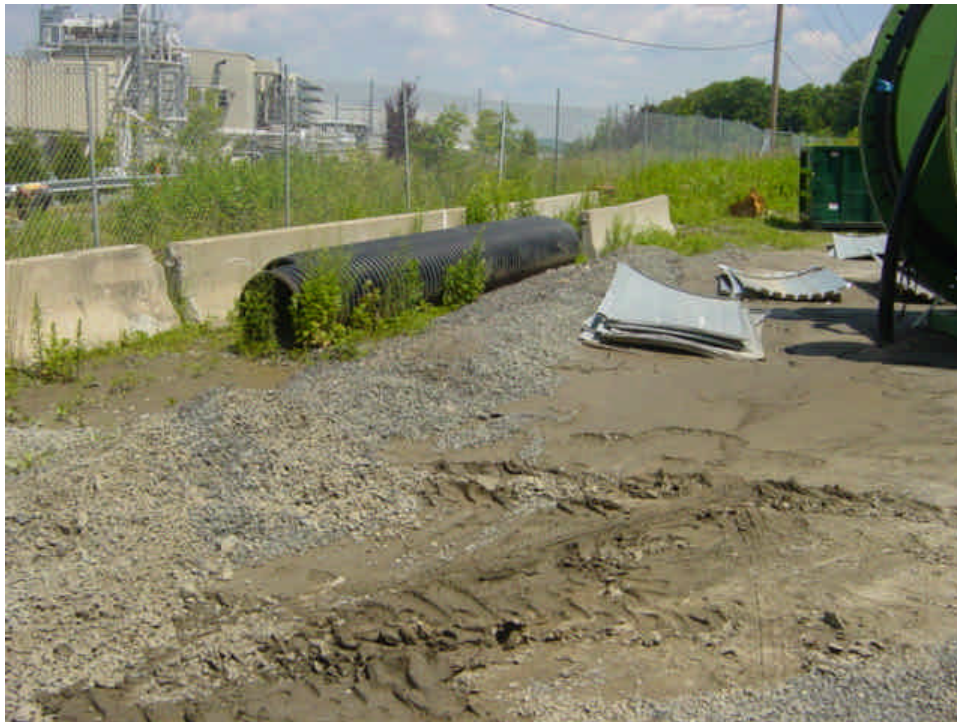
Some of the accumulated material has been removed from the stone barrier near the entrance to the Shelland Street yard.
