Docket No. 272 – Development and Management Plan Inspection

Segment 3 Underground Line

Date: June 27, 2008

Location: East Devon Substation to the Housatonic River Crossing

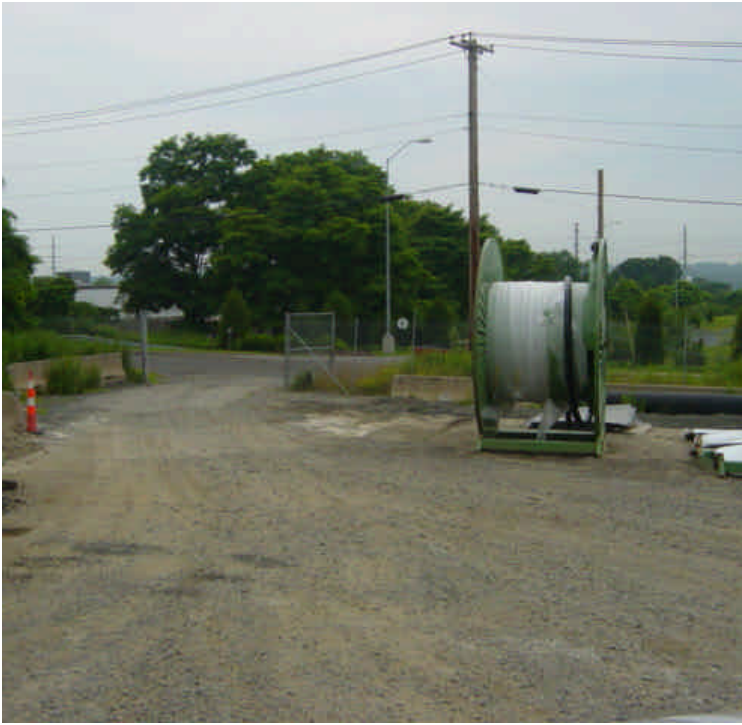
Some of the accumulated material has been removed from the stone barrier near the entrance to the Shelland St. yard.

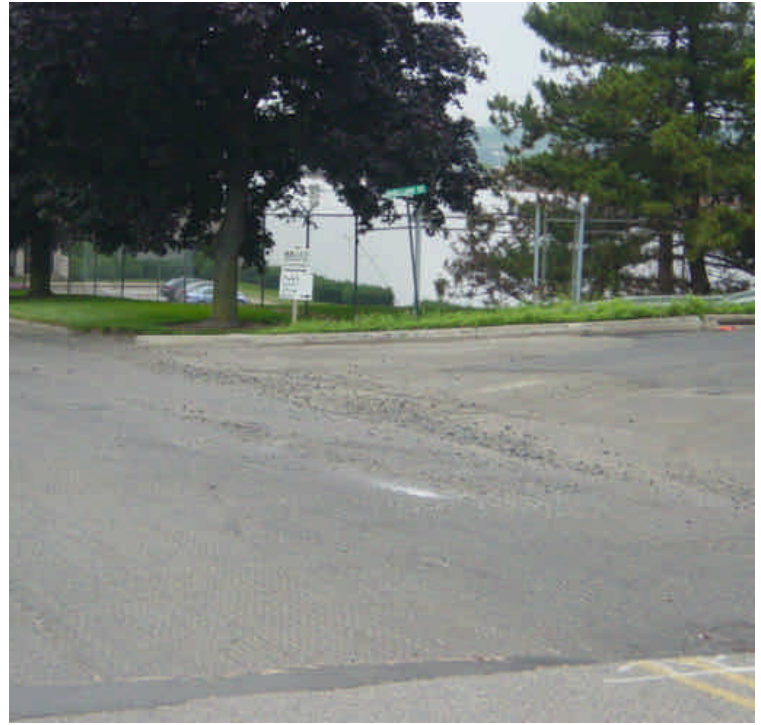
Portions of Caswell St. and Shelland St. have been milled in preparation for paving activities.

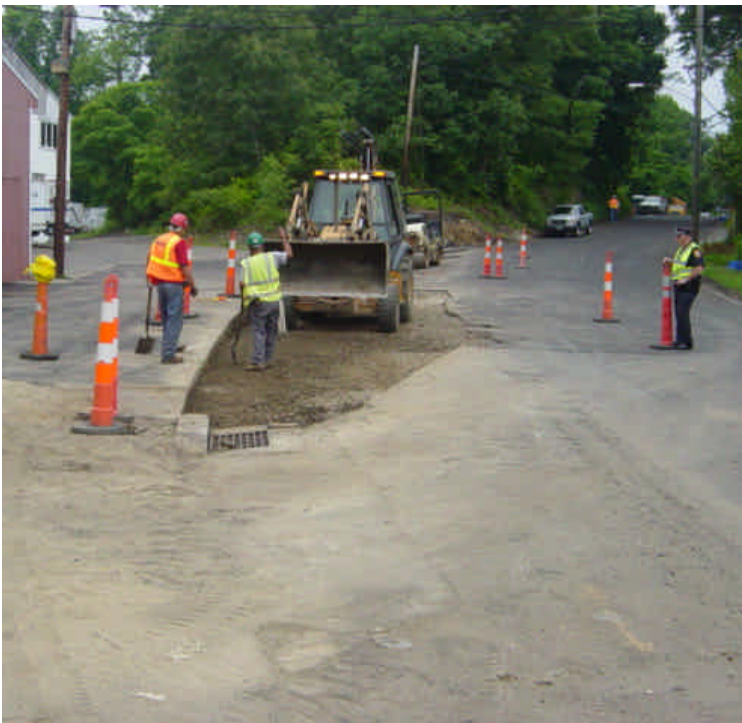
HDD tie-in work has been completed near sta. #1030. A small section was being regraded to facilitate drainage. Sediment has accumulated along the edge of the roadway near the catch basin. Controls should have been installed with the adjacent work.

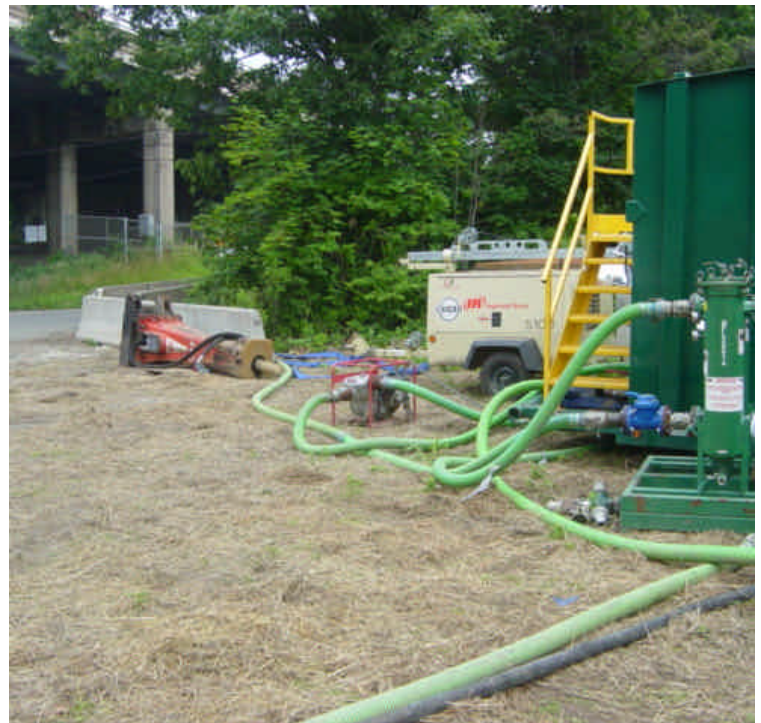
Hydraulic jacking hammer was stored near sta. #1020 without proactive secondary containment.
