**Docket No. 272 – Development and Management Plan Inspection**

**Segment 3 Underground Line**

**Date:** July 2, 2008

**Location:** East Devon Substation to the Housatonic River Crossing

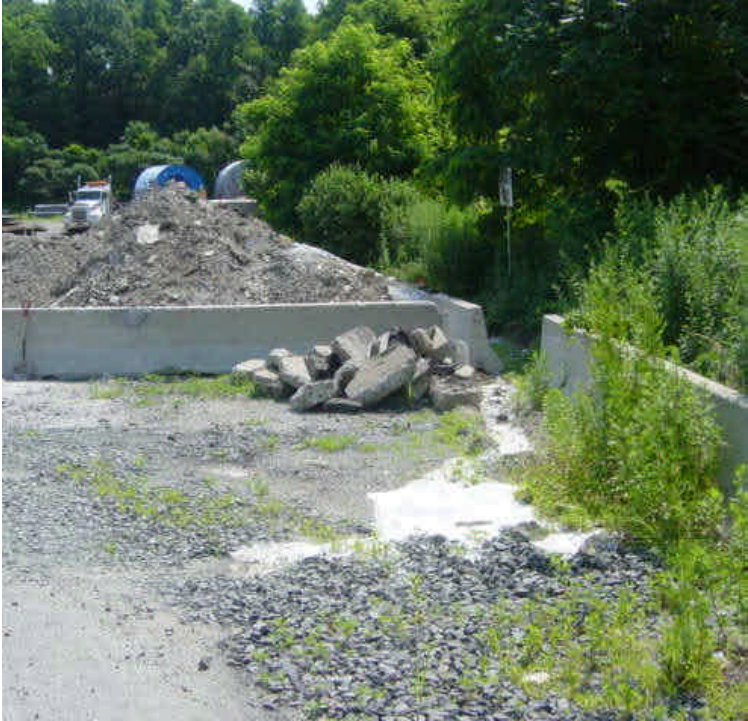
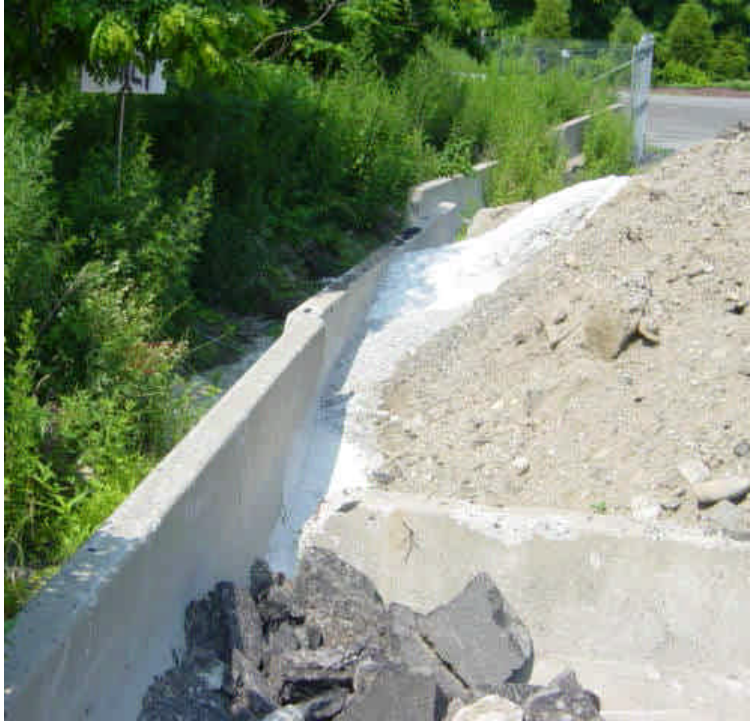
Areas of Inspection	Observation	Recommended Action	Corrected Action
	<p>it eventually cured. No concrete work associated with the project was ongoing when the washouts occurred. It is unclear whether the washouts are project related. 7/2/08</p>	<p>yard to prevent unauthorized vehicles from entering the yard. 7/2/08</p>	
<p><b>Inland Wetland and Watercourse encroachment and mitigation</b></p>	<p>Inland Wetland resource areas are located near sta. #1012 to 1021, #1051, and #1053. 7/2/08</p>	<p>Monitor resource areas to ensure that non-permitted encroachment or impacts do not occur. 7/2/08</p>	<p>NA</p>
<p><b>Staging, Storage, and Parking Areas</b></p>	<p>A contractor lay-down yard is located in Milford off of Shelland St. Stone is in place throughout the yard to reduce mud and subsequent tracking. 7/2/08</p> <p>A sizable amount of stockpiled material has overtopped the concrete storage bins and spilled onto the adjacent silt fence. Contractor has stated they plan to remove the material prior to final restoration (since 3/6). Material has been removed from behind one of the bins, but remains in other areas. 5/8-7/2/08</p>	<p>See Erosion Control and Spills and Material Storage sections for more details. 7/2/08</p> <p>Contain material within established storage area and limits of the yard. Consider removing the remainder of the material that has been pushed beyond the limits of the yard now, rather than during final restoration. 3/6-7/2/08</p>	<p>NA</p> <p>Needs additional attention.</p>

**Evidence of what appears to be several concrete washouts were observed near the material storage bunkers. Slurry material flowed out the back of the bunker and towards the entrance to the yard where it eventually cured. No concrete work associated with the project was ongoing when the washouts occurred. It is unclear whether the washouts are project related.**

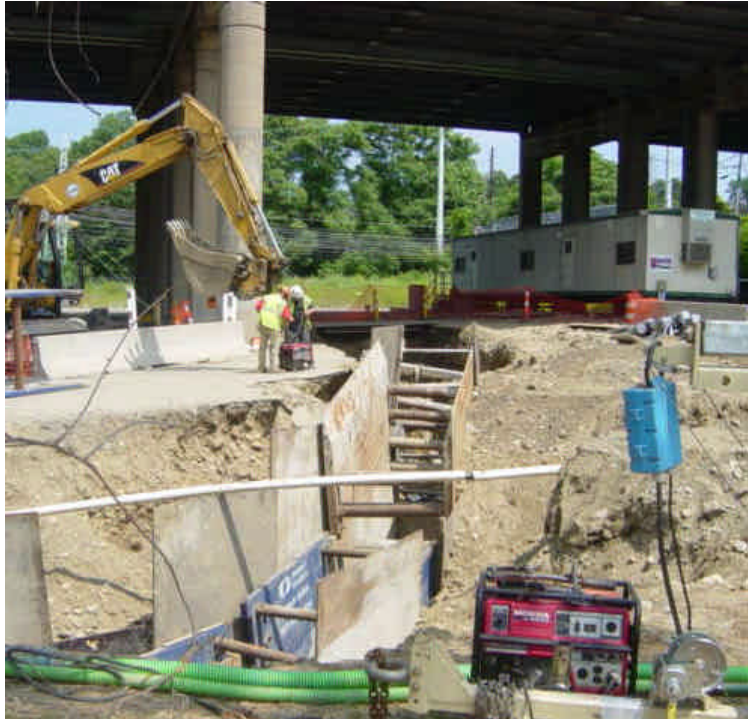
<b>Excavation continues near sta. #1020 to connect/tie-in with the HDD work. Work was temporarily on hold at the time of the inspection. 7/2/08</b>	<b>None. 7/2/08</b>	<b>NA</b>
	<b>Tie-in with the HDD work was complete near sta. #1030. The area has been</b>	<b>None. 7/2/08</b>	<b>NA</b>

**Trenching continues near sta. #1020 to tie-in to the HDD work.**

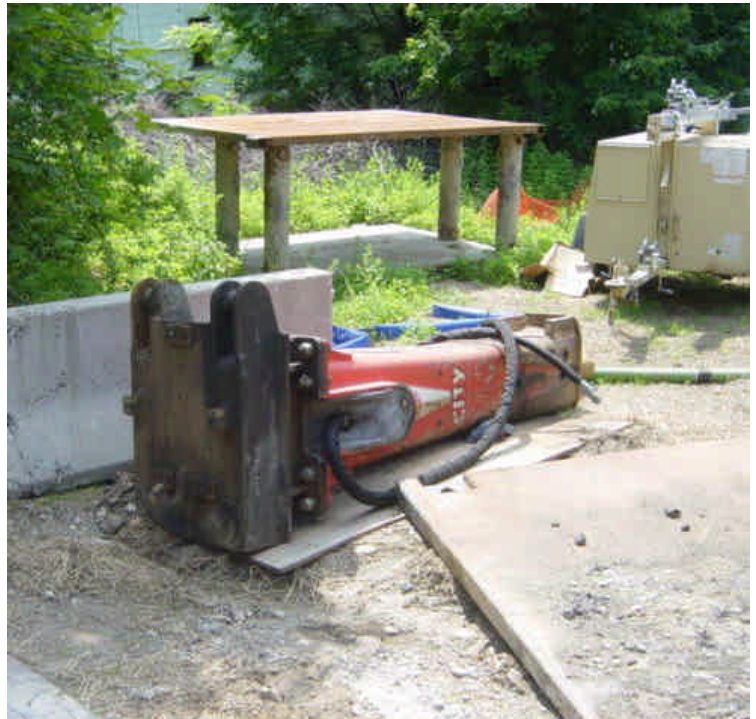
Blasting	No blasting has been proposed. 7/2/08	None 7/2/08	NA
Spills and Material Storage	<p>Reserve spill cleanup materials/kits were observed in the storage yard. 7/2/08</p> <p>The hydraulic jacking hammer that was previously observed without proactive containment near sta. #1020 now has plywood placed underneath to contain any leaks. 7/2/08</p> <p>Stockpiled materials are overtopping the established storage bins, beyond the perimeter controls of the yard. (noted since 4/25/07) The amount of material has increased (since 3/6/08). Material has been removed from behind one of the bins, but</p>	<p>Continue to bring spill kits to active work sites. 7/2/08</p> <p>When equipment containing hydraulic fluid needs to be temporarily stored on site, provide secondary containment, proactively. 7/2/08</p> <p>Previously, contractors stated the materials will be removed when the area is restored. However, due to the increase in amount of material, consider removing the material beyond the yard limits sooner rather than waiting until yard restoration. 3/6-7/2/08</p>	<p>NA</p> <p>Plywood has been placed under the hydraulic jacking hammer.</p> <p>Needs additional attention.</p>

**A piece of plywood has been placed under the hydraulic jacking hammer stored near sta. #1020 to proactively contain any potential leaks.**
