Docket No. 272 – Development and Management Plan Inspection

Segment 3 Underground Line

Date: August 21, 2008

Location: East Devon Substation to the Housatonic River Crossing

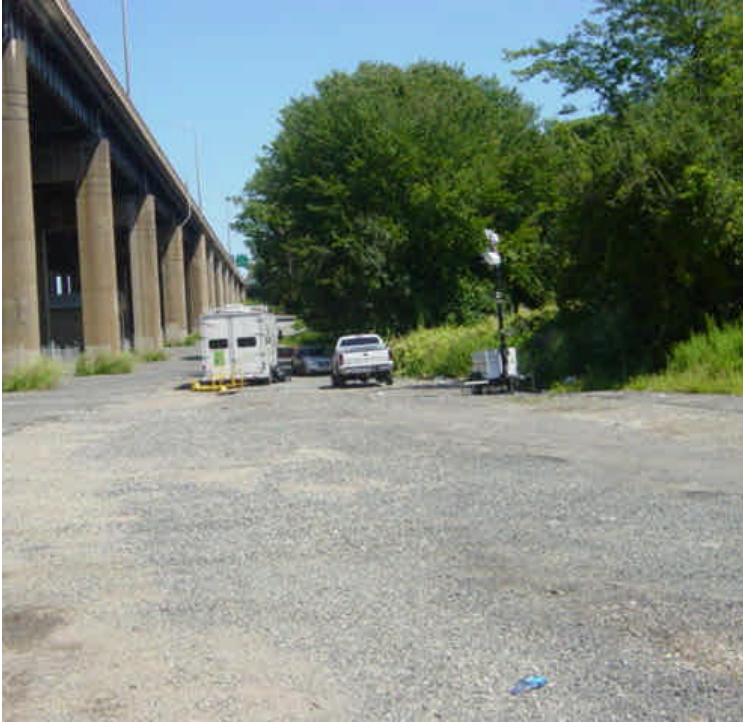
Electrical contractor was on site at vault #1. The areas have been backfilled with crushed stone and are generally stable. Final restoration is on-hold pending a planned DOT drainage project.

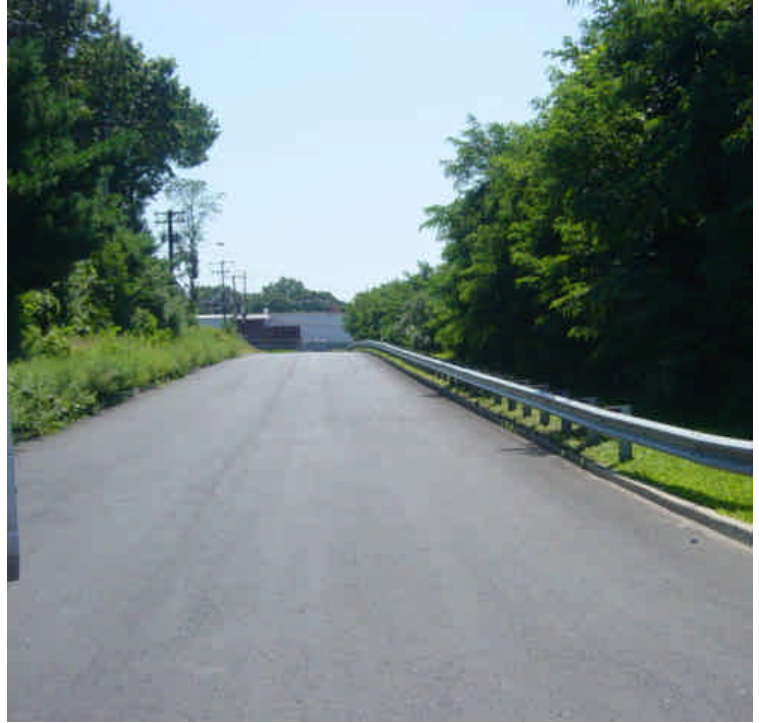
Portions of Shelland Street have been repaved.

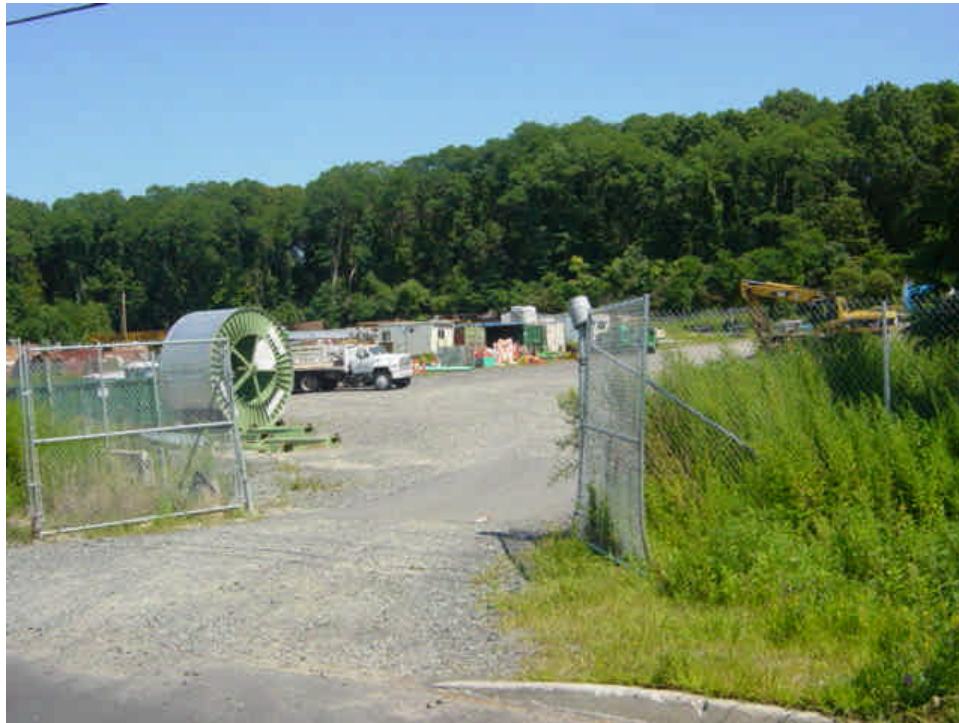
A contractor lay-down yard is located in Milford off of Shelland St. Stone is in place throughout the yard to reduce mud and subsequent tracking
