**Docket No. 272 – Development and Management Plan Inspection**

**Segment 3 Underground Line**

**Date:** September 5, 2008

**Location:** East Devon Substation to the Housatonic River Crossing

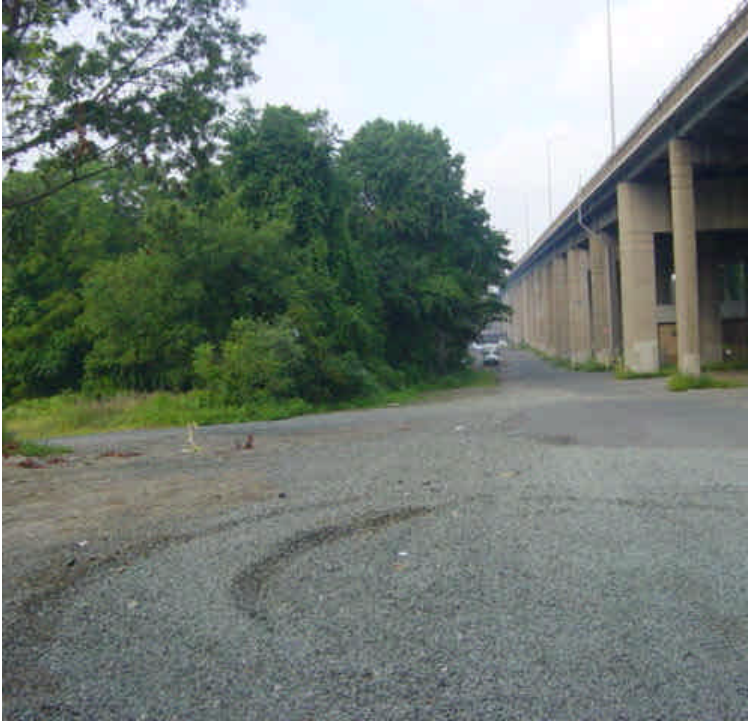
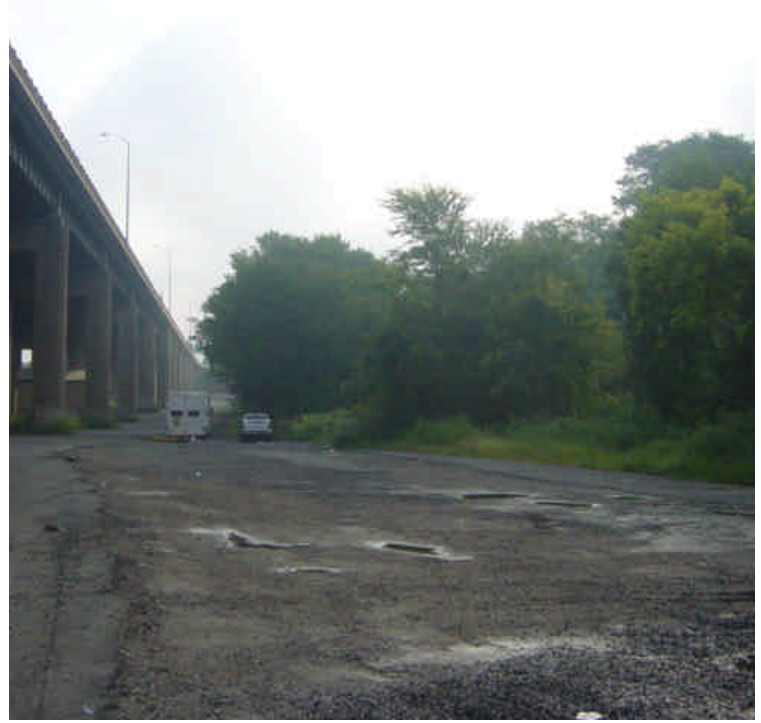
**The area near sta. #15-20 remains backfilled with crushed stone and is generally stable. Final restoration is on-hold pending a planned DOT drainage project.**

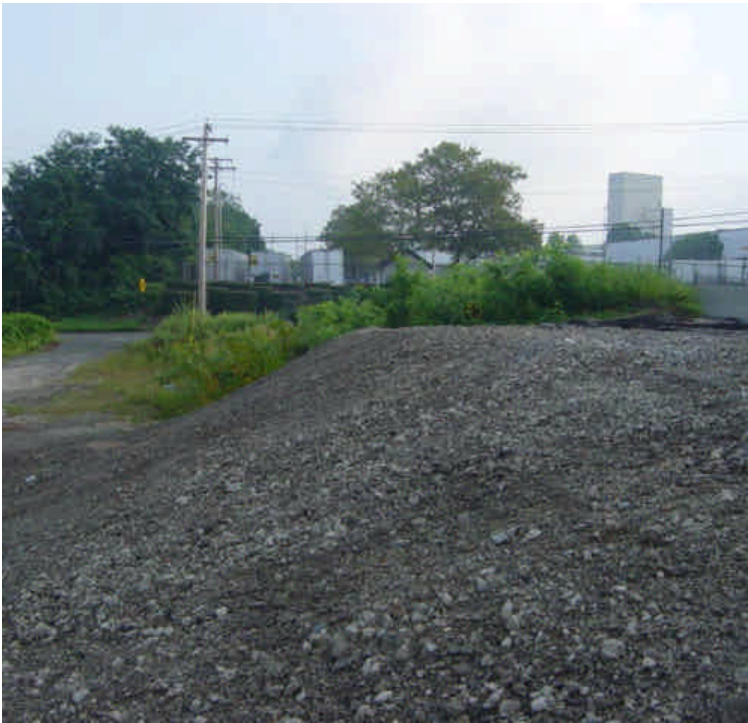
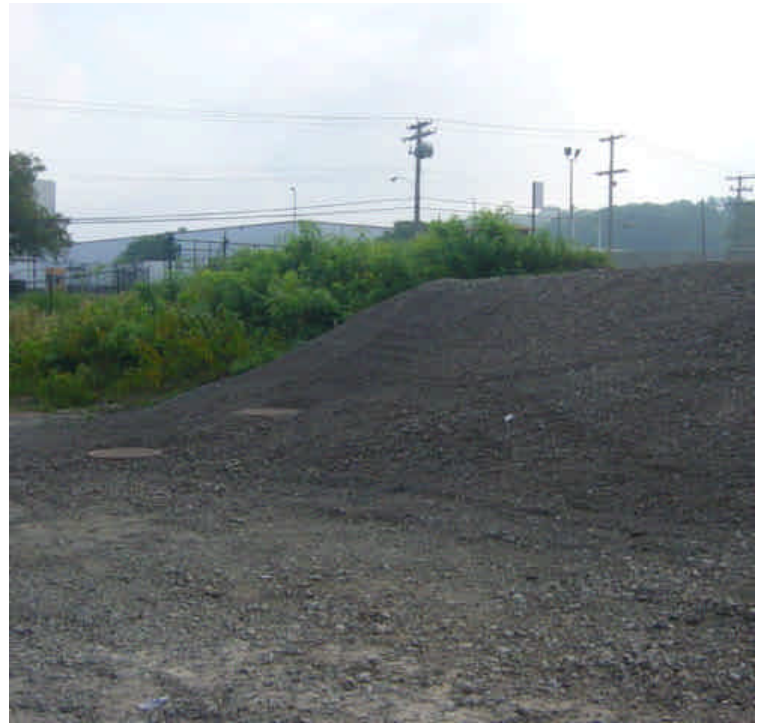
<p>The slope near sta. #1080 has been re-graded as part of the final restoration plan but soil remains exposed for several weeks. 9/05/08</p>	<p>Continue to monitor and provide vegetative cover/plantings as soon as possible. See Soils section for more details. 8/14-9/05/08</p>	<p>Needs final restoration.</p>
	<p>Stone berm and silt fence remain near the entrance to the yard. The area is partially vegetated and stable. A small section of silt fence is sagging but continues to function. 9/05/08</p>	<p>Monitor the effectiveness of existing controls. Repair sagging section of silt fence. 9/05/08</p>	<p>Needs attention when feasible.</p>
	<p>A stone construction pad is in place at the entrance to the Shelland Street yard. 9/05/08</p>	<p>None. 9/05/08</p>	<p>NA</p>
<p>Inland Wetland and Watercourse encroachment and mitigation</p>	<p>Inland Wetland resource areas are located near sta. #1012 to 1021, #1051, and #1053. 9/05/08</p>	<p>Monitor resource areas to ensure that non-permitted encroachment or impacts do not occur. 9/05/08</p>	<p>NA</p>

**Area near sta. #1080 was re-graded several weeks ago and remains exposed. Continue to monitor and permanently stabilize the area as soon as possible.**
