Docket No. 272 – Development and Management Plan Inspection

Segment 3 Underground Line

Date: September 12, 2008

Location: East Devon Substation to the Housatonic River Crossing

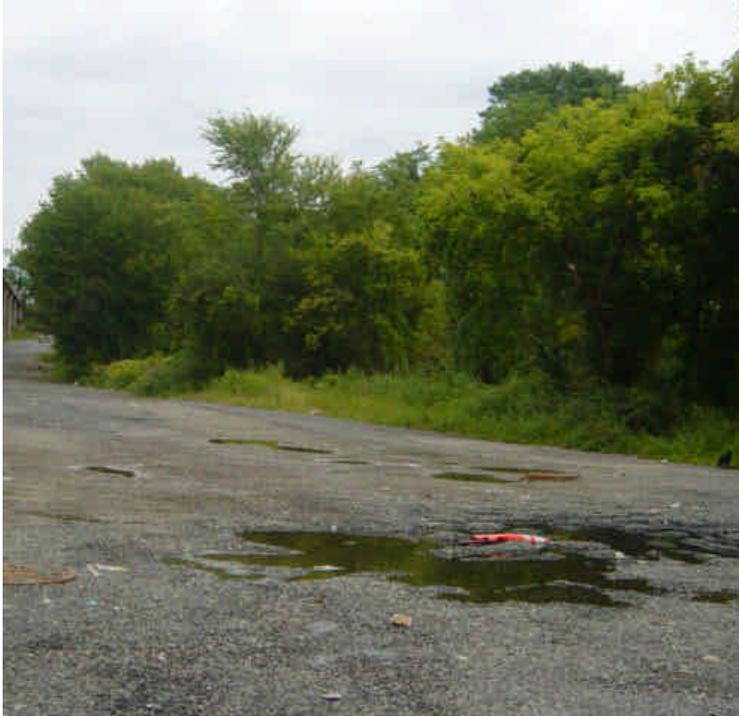
The area near sta. #15-20 has been backfilled with crushed stone and is generally stable. Final restoration is on-hold pending a planned DOT drainage project. Clear water continues to pool near the vault.

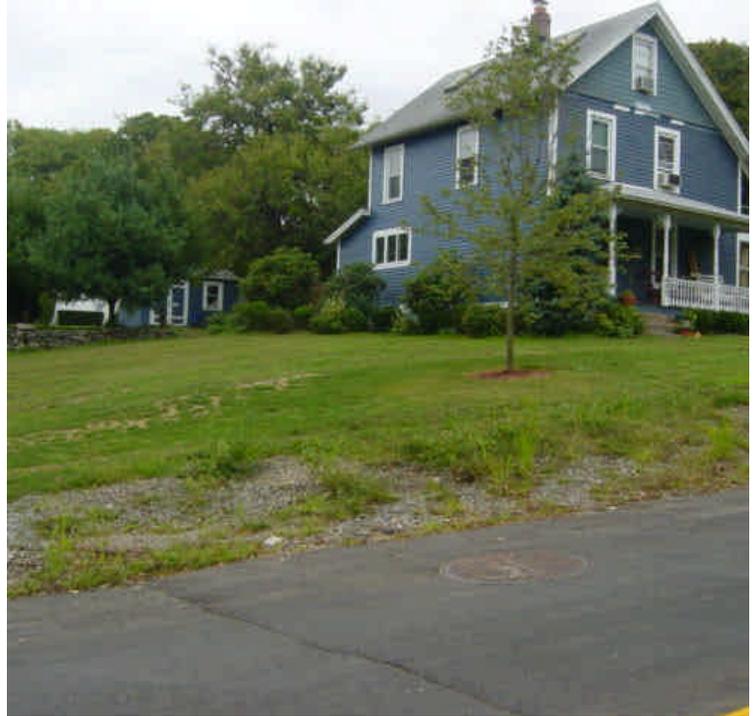
Area near sta. #1040 has been partially restored and remains backfilled with processed material. Restore the area to original lawn conditions.

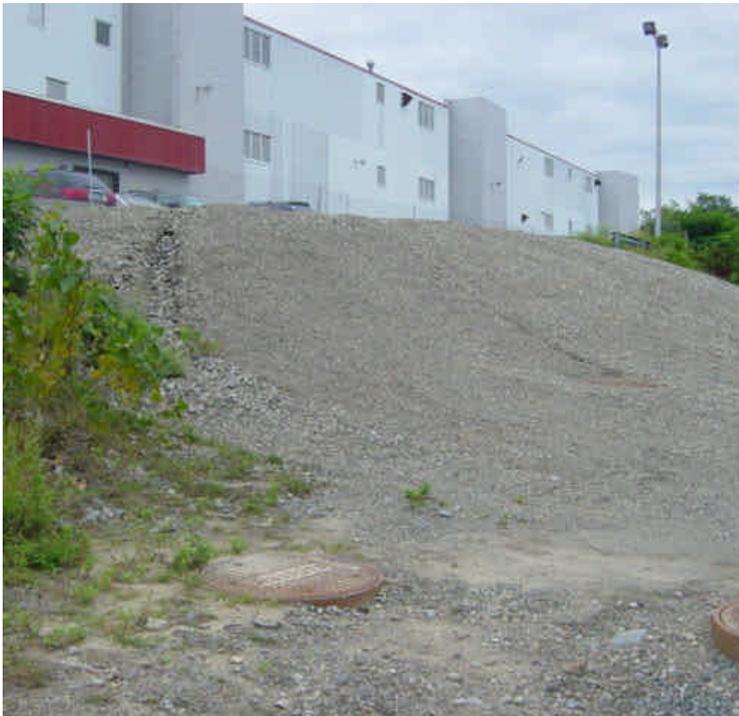
Area near sta. #1080 was re-graded several weeks ago and remains exposed. permanently stabilize the area. Continue to monitor and permanently stabilize the area as soon as possible.

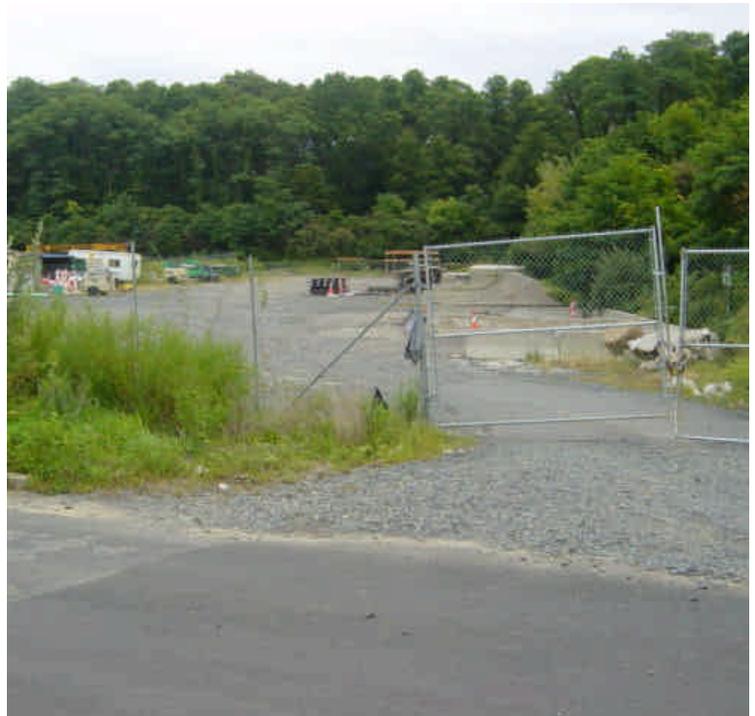
Equipment is beginning to demobilize from the Shelland St yard. Stockpiled materials are also diminishing.
