**Docket No. 272 – Development and Management Plan Inspection**

**Segment 3 Underground Line**

**Date:** September 19, 2008

**Location:** East Devon Substation to the Housatonic River Crossing

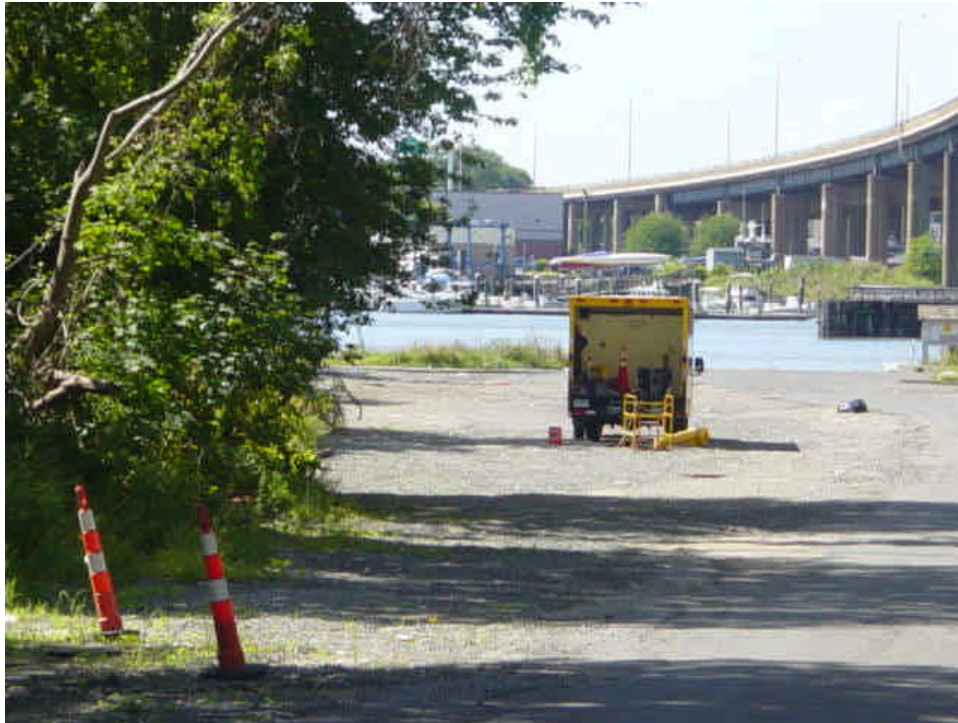
**Electrical contractor was on site at vault #1.**

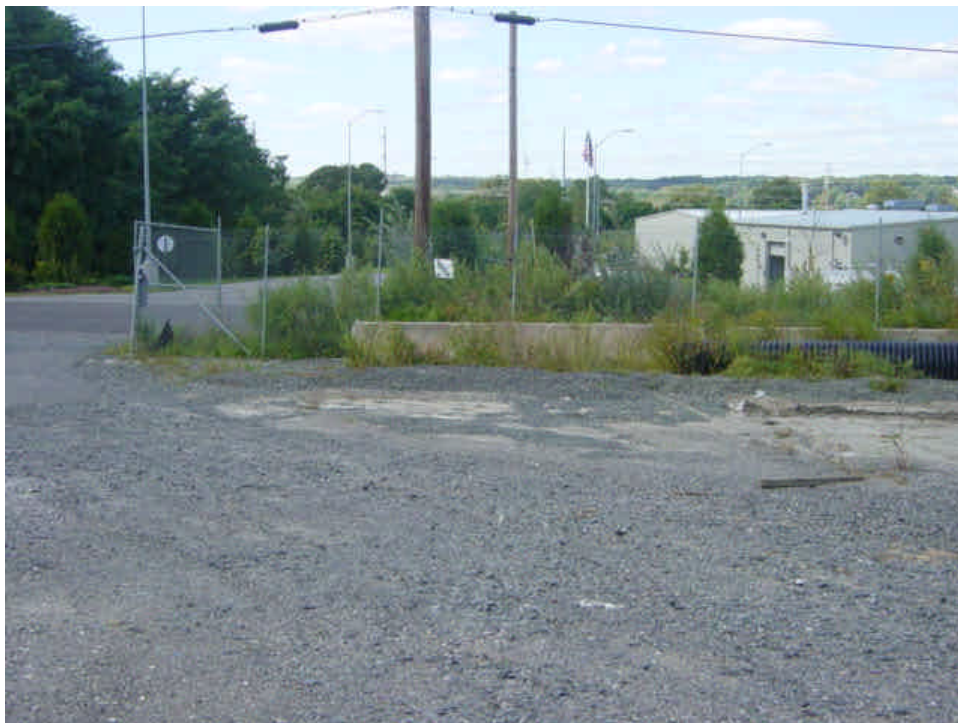
**Accumulated sediment remains contained near the entrance to the Shelland Street yard. Equipment is being demobilized as work is concluding.**

<b>Areas of Inspection</b>	<b>Observation</b>	<b>Recommended Action</b>	<b>Corrected Action</b>
<b>Access Roads and Adjacent Roadways</b>	<b>A crushed-stone berm controlling sedimentation remains near the entrance to the Shelland Street lay-down yard. 9/19/08</b>	<b>Continue to monitor area and sweep roadway as necessary. 9/19/08</b>	<b>Not applicable (NA)</b>
	<b>A temporary access drive to the boat ramp off of Naugatuck Ave. remains but was no longer in use. 9/19/08</b>	<b>None. 9/19/08</b>	<b>NA</b>
<b>Vault Openings and Trench Construction</b>	<b>Electrical contractor on-site at vault #1 &amp; #2. 9/19/08</b>	<b>None. 9/19/08</b>	<b>NA</b>
<b>Erosion and Sediment Controls</b>	<b>Trenching work in paved areas has been completed. Filter fabric or filter socks remain in some catch basins, while other basins will be cleaned when work is completed. 9/19/08</b>	<b>If work is complete, remove any remaining controls and clean the catch basins as necessary. If work resumes, prevent sediment from entering basin. 9/19/08</b>	<b>Needs regular attention.</b>
