Docket No. 272 – Development and Management Plan Inspection

Segment 3 Underground Line

Date: September 26, 2008

Location: East Devon Substation to the Housatonic River Crossing

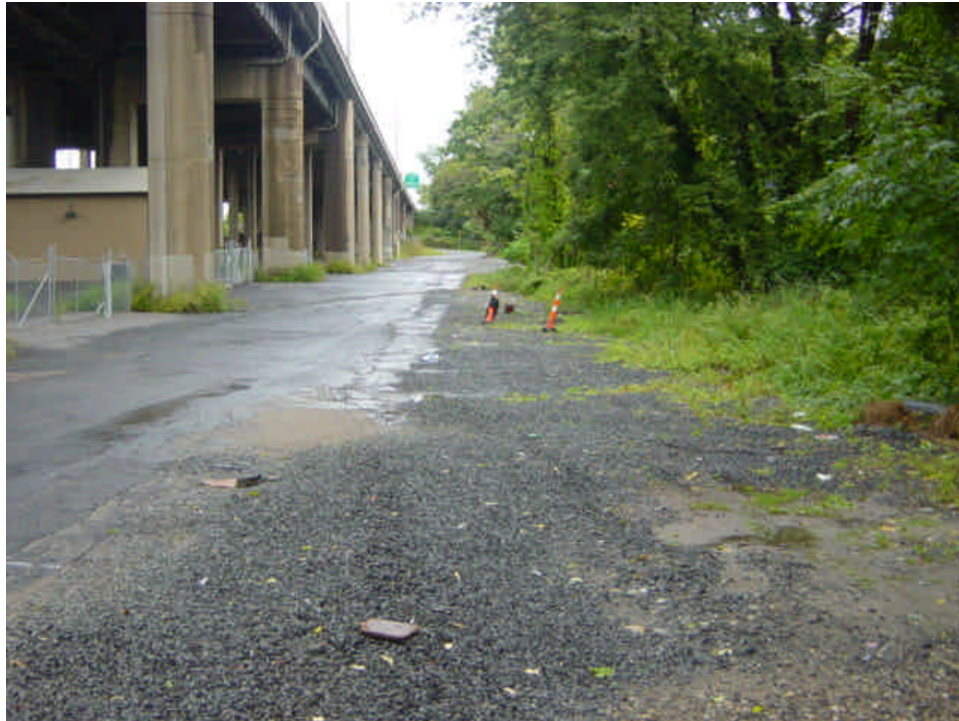
Areas of Inspection	Observation	Recommended Action	Corrected Action
<p>Milford lay-down yard</p>	<p>Excavation work is complete near sta. #1015-1020. The area is stable but the surface is waiting to be paved (portions since 6/6), leaving some potential for run-off. However, the pooling water and run-off from this area is clear. 9/26/08</p>	<p>Final restoration efforts are on hold until after a planned DOT drainage project. Install controls if necessary until the area is resurfaced. 8/14-9/26/08</p>	<p>Continue to monitor.</p>
	<p>The slope near sta. #1049 (vault #3) was still partially covered in exposed process material. It should be placed with topsoil and seeded. 9/26/08</p>	<p>Apply topsoil and seed or establish final cover. 9/26/08</p>	<p>The slope needs final restoration. Needs evaluation</p>
	<p>The slope near sta. #1080 has been re-graded as part of the final restoration plan but soil remains exposed for several weeks. A gully has started to form. 9/12-9/26/08</p>	<p>Continue to monitor and provide vegetative cover/plantings as soon as possible. See Soils section for more details. 8/14-9/26/08</p>	<p>Needs final restoration.</p>

Area near sta. #1015-1020 remains stable and is temporarily backfilled with crushed stone. The area is waiting to be paved.

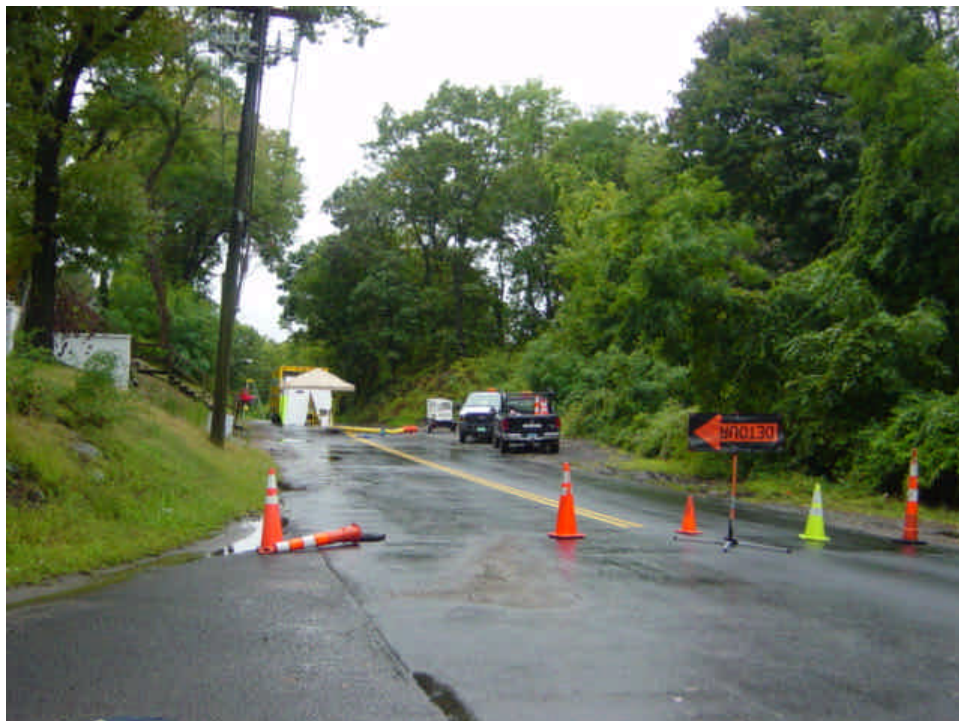
Electrical contractor was on site near sta. #1031 performing work at the vault.
