Docket No. 272 – Development and Management Plan Inspection

Segment 3 Underground Line

Date: October 3, 2008

Location: East Devon Substation to the Housatonic River Crossing

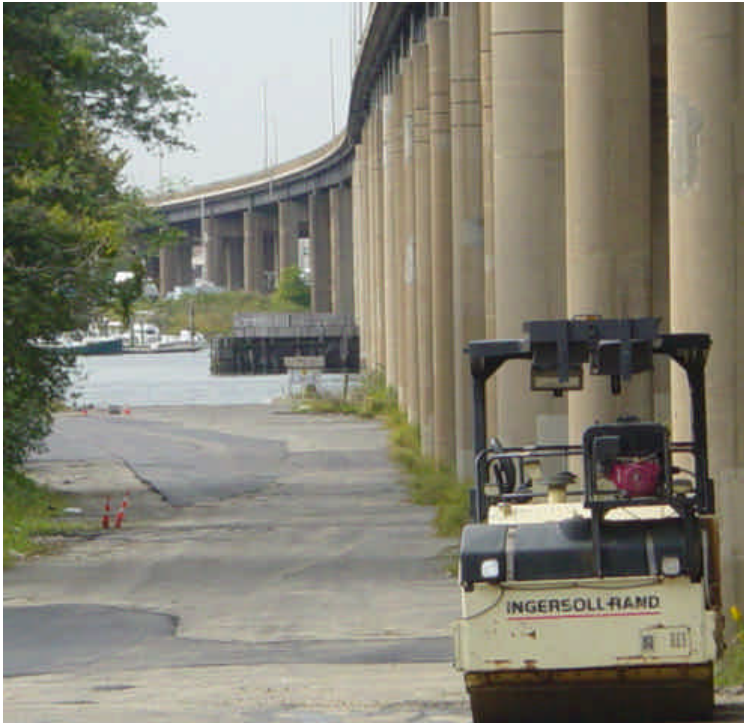
Area near sta. #1015-1020 was being paved at the time of the inspection. Once completed, the area will be fully restored.

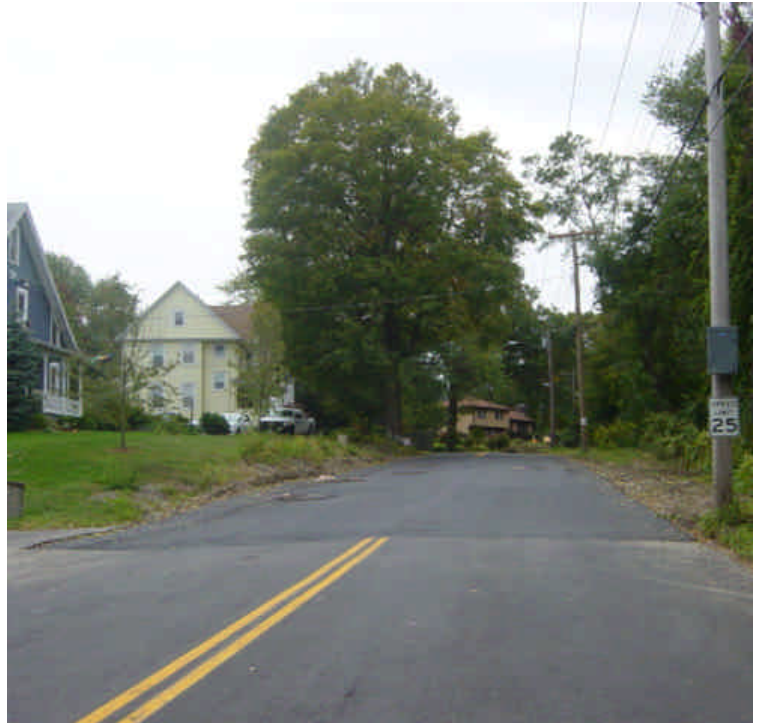
Additional Observations	Area near vault #3 has been resurfaced as part of final restoration. 10/03/08	None. 10/03/08	NA

Area near vault #3 has been resurfaced as part of final restoration. Exposed process material at the base of the adjacent lawn should be covered in topsoil and seeded.

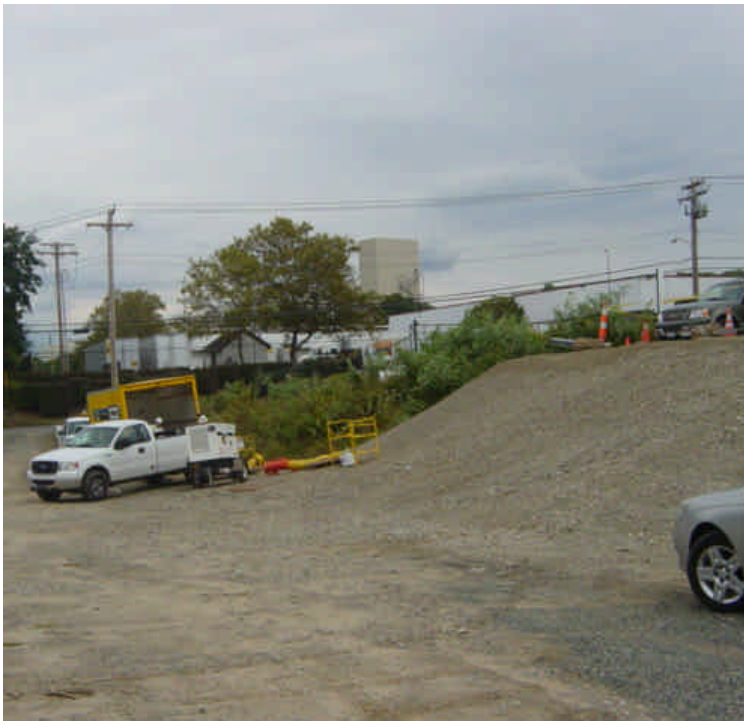
Electrical contractor was on site near sta. #1080 performing work at vault #5. The exposed slope needs final stabilization.

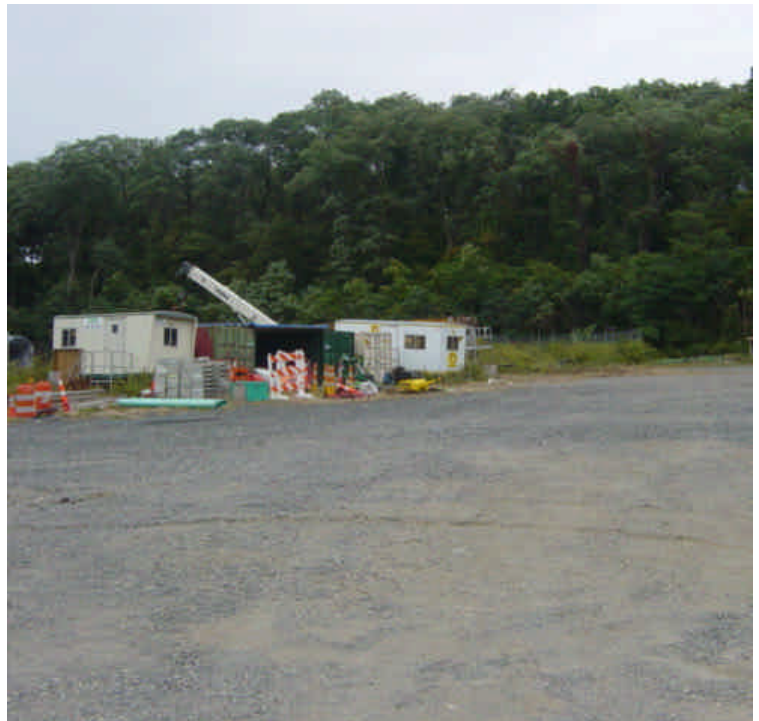
Equipment continues to demobilize from the Shelland Street lay-down yard as work is concluding
