Docket No. 272 – Development and Management Plan Inspection

Segment 3 Underground Line

Date: October 10, 2008

Location: East Devon Substation to the Housatonic River Crossing

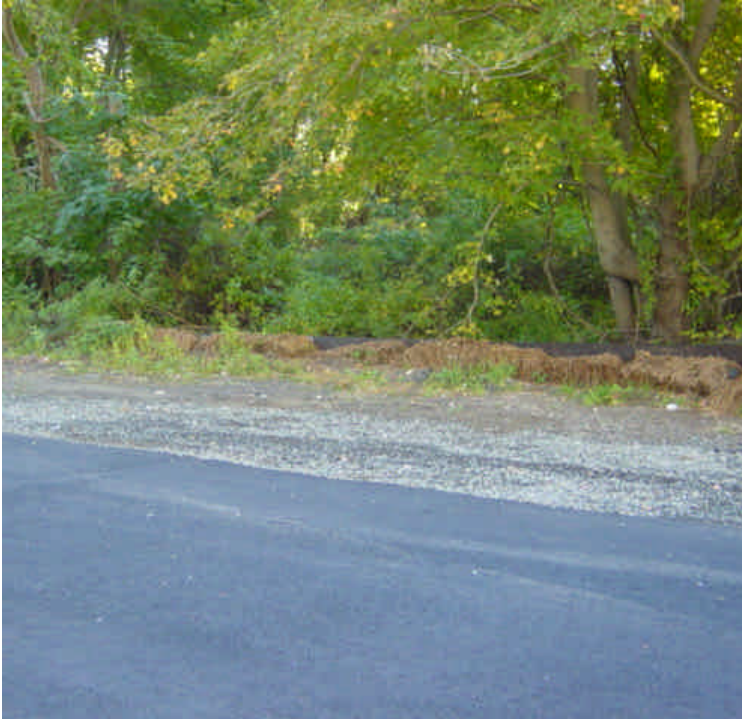
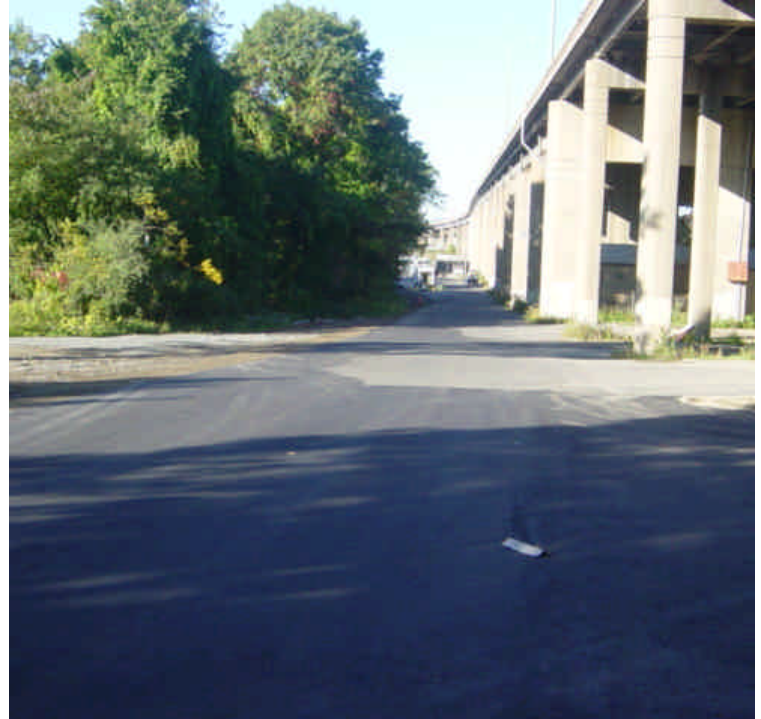
Area near sta. #1015-1020 has been repaved as part of final restoration. Some hay bales remain in one area near sta. #1017. Silt fence should be removed but haybales can remain.

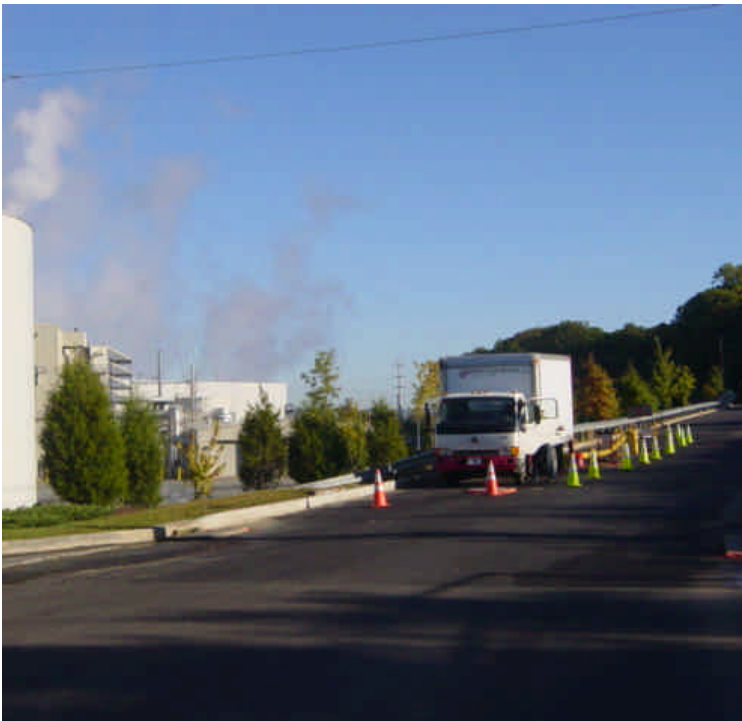
Electrical contractor was on site at vault #6.

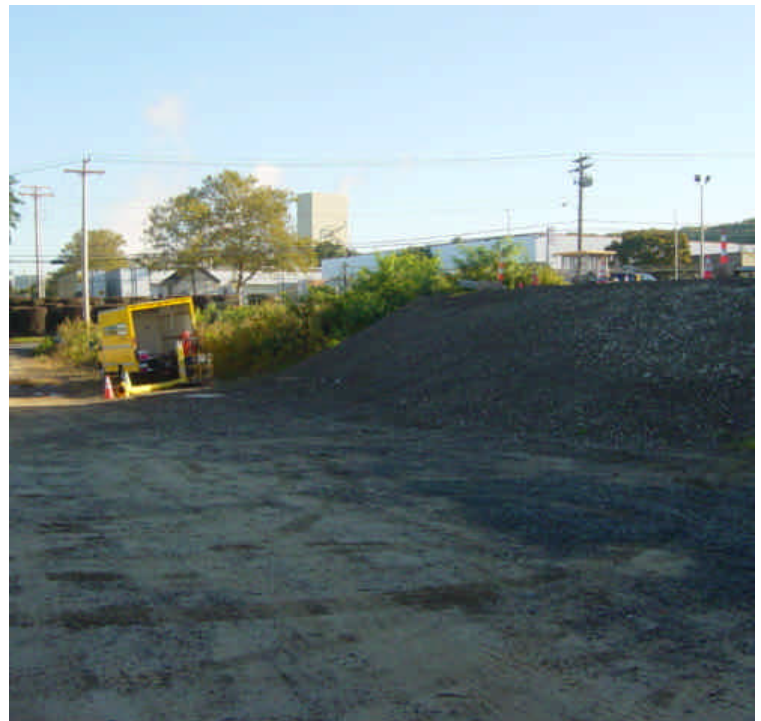
Slope near sta. #1080 remains exposed. The area has been this way for several weeks and needs to be stabilized. Electrical contractor was also on-site at vault #5.
