**Docket No. 272 – Development and Management Plan Inspection**

**Segment 3 Underground Line**

**Date:** October 16, 2008

**Location:** East Devon Substation to the Housatonic River Crossing

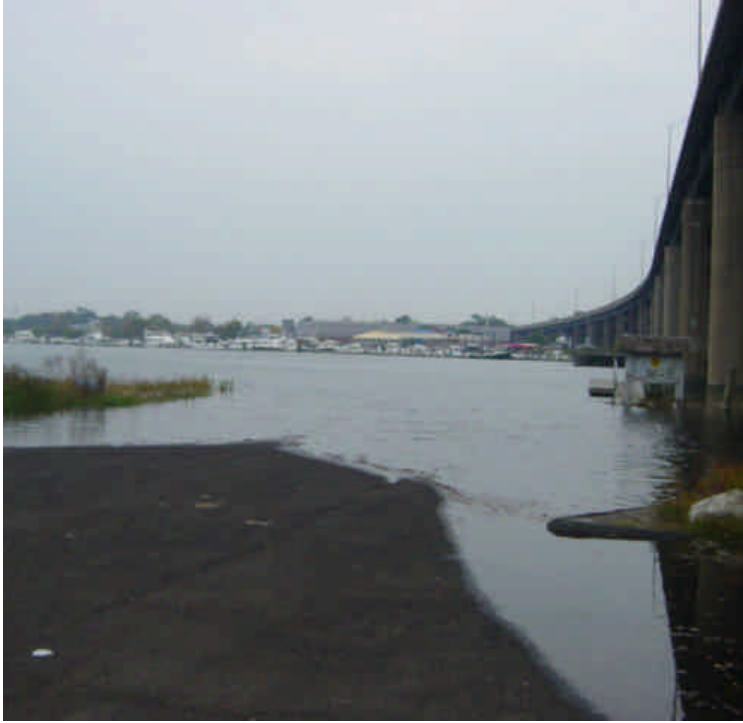
**Area near sta. #1015-1020 has been repaved as part of final restoration. Electric contractor was on site at vault #1.**

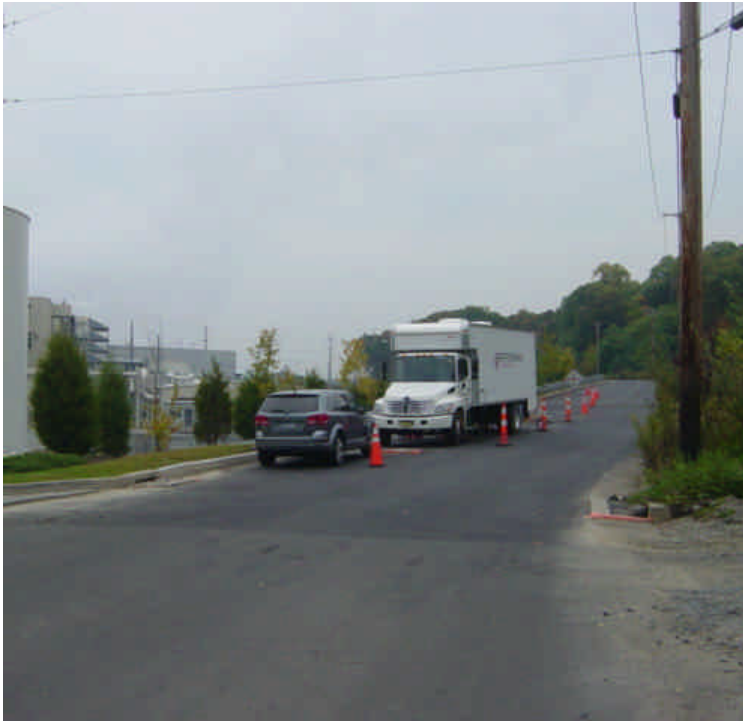
**Electrical contractor was on site at vault #6.**

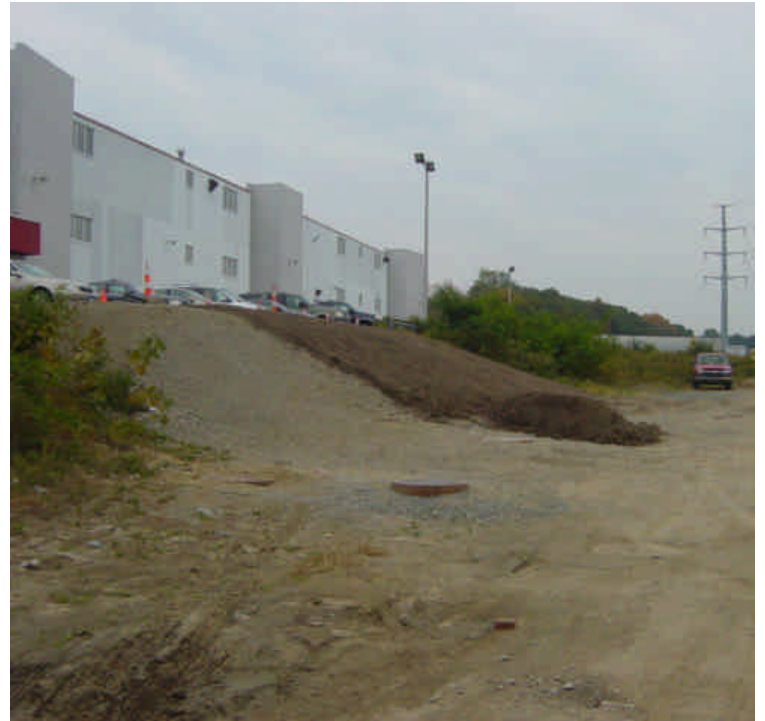
**New topsoil was being applied to the slope near sta. #1080. Ensure that soil is stabilized with mulch as soon as feasible.**
