Docket No. 272 – Development and Management Plan Inspection

Segment 3 Underground Line

Date: October 24, 2008

Location: East Devon Substation to the Housatonic River Crossing

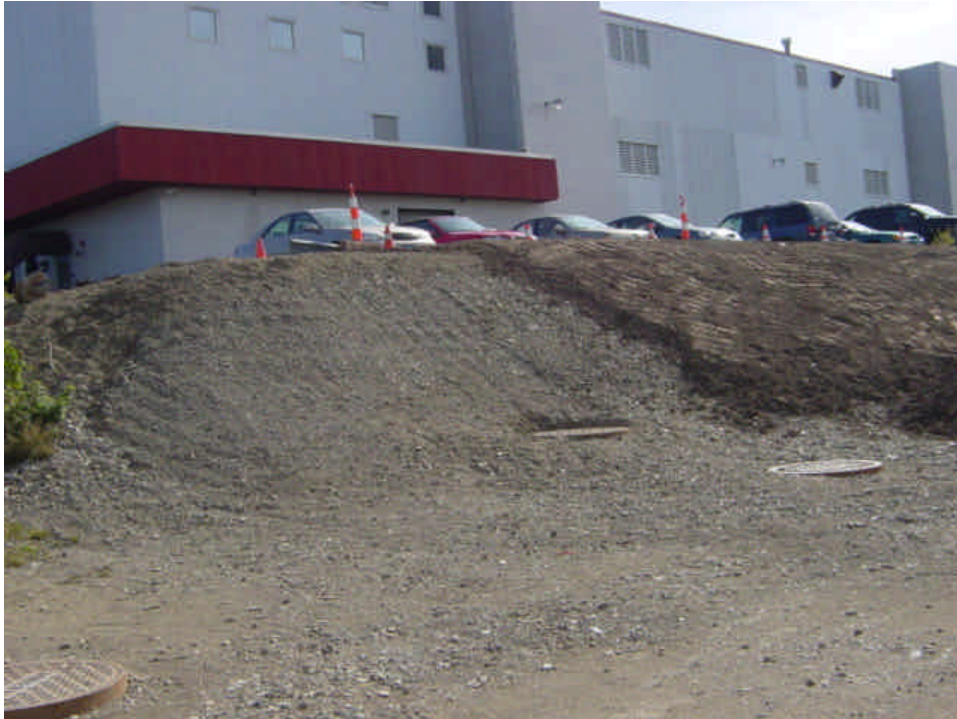
New topsoil had been applied to a portion of the slope near sta. #1080 last week. Complete the application and ensure that soil is stabilized with mulch as soon as feasible.

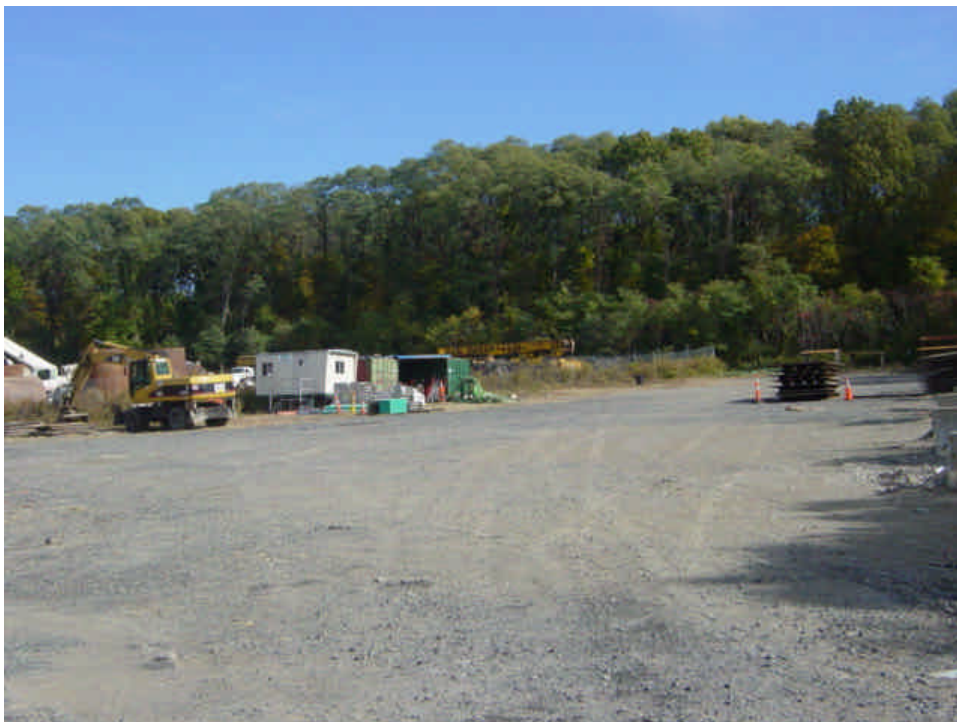
No new issues were observed at the Shelland Street yard. Equipment continues to be demobilized as work is nearing completion. Ensure a restoration agreement is worked out between remaining contractors.
