Docket No. 272 – Development and Management Plan Inspection

Segment 3 Underground Line

Date: November 7, 2008

Location: East Devon Substation to the Housatonic River Crossing

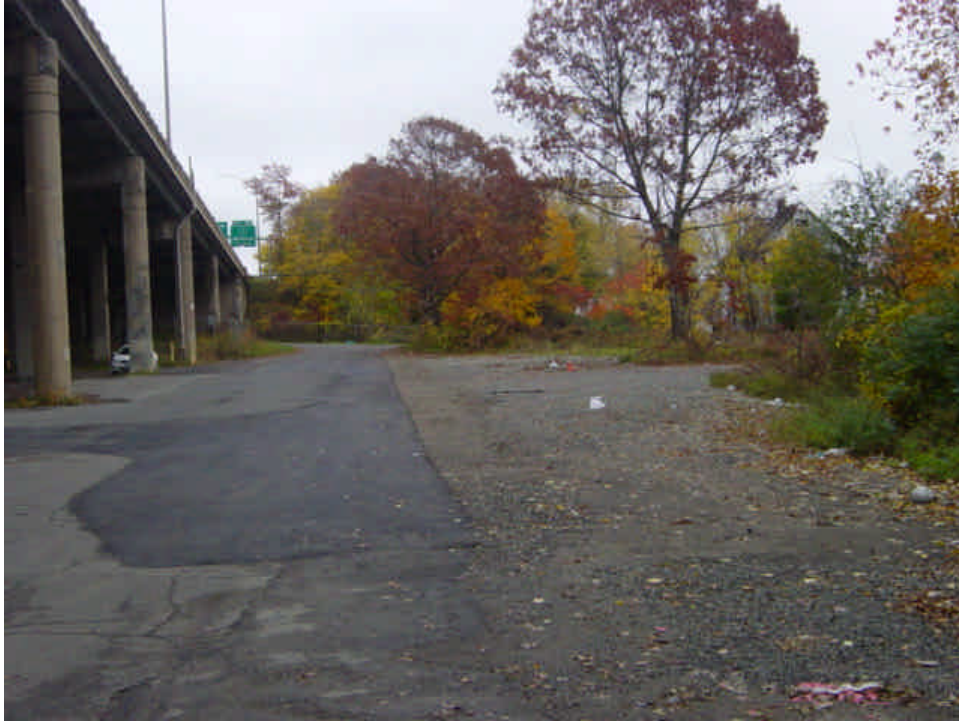
Work in the area of sta #1015-1020 is complete and the area was paved.

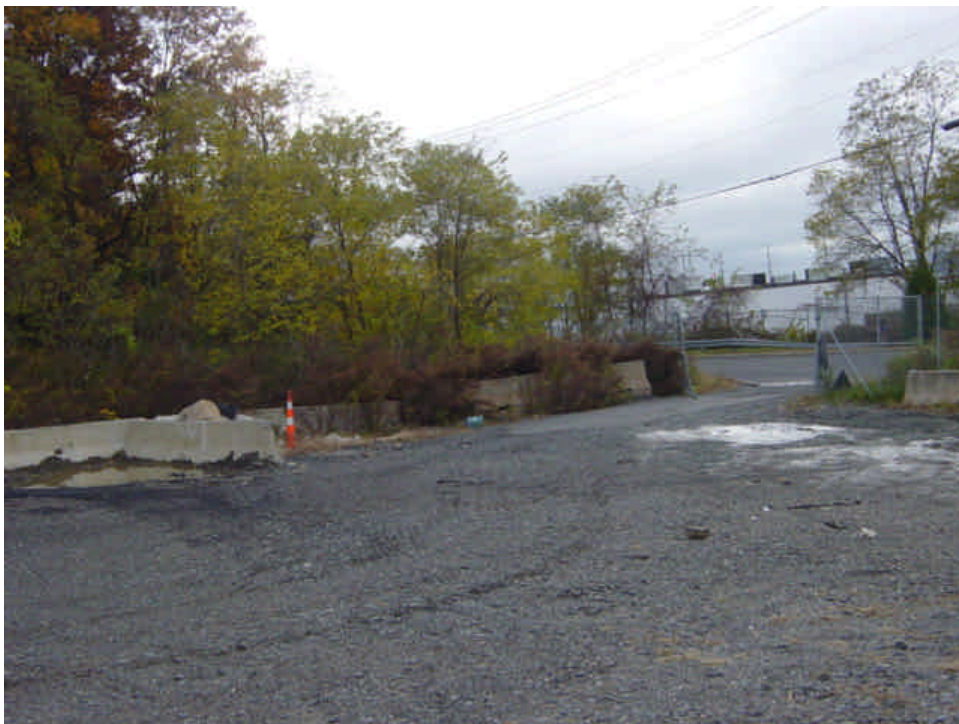
No tracking or dust issues were observed at the Shelland St. lay-down yard. Equipment is being demobilized from the yard as work is nearing completion. Portions of the yard will continue to be used on other projects.
