Docket No. 272 – Development and Management Plan Inspection

Segment 4a Underground Line

Date: January 11, 2008

Location: Westport Avenue to the Norwalk Substation in the City of Norwalk

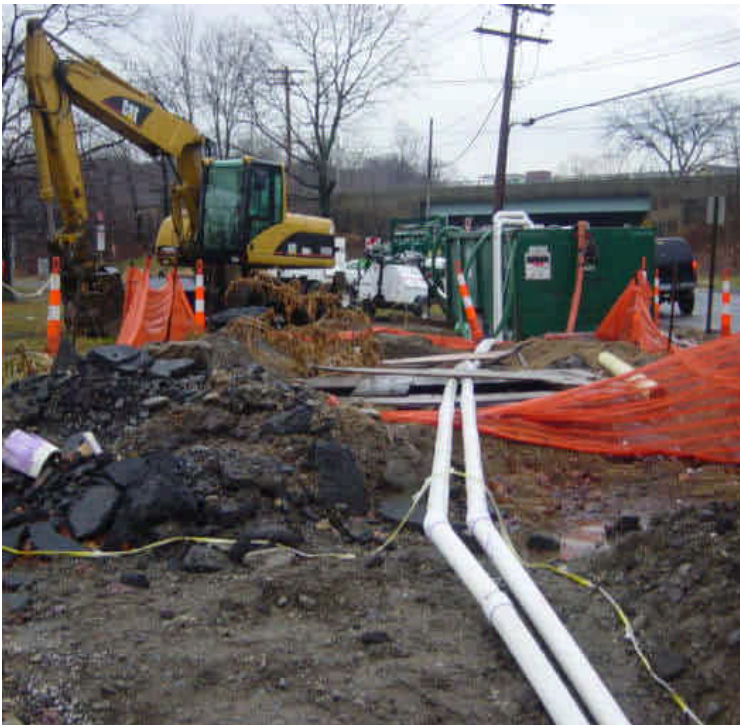
<p>Dewatering</p>	<p>Dewatering activities discharging from a containment tank into a municipal sewer were observed at the time of the inspection at sta. #462-464. Clean water was observed overflowing from</p>	<p>Continue to properly contain and/or filter discharge water when dewatering is required. 1/11/08</p> <p>Attend to the overflow and avoid contact</p>	<p>NA</p> <p>Needs attention</p>

Areas of Inspection	Observation	Recommended Action	Corrected Action
	<p>the dewatering tank onto the soil surface, picking up minor amounts of sediment and washing them into the roadway. 1/11/08</p> <p>Dewatering to appropriate containment was observed at sta #791-792, where removal of PCB affected soil continues. 1/11/08</p>	<p>between clean dewatering discharge and exposed soil in order to prevent unnecessary turbidity. 1/11/08</p> <p>Continue to properly contain and/or filter discharge water when dewatering is required. 1/11/08</p>	NA
Spills and Material Storage	<p>Spill cleanup materials/kits were observed in the storage yards. 1/11/08</p> <p>Some of the minor debris noted near the entrance to the Kings Highway laydown yard has been removed. 1/11/08</p>	<p>Ensure that spill kits are also present with each vehicle during active construction 1/11/08</p> <p>Continue to remove and dispose of debris for appearances. 12/5/07-1/11/07</p>	<p>NA</p> <p>Some of the debris has been removed.</p>

Dewatering from the frac tank was taking place near station #462-464. Clear water was observed overflowing from the containment tank onto the soil surface. This caused minor amounts of sedimentation to flow onto the roadway.

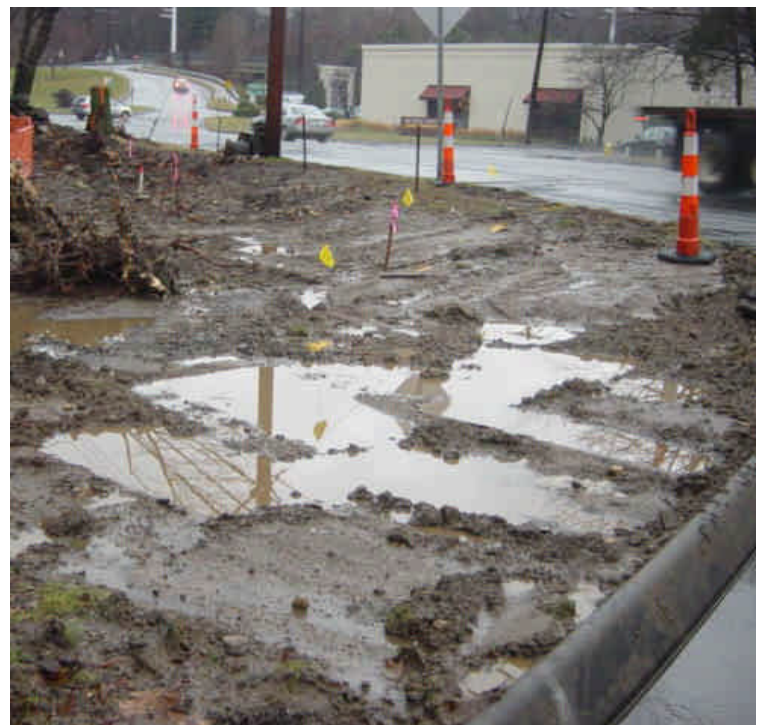
The area near station #503-504 has been grubbed to prepare for trenching. A pile of soil was contained with silt fence. No sediment tracking was observed in this area.

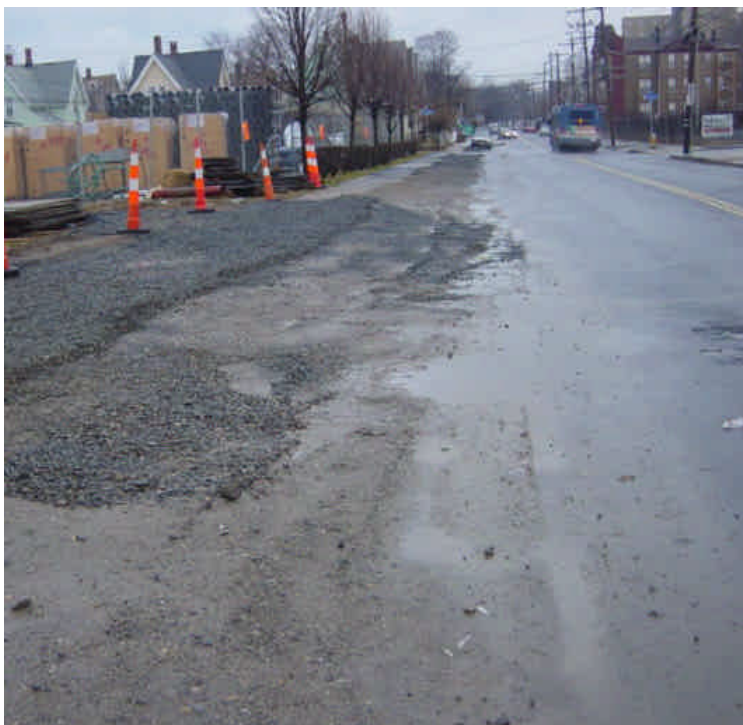
Areas of Inspection	Observation	Recommended Action	Corrected Action
	<p>1/11/08</p> <p>Soils near sta. #801-803 (vault #49) were partially covered with hard pack/ crushed stone but remain somewhat exposed. However, active work was noted here. 1/11/08</p>	<p>See erosion control section for more details. Provide temporary or final stabilization within the approved timelines. 11/21/07-1/11/08</p>	<p>Crushed stone was applied. Provide additional attention when work is complete.</p>
<p>State species of concern, threatened and endangered species.</p>	<p>According to the D&M plan, state-listed species are not located in this work area. 1/11/08</p>	<p>None.</p>	<p>NA</p>
<p>Vegetative clearing (including trees to save or danger trees noted) or stabilization</p>	<p>Sidewalk has been recently installed near sta. #596-598. Topsoil has been spread in some areas but remains exposed. 11/21/07-1/11/08</p> <p>Some portions of the trench work along Pequot Ave. remain un-vegetated but stable. 1/11/08</p> <p>Two trees were removed near sta. #462 in accordance with the D&M Plan (3/27/07). One tree was removed near vault #42 (7/25/07). 1/11/08</p> <p>Equipment and materials belonging to crews working on Singer Substation were being stored between Main St. & Broad St. There is no sediment tracking at this time. 1/11/08</p>	<p>Stabilize exposed soils sufficiently for winter months within the appropriate timelines. Area has passed 21 days but now has snow cover. 1/11/08</p> <p>Permanently stabilize remaining exposed areas when feasible. 1/11/08</p> <p>Vegetation should be restored as necessary upon completion of work in these areas. 1/11/08</p> <p>UI and associated contractors have agreed to provide restoration to this area when work is complete. (not covered under this report). 1/11/08</p>	<p>Needs to be monitored and needs attention when thaw occurs.</p> <p>NA</p> <p>NA</p> <p>UI crews will be providing restoration here when their access needs are complete.</p>

Exposed soil along the shoulder near sta. #801-803 had been partially covered with crushed stone. Further temporary stabilization should occur and roadway should be swept as needed.

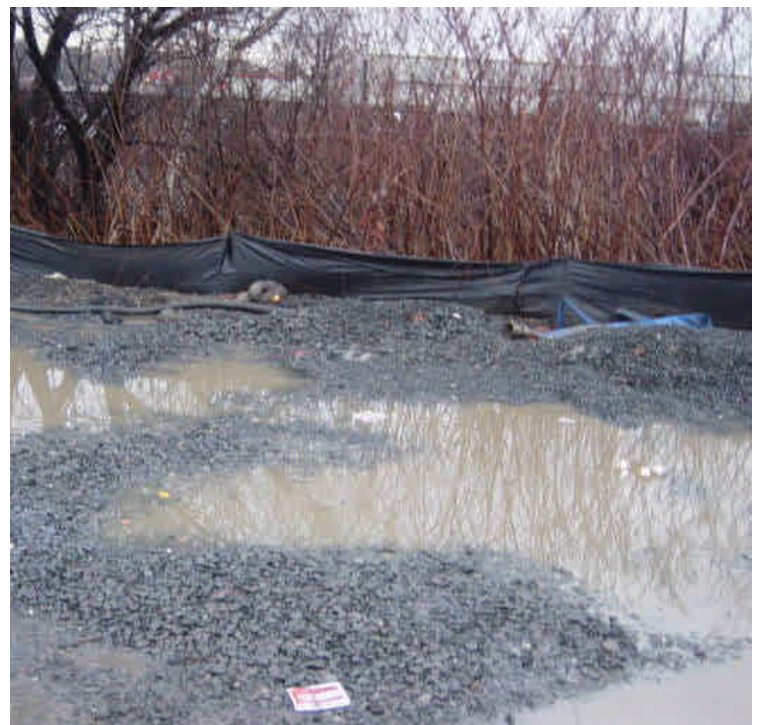
Areas of Inspection	Observation	Recommended Action	Corrected Action
<p>Kings Highway Lay-down Yard (Off Kings Highway, near Rt. 1 rotary)</p>	<p>Perimeter controls remain in place. In past weeks, minor sediment tracking was observed near the entrance to the yard. Stone previously spread throughout the yard has been plowed into piles adjacent to the perimeter controls during snow removal activities. 12/31-1/11/08</p>	<p>Continue to monitor and maintain controls and sweep the roadway as necessary. Re-spread the crushed stone throughout the yard to reduce the potential for tracking and to limit the amount of material piled near controls. 12/31-1/11/08</p>	<p>Needs attention when feasible.</p>
<p>Inland Wetland and Watercourse encroachment and mitigation</p>	<p>The Kings Highway lay-down yard is located adjacent to potential resource areas and a concrete lined waterway. 1/11/08</p>	<p>See erosion control section. 1/11/08</p>	<p>NA</p>

Silt fence was present around the edge of the Kings Highway laydown yard. Turbidity was observed in puddles contained to site during a rain event. No sediment tracking was observed at the entrance to the laydown yard. Piles of stone had been created during snow clearing and should be spread within the yard.
