**Docket No. 272 – Development and Management Plan Inspection**

**Segment 4a Underground Line**

**Date:** January 18, 2008

**Location:** Westport Avenue to the Norwalk Substation in the City of Norwalk

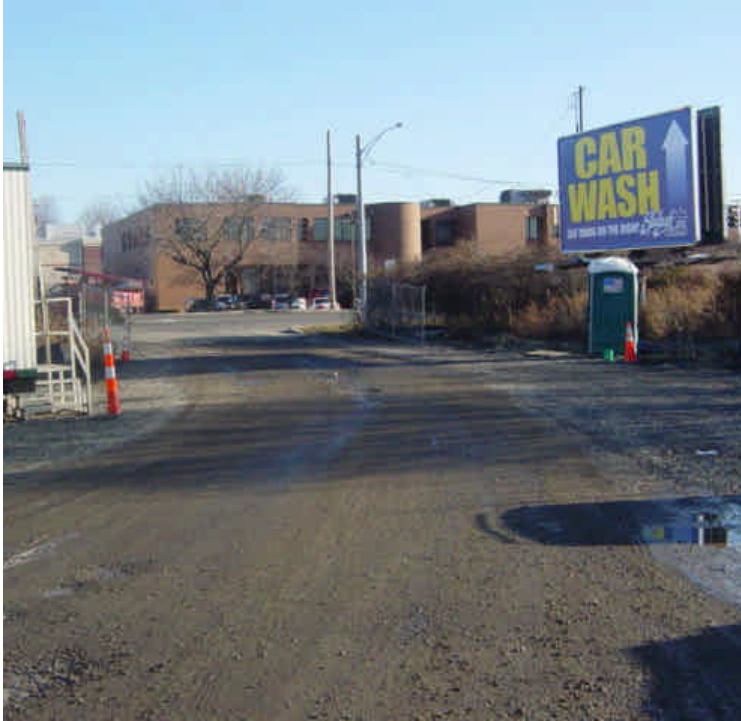
**At the Kings Highway laydown yard, crushed stone has been used to temporarily stabilized the entrance but minor sediment tracking was observed on the roadway. The debris has also been removed from around the silt fence at the entrance.**

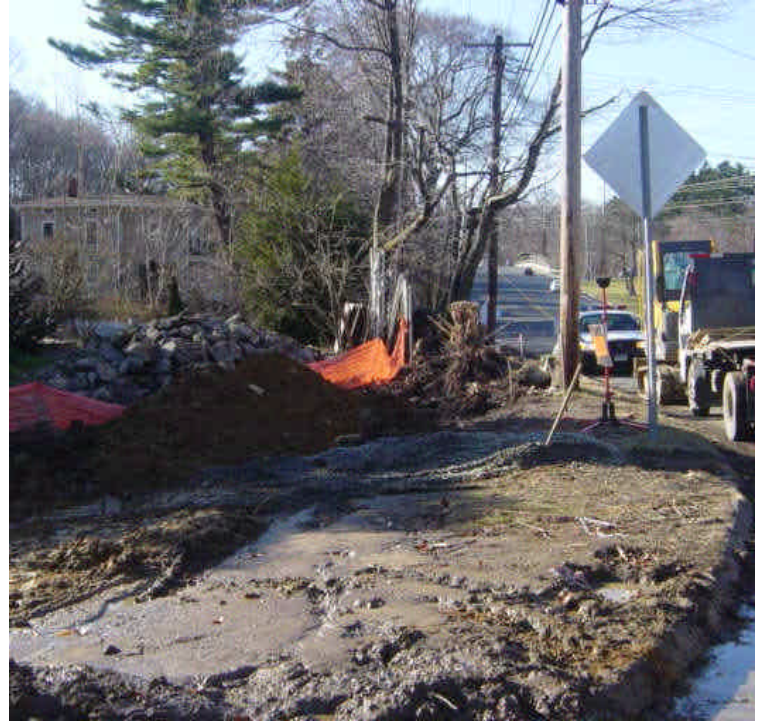
**At stations #503-504, a portion of a stone wall has been removed. The stones have been placed in the adjacent homeowner's back yard until the work is complete. The silt fence surrounding a soil stockpile next to the roadway has collapsed.**

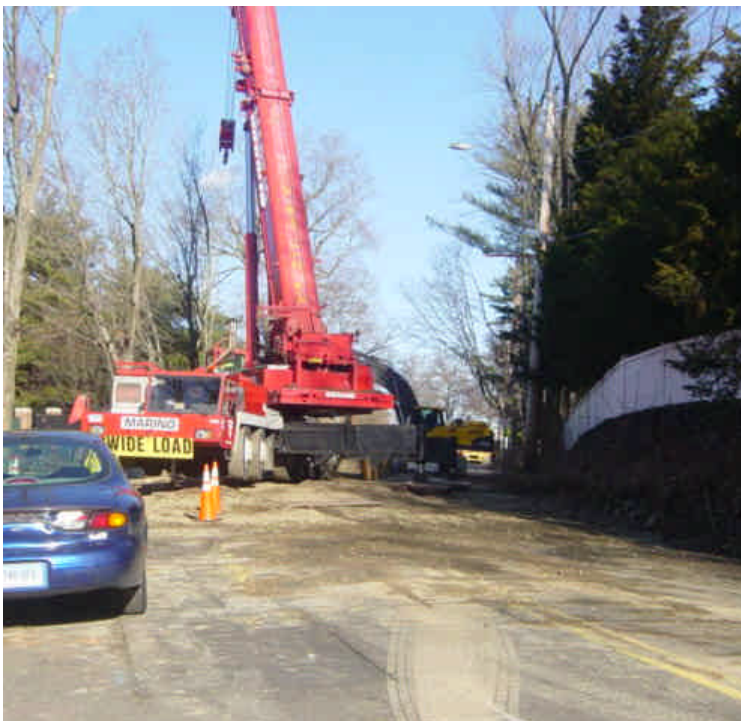
**Near station #490, a crane was setting vault 29 into place on Pequot Avenue. Steel plates and sediment tracking were observed in the roadway here. Sweep all sediment before the end of the work day.**

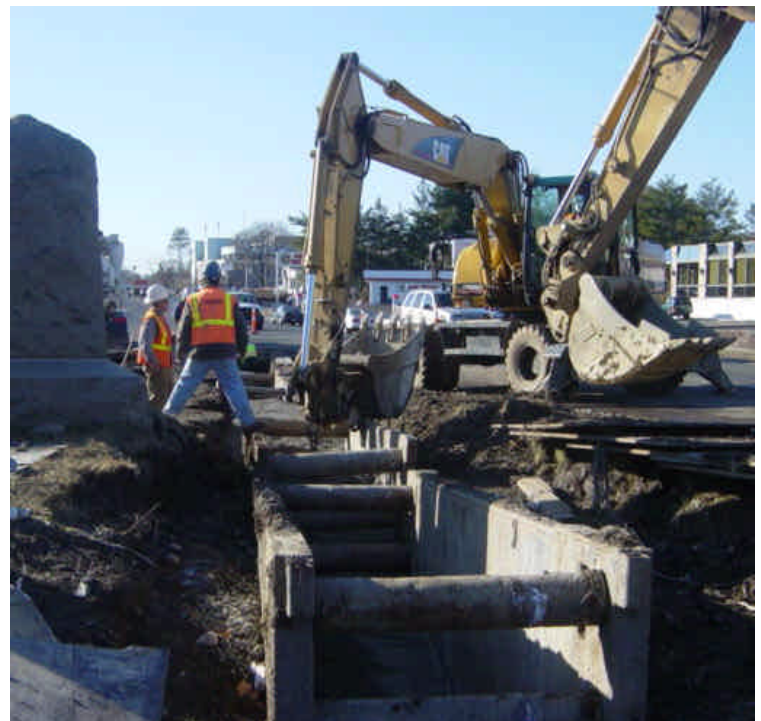
<b>Areas of Inspection</b>	<b>Observation</b>	<b>Recommended Action</b>	<b>Corrected Action</b>
<b>Dewatering</b>	<b>Appropriate dewatering activities, discharging from a containment tank into a municipal sewer were observed at the time of the inspection at sta. #462-464. However, some sediment tracking and slurry from the work area were still observed on the roadway. 1/18/08</b>	<b>Continue to properly contain and/or filter discharge water when dewatering is required. Avoid contact between clean dewatering discharge and exposed soil in order to prevent unnecessary turbidity. See erosion control section. 1/18/08</b>	<b>Needs regular attention.</b>
<b>Spills and Material Storage</b>	<b>Spill cleanup materials/kits were observed in the storage yards. 1/18/08</b>  <b>The debris was removed near the entrance to the Kings Highway laydown yard. 1/18/08</b>	<b>Ensure that spill kits are also present with each vehicle during active construction 1/18/08</b>  <b>Continue to monitor: 12/5/07-1/18/08</b>	<b>NA</b>  <b>Debris was cleaned up.</b>

**At stations #462-464, trenches were being filled. Ruts and sediment tracking need attention here. There was slurry being spilled on the ground during the inspection. Sweep the roadway at the end of the workday and attend to the slurry.**
