Docket No. 272 – Development and Management Plan Inspection

Segment 4a Underground Line

Date: January 24, 2008

Location: Westport Avenue to the Norwalk Substation in the City of Norwalk

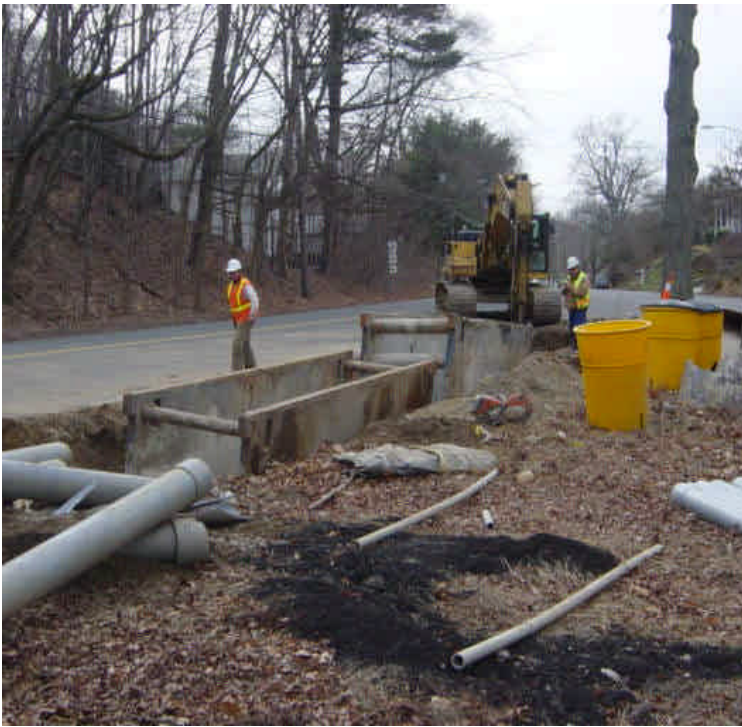
Trenching activities continue along Pequot Avenue near sta #494-495.

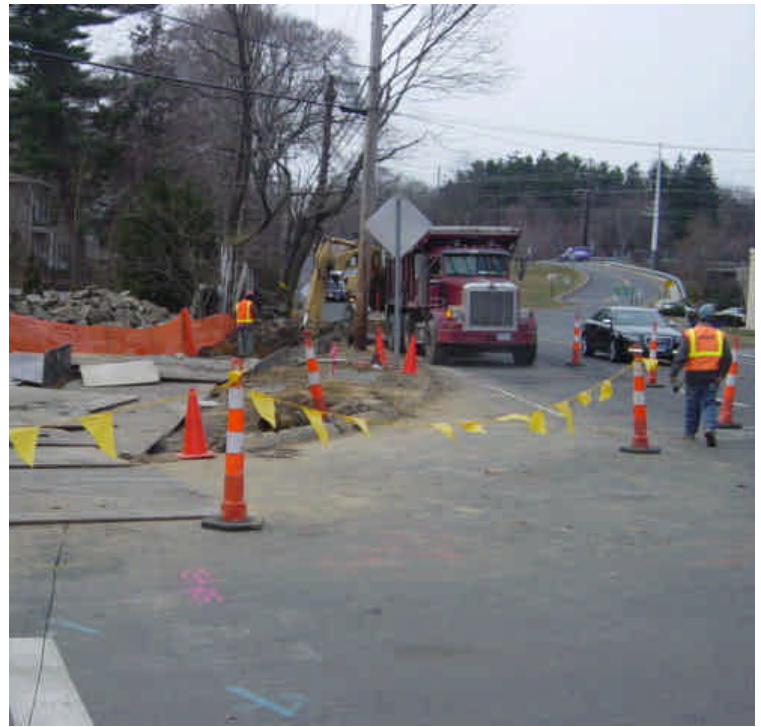
Trenching activities continue at stations #503-504, a portion of a stone wall has been removed. The stones have been placed in the adjacent homeowner's back yard until the wall can be restored.

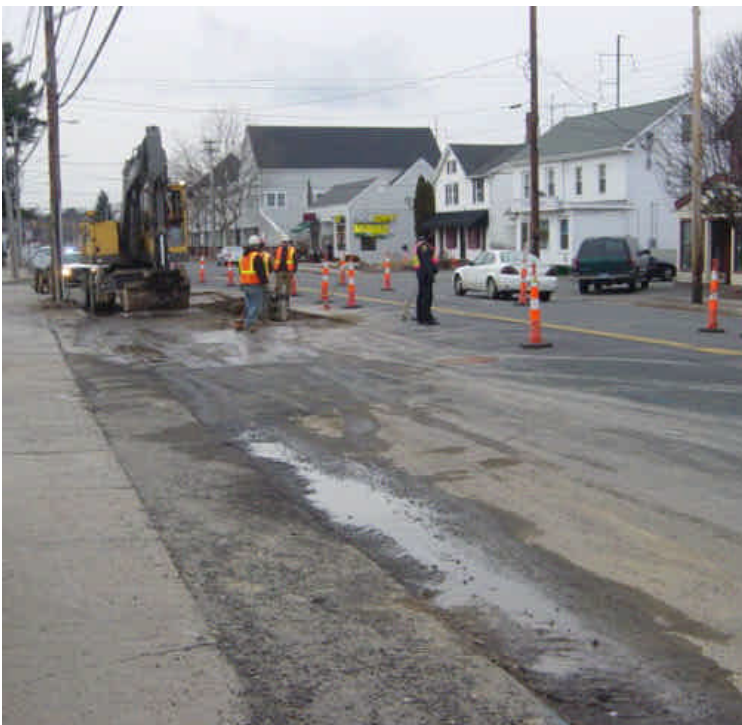
Trenching and backfill operations continue at sta. #535-536. Sediment tracking and some run-off was observed along the roadway.

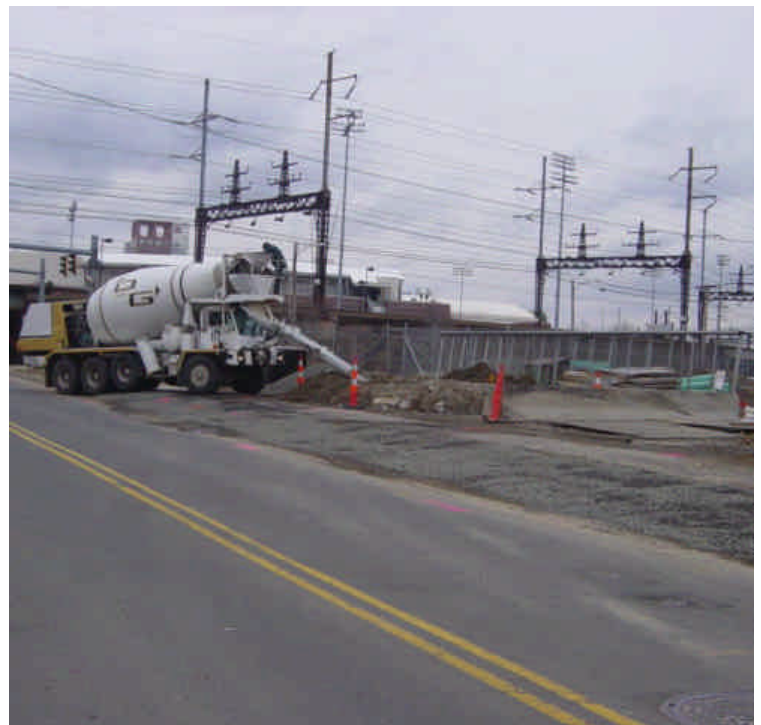
Concrete washouts were being performed properly in a contained area.
