**Docket No. 272 – Development and Management Plan Inspection**

**Segment 4a Underground Line**

**Date:** February 7, 2008

**Location:** Westport Avenue to the Norwalk Substation in the City of Norwalk

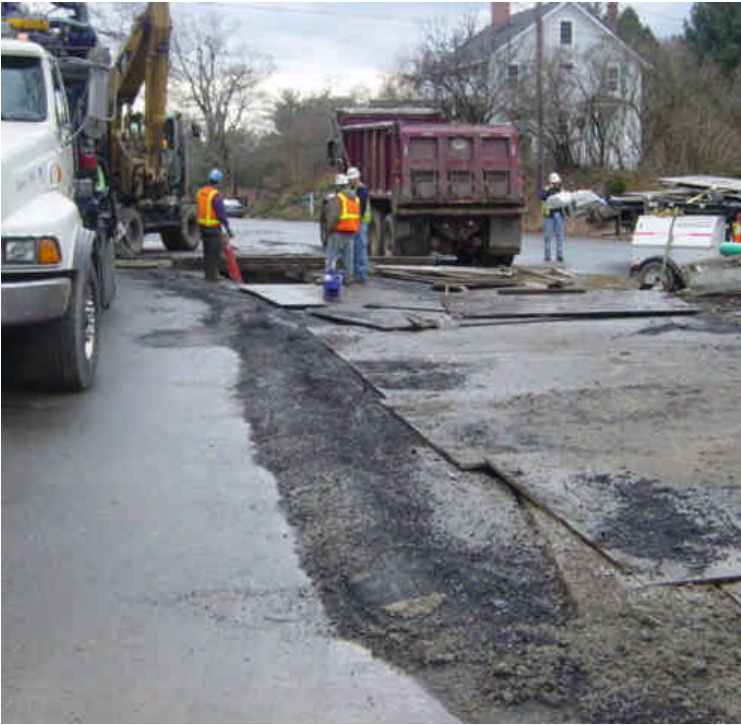
**Trenching activities continue along Pequot Ave. near sta. #493 to 494. A temporary bituminous berm was created along the edge of the steel road plates to divert runoff away from the trench. Excavated material from the trench was being placed into a dump truck. Ground water from the soil was draining out of the back of the truck. The turbid runoff was flowing along the curb line for approximately 250 feet before reaching a protected catch basin. During the inspection, a contractor Supervisor was called out to the site to address the multiple issues in this area.**

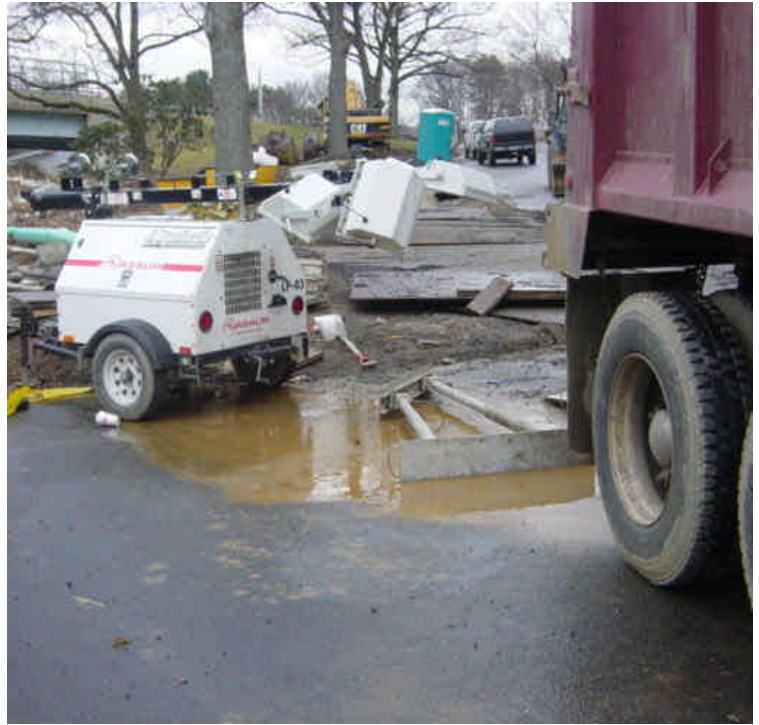
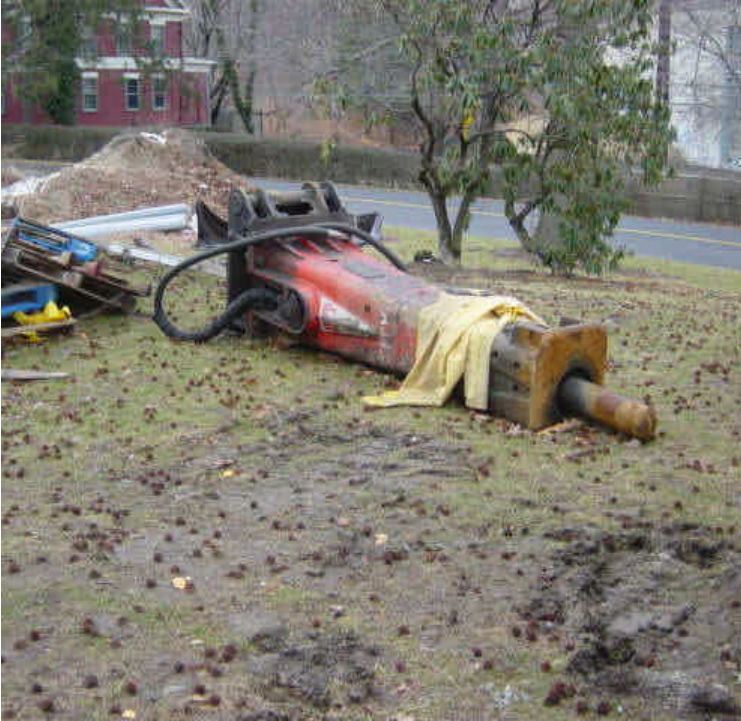
**A hammer/breaker attachment containing hydraulic fluid was being stored on the median near sta. #495 without proper, proactive secondary containment.**

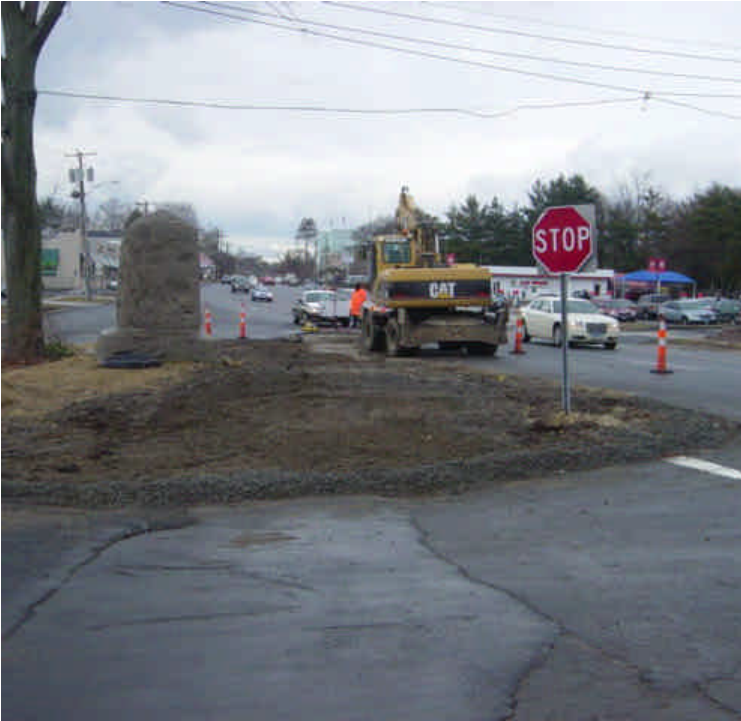
**Crushed stone has been placed around the edge of the median to form a temporary curb near sta. #461.**

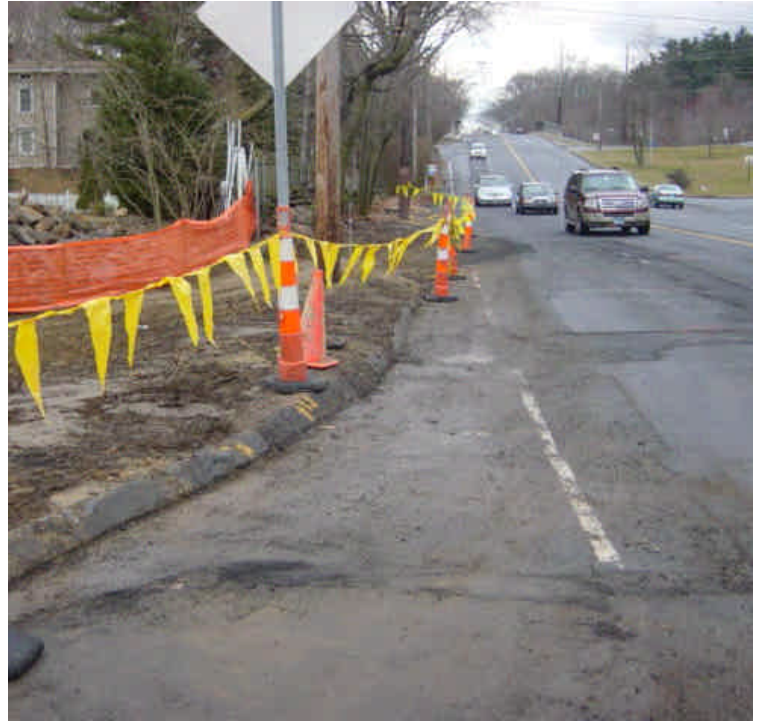
**Work continues near sta. #502-503. The roadway appears to have been recently swept. However, a minor amount of sediment remained along the curb line.**

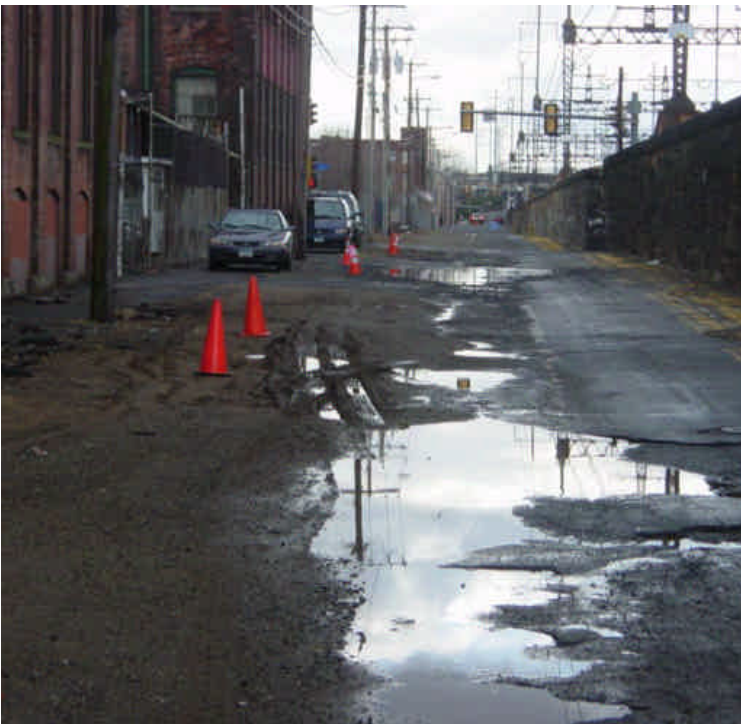
**Some ruts were noted along the shoulder of Railroad Ave. near sta. #737. Ruts were likely from normal traffic but more hard pack or gravel may be needed here.**

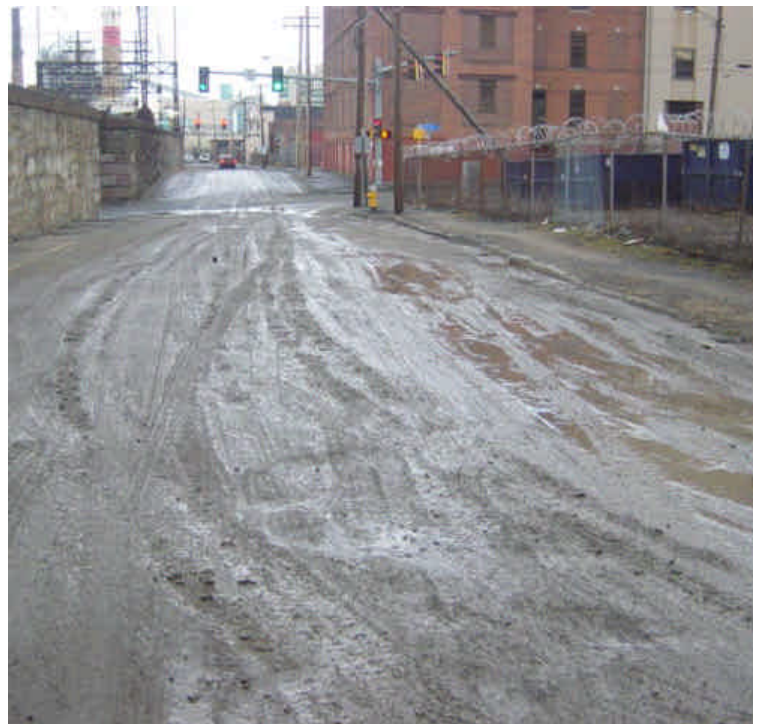
**Heavy sediment tracking was observed from a lay-down yard on Railroad Ave. near Myrtle Ave., but neither the yard nor the sediment is related to this project.**
