**Docket No. 272 – Development and Management Plan Inspection**

**The Connecticut Light and Power Company Certificate of Environmental Compatibility and Public Need for the construction of a new 345-kV electric transmission line and associated facilities between Scovill Rock Switching Station in Middletown and Norwalk Substation in Norwalk, Connecticut, including reconstruction of portions of existing 115-kV and 345-kV electric transmission line, the construction of Beseck Switching Station in Wallingford, East Devon Substation in Milford, (and Singer Substation in Bridgeport), modifications at Scovill Rock Switching Station and Norwalk Substation, and the reconfiguration of certain interconnections.**

**Segment 4a Underground Line**

**Date:** February 14, 2008

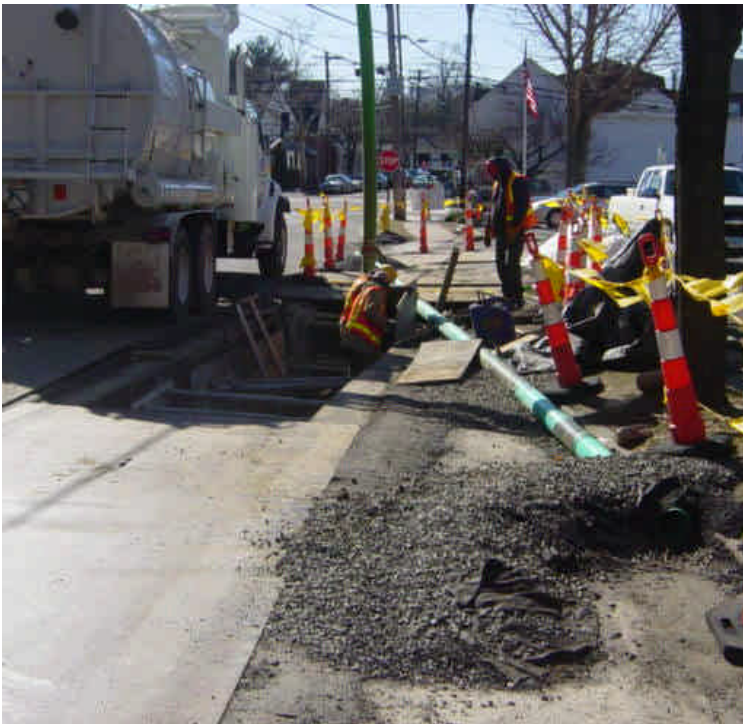
**Trenching activities continue along Pequot Ave. near sta. #482 to 485. A temporary diversion drain has been installed to facilitate drainage along the roadway during construction.**

| <b>Areas of Inspection</b> | <b>Observation</b> | <b>Recommended Action</b> | <b>Corrected Action</b> |
|---|--|--|---|
| <b>Dewatering</b> | <b>Dewatering was observed near sta. #482-487. A temporary diversion drain was also set up in this area. 2/14/08</b> | <b>Continue to properly contain and/or filter discharge water when dewatering is required. 2/14/08</b> | <b>NA</b> |

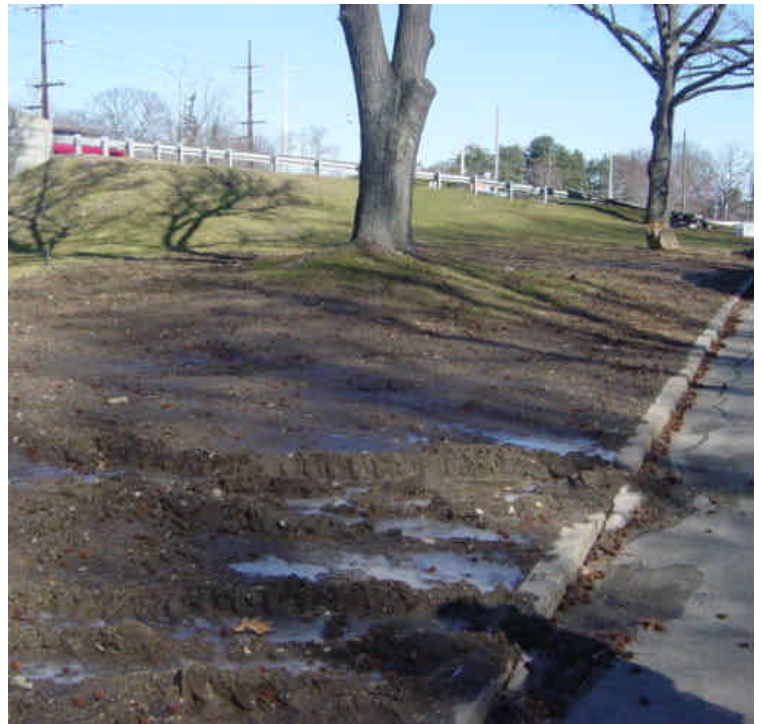
| Areas of Inspection | Observation | Recommended Action | Corrected Action |
|---|---|--|--|
| | <p>Equipment was being stored on the median near sta. #496 - 497. The large ruts observed last week have been re-graded. A minor amount of sediment was also observed on the roadway and along the curb line. 2/14/08</p> | <p>Mulch should be placed on exposed soil for temporary stabilization. Place crushed stone in areas used for parking. Full restoration will be required when access needs are complete. 2/14/08</p> | <p>Rutted area has been re-graded. Additional stabilization is needed.</p> |

**Rutted area along Pequot Ave. near sta. #495 has been re-graded to remove the ruts. A minor amount of sediment remains along the roadway and curb line. Mulch should be placed on exposed soil.**

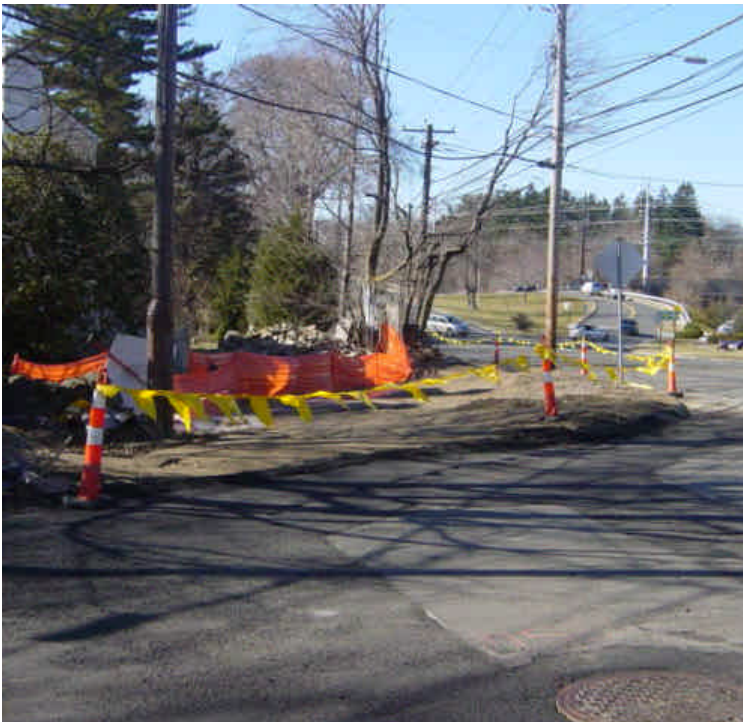
| Areas of Inspection | Observation | Recommended Action | Corrected Action |
|---|---|--|--|
| Bridgeport | <p>At sta. #503-504, soils remain exposed for active work. Temporary bituminous curb has been installed. 2/14/08</p> | <p>Ensure soils are contained to the work area. Sweep roadways before the end of a work day as necessary to minimize tracking. 2/14/08</p> | <p>Temporary bituminous curb has been installed.</p> |

**Work continues near sta. #502-503. A temporary bituminous curb has been installed and steel plates remain in the parking lot area across the street.**

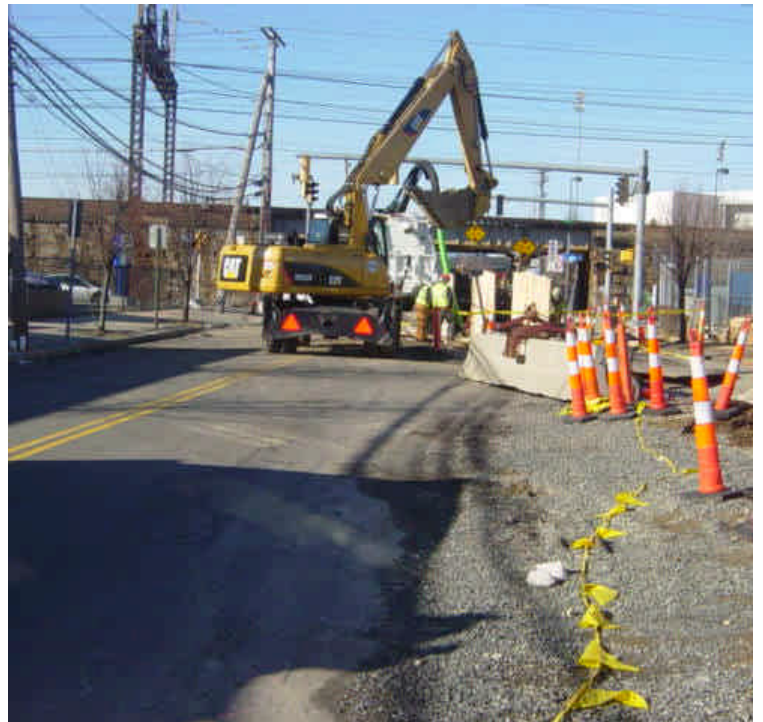
**Trenching and backfilling activities continue near sta. #799. Some remnants/pebbles of temporary cold-patch material were observed in the area of the work zone along the curb and sidewalk.**
