Docket No. 272 – Development and Management Plan Inspection

Segment 4a Underground Line

Date: February 27, 2008

Location: Westport Avenue to the Norwalk Substation in the City of Norwalk

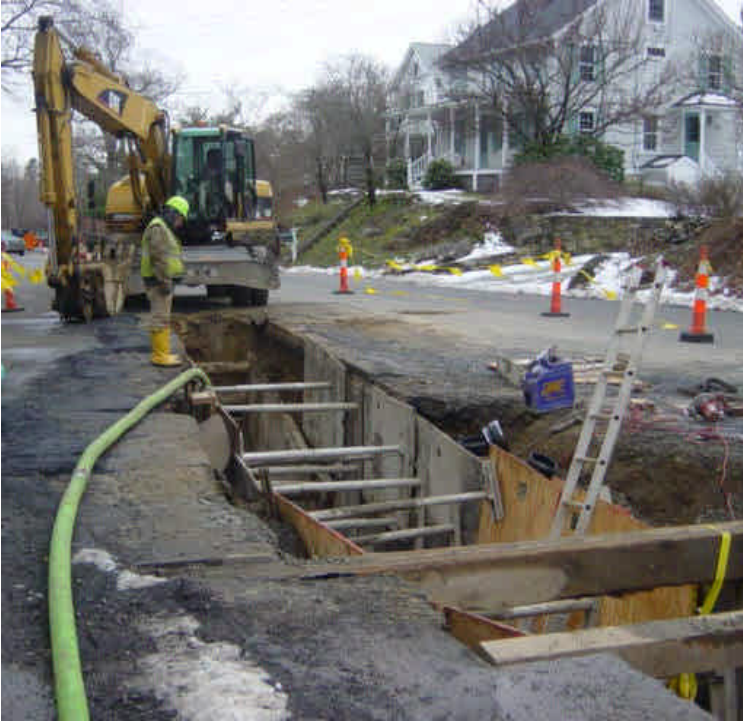
At sta. 491-493 on Pequot Avenue, dewatering and trenching were in progress.

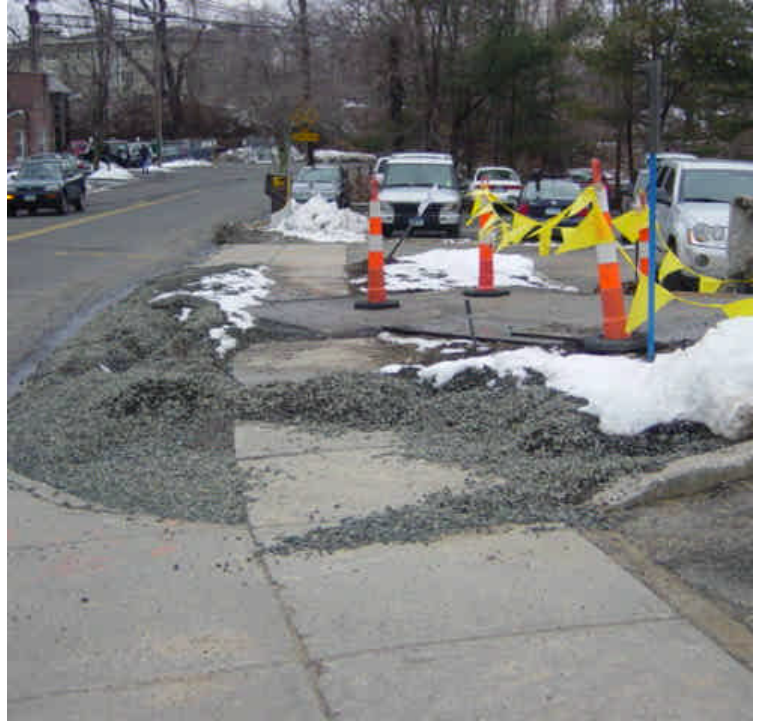
Near the corner of Pequot Avenue and Old Post Road, stone has been installed to stabilize previously exposed soil near the bank parking lot.

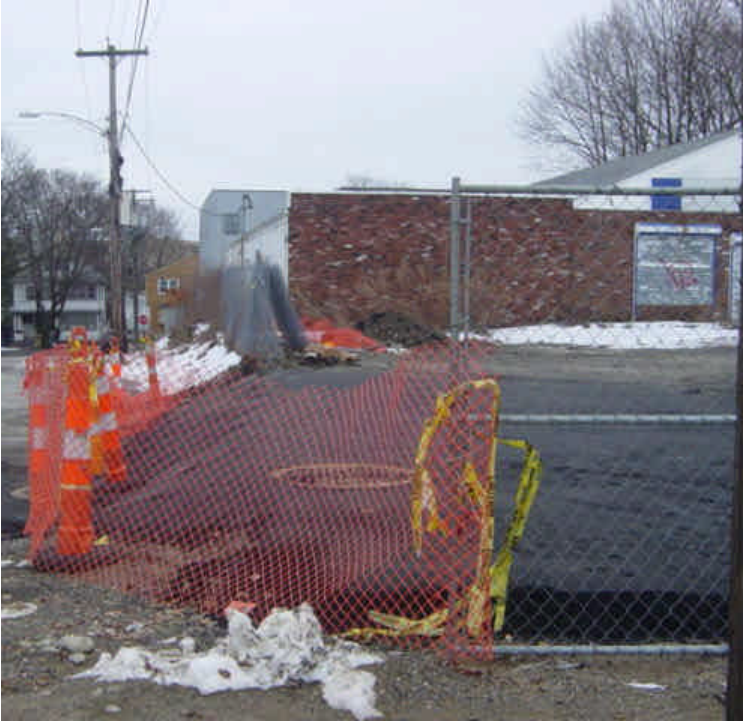
Vault #42 has been paved near Fairfield Avenue in Bridgeport.

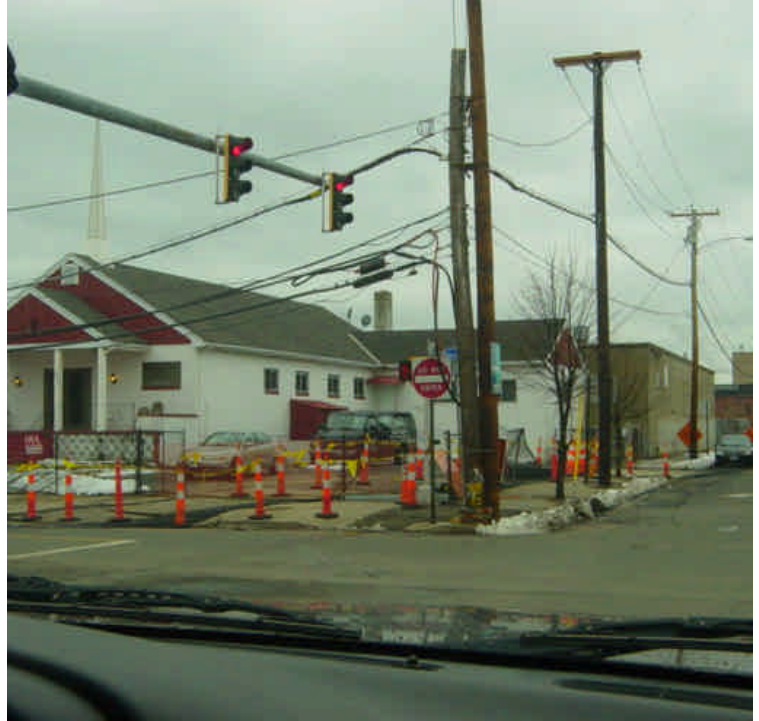
Trenching has been completed at stations 799-800. Steel plates were in place while no active work was in progress.
