Docket No. 272 – Development and Management Plan Inspection

Segment 4a Underground Line

Date: March 13, 2008

Location: Singer Substation to Fairfield/Westport Town Line

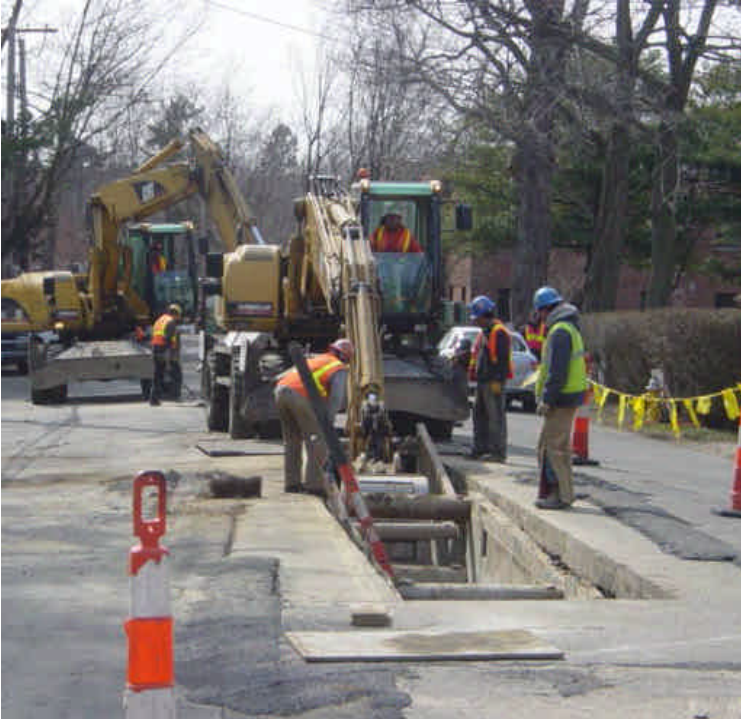
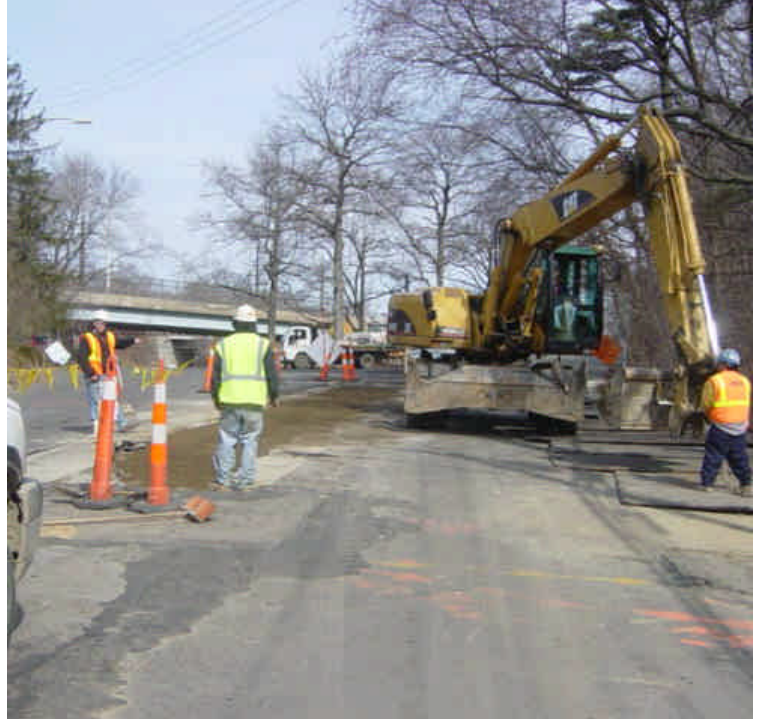
Both photos (above) show trenching and backfilling activities continuing near sta. #488-493.

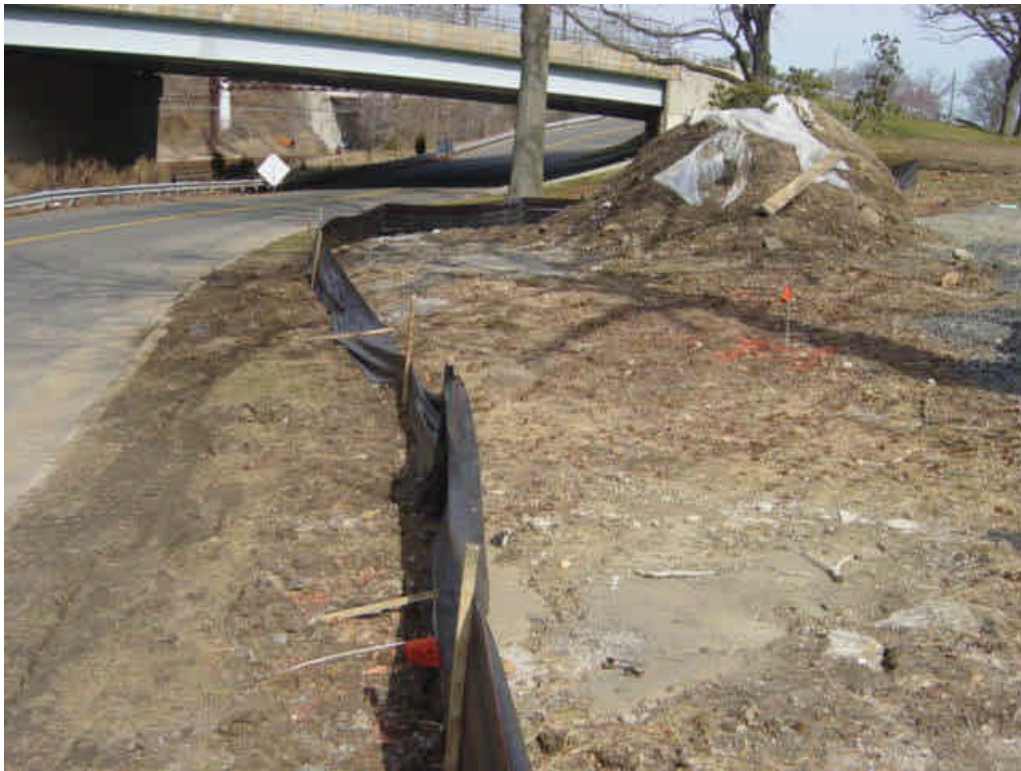
Multiple concrete washouts were observed along the median near sta. #495. The areas were contained within erosion controls, but a single, lined location should be designated for future washouts to minimize unnecessary impacts.
