Docket No. 272 – Development and Management Plan Inspection

Segment 4a Underground Line

Date: March 28, 2008

Location: Singer Substation to Fairfield/Westport Town Line

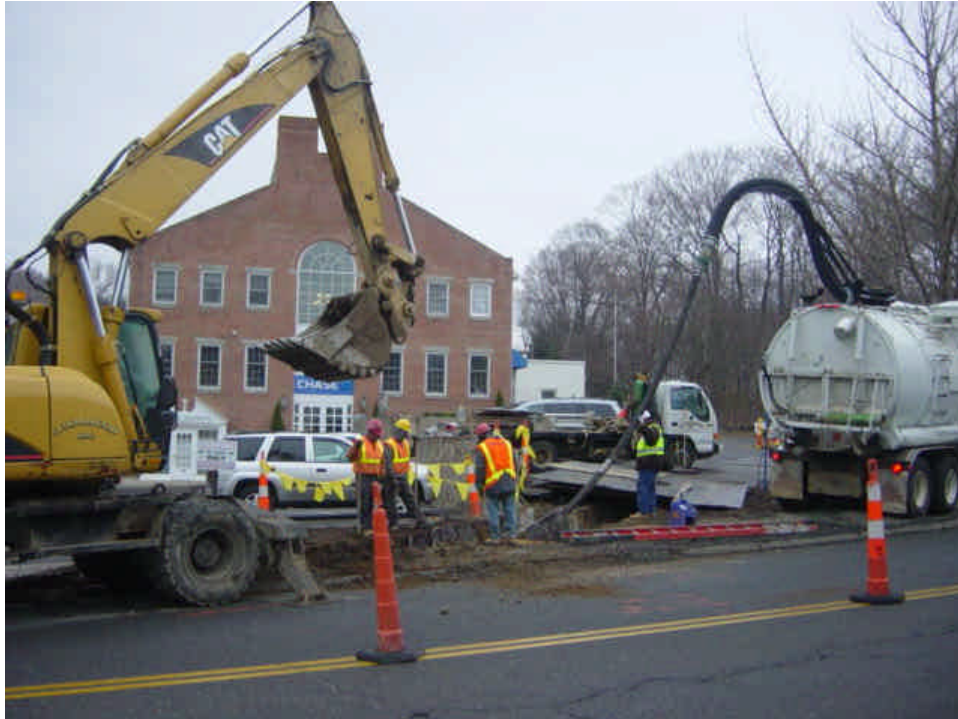
Trenching activities continue near sta. #482-483. Dewatering was ongoing at the time of the inspection and water appeared to be handled appropriately.

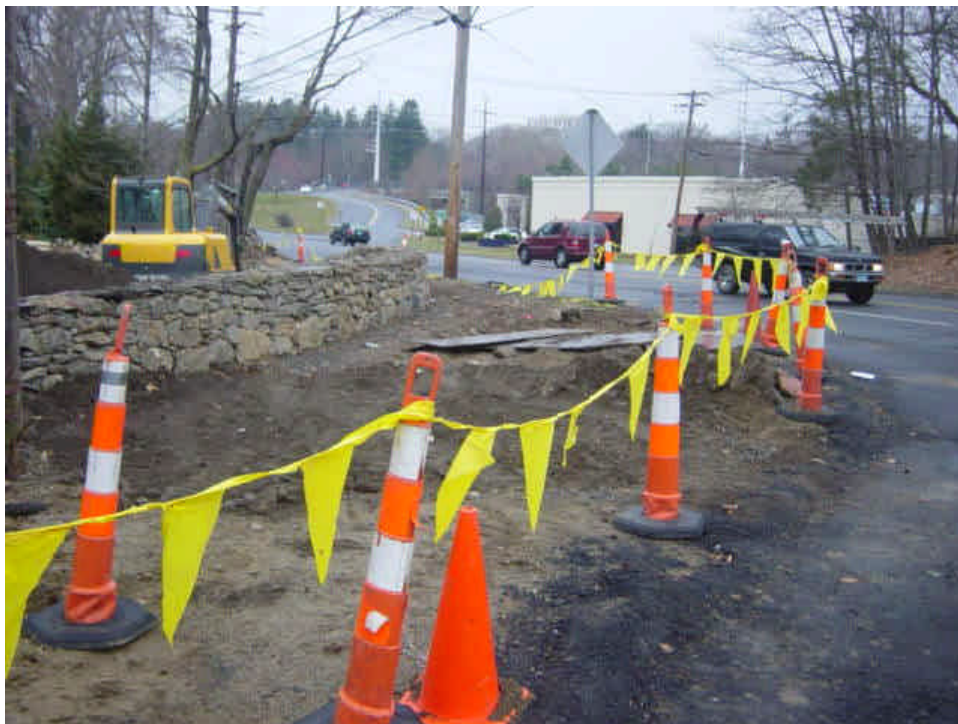
The stone wall is being reconstructed near sta. #502-503. No active work was occurring at the time of the inspection. Exposed soils around the wall need to be either temporarily stabilized or permanently restored.
