Docket No. 272 – Development and Management Plan Inspection

Segment 4a Underground Line

Date: April 3, 2008

Location: Singer Substation to Fairfield/Westport Town Line

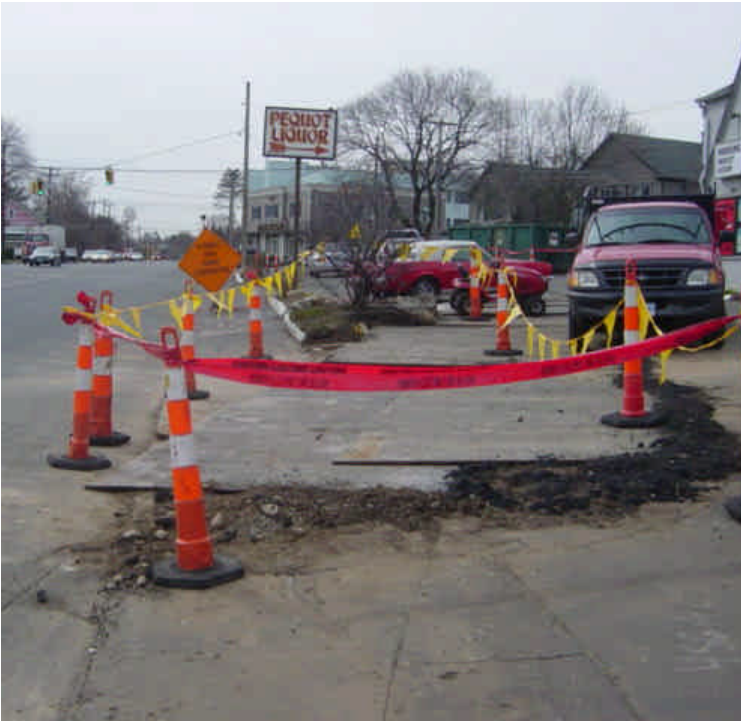
Steel plates remain over the trench near sta. #454-456 as vault tie-in work is underway.

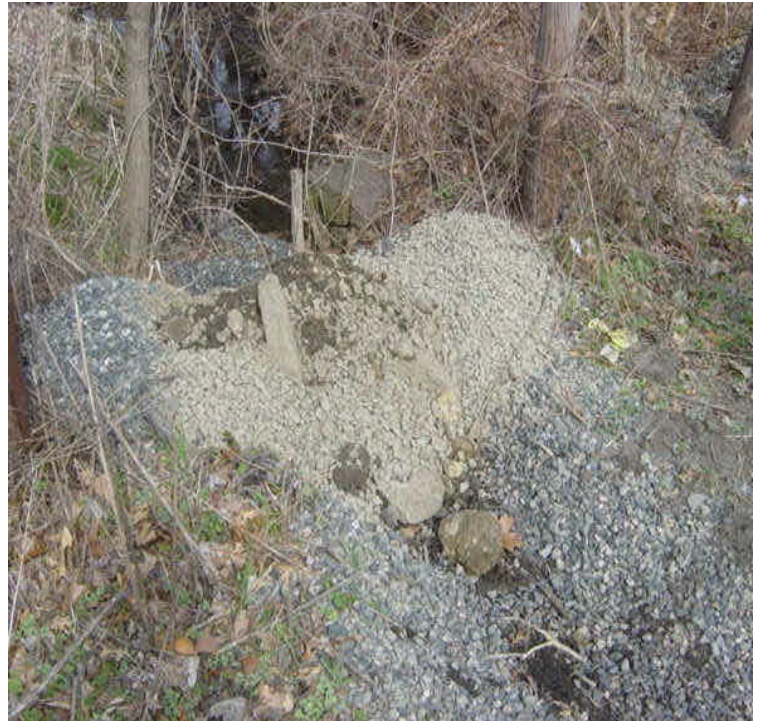
<p>Inland Wetland and Watercourse encroachment and mitigation</p>	<p>The Kings Highway lay-down yard is located adjacent to potential resource areas and a concrete lined waterway. 4/03/08</p> <p>Crushed stone has been placed along a drainage swale near sta. #480. A minor amount of stone has been inadvertently placed past the controls and into the adjacent channel. 4/03/08</p>	<p>See Erosion and Sediment Controls section. 4/03/08</p> <p>Carefully (by hand) remove crushed stone that has been inadvertently placed in the adjacent channel. 4/03/08</p>	<p>NA</p> <p>Needs attention.</p>
<p>Staging, Storage, and Parking Areas</p>	<p>A contractor lay-down yard is located off of Kings Highway near the Rt. 1 rotary. Reserve spill kits are located near the equipment trailers. Debris material and old railroad ties, which have been stored within the yard, are being sorted and processed for disposal. 4/03/08</p>	<p>See Erosion Control and Spills and Material Storage sections. 4/03/08</p>	<p>NA</p>

Crushed stone was placed along a drainage swale near sta. #480, to filter sediment. Some stone was inadvertently placed in the channel beyond the controls and it will need to be removed.

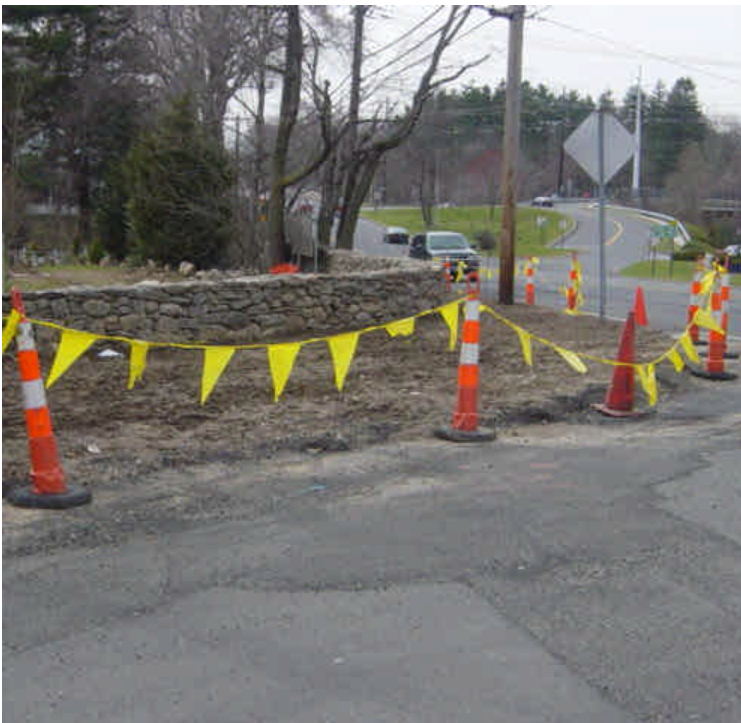
Areas of Inspection	Observation	Recommended Action	Corrected Action
	some shrubs had been removed from the work area at sta #503 per the D&M plan. The stone wall has been rebuilt. 4/03/08	the D&M plan. Soils need vegetative cover. 4/03/08	been rebuilt.
Dewatering	Dewatering was not observed during this week's inspection. 4/03/08	Continue to properly contain and/or filter discharge water when dewatering is required. 4/03/08	NA
Spills and Material Storage	Spill cleanup materials/kits were observed in the storage yards. 4/03/08	Ensure that spill kits are also present with each vehicle during active construction 4/03/08	NA
Additional Observations	None. 4/03/08	None. 4/03/08	NA

The stone wall has been reconstructed near sta. #502-503. Exposed soil still needs to be stabilized.

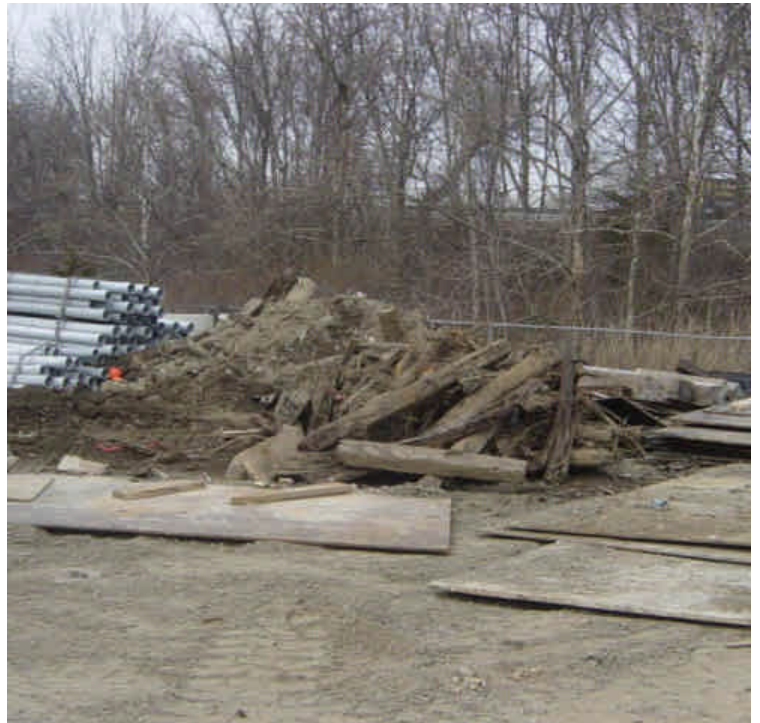
Debris materials and old railroad ties, which have been stored within the Kings Highway yard, are being sorted and processed for disposal.
