Docket No. 272 – Development and Management Plan Inspection

Segment 4a Underground Line

Date: April 24, 2008

Location: Singer Substation to Fairfield/Westport Town Line

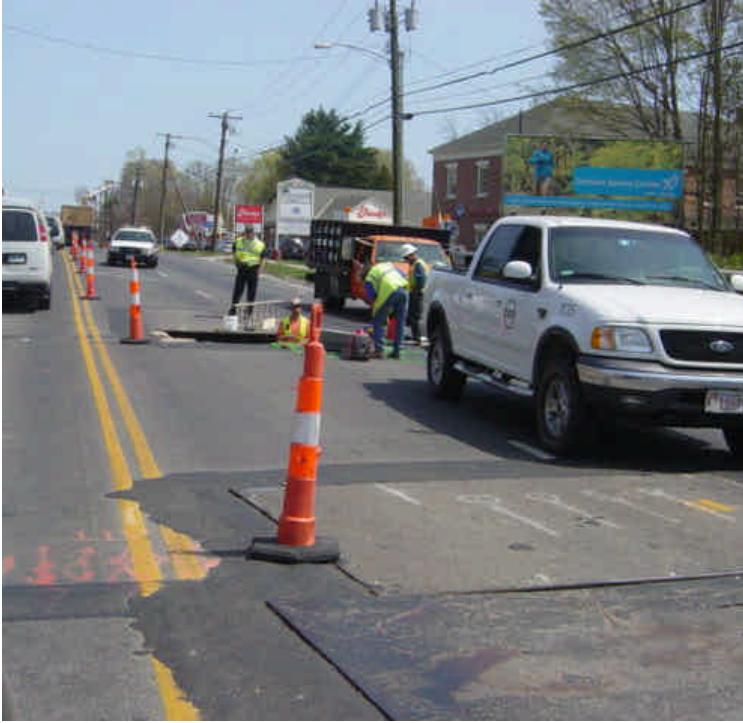
Utility work was ongoing at the bridge over Sasco Creek near sta. #441 in preparation to attach the conduit to the existing bridge structure.

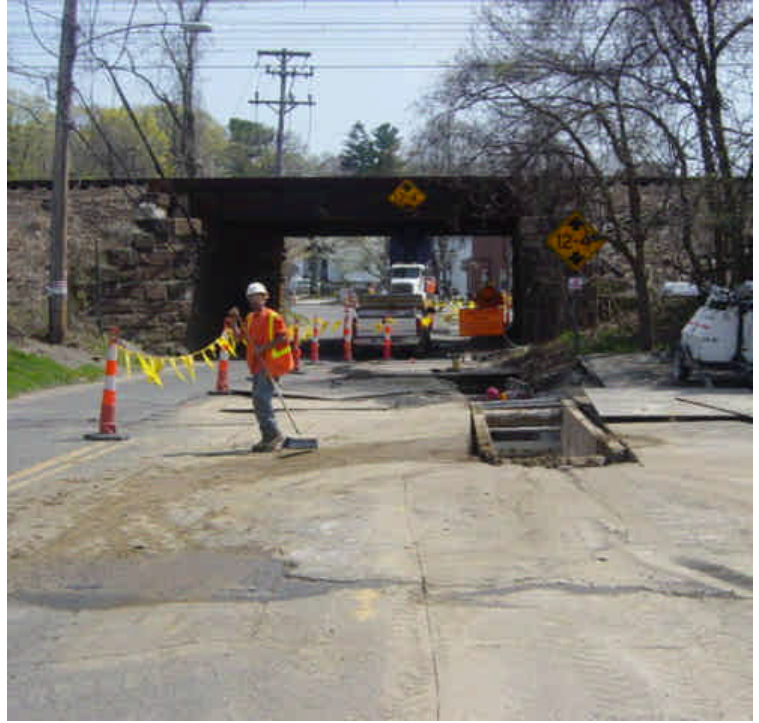
Trenching activities continue near sta. #477-478. Crews were observed sweeping the roadway in an effort to reduce sediment tracking.

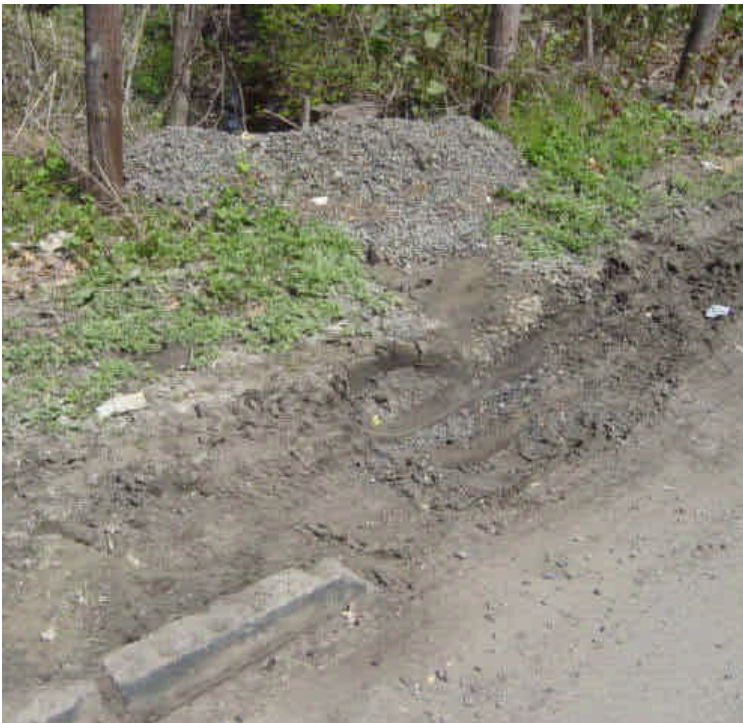
Heavy ruts were observed near the drainage swale at sta. #480. A pile of crushed stone has been placed near the edge of the swale and should be spread over the exposed soil to stabilize the area. Repair the curbing when feasible.

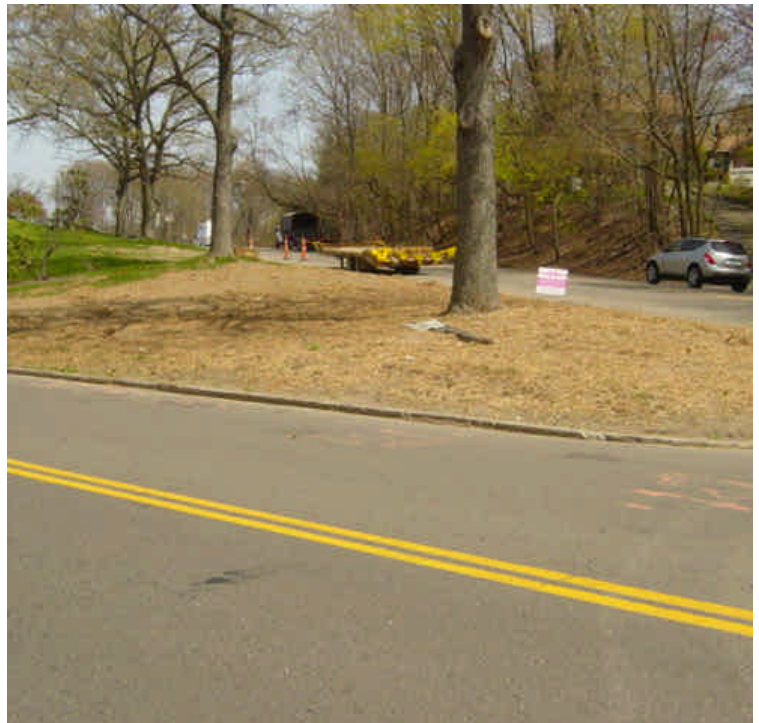
Seed and mulch have been applied over the previously exposed soil on the median near sta. #495.
