**Docket No. 272 – Development and Management Plan Inspection**

**Segment 4a Underground Line**

**Date:** May 1, 2008

**Location:** Singer Substation to Fairfield/Westport Town Line

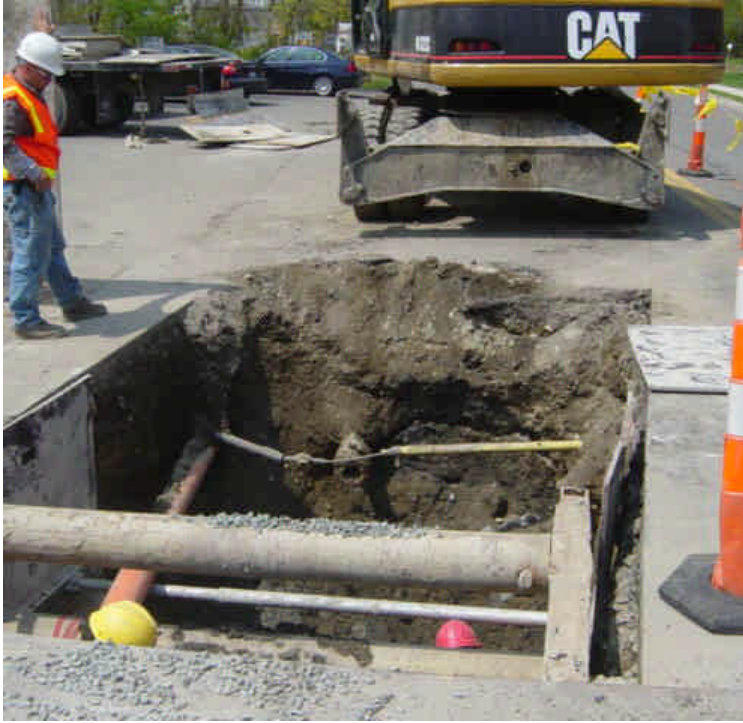
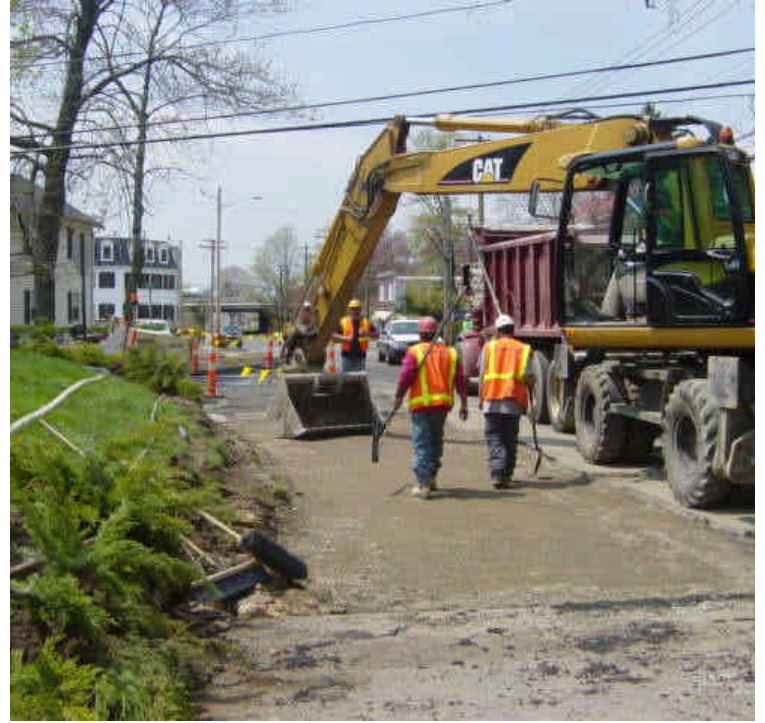
**Work continues near sta. #473-478. Crews were trenching in some areas while other areas were being backfilled and prepared for paving.**

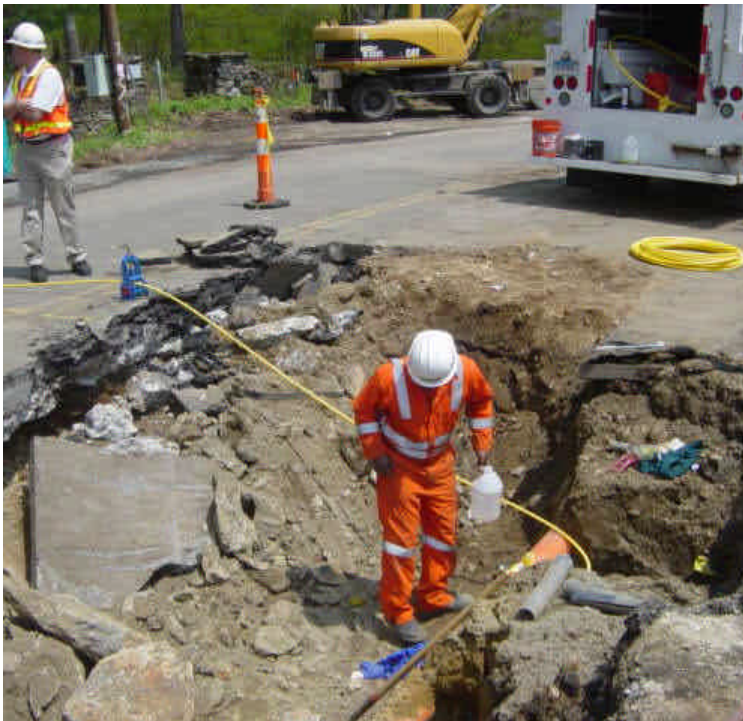
Areas of Inspection	Observation	Recommended Action	Corrected Action
	<p><b>Creek. These activities will be covered in the water and railroad crossings report. 5/1/08</b></p> <p><b>While trenching near sta #474, a gas line was ruptured. The gas company responded to repair the line and no injuries were reported. 5/1/08</b></p>	<p><b>None at this time. 5/1/08</b></p>	<p><b>NA</b></p>

**While trenching near sta. #474, a gas line was ruptured. The gas company responded to repair the broken line and there were no injuries reported.**

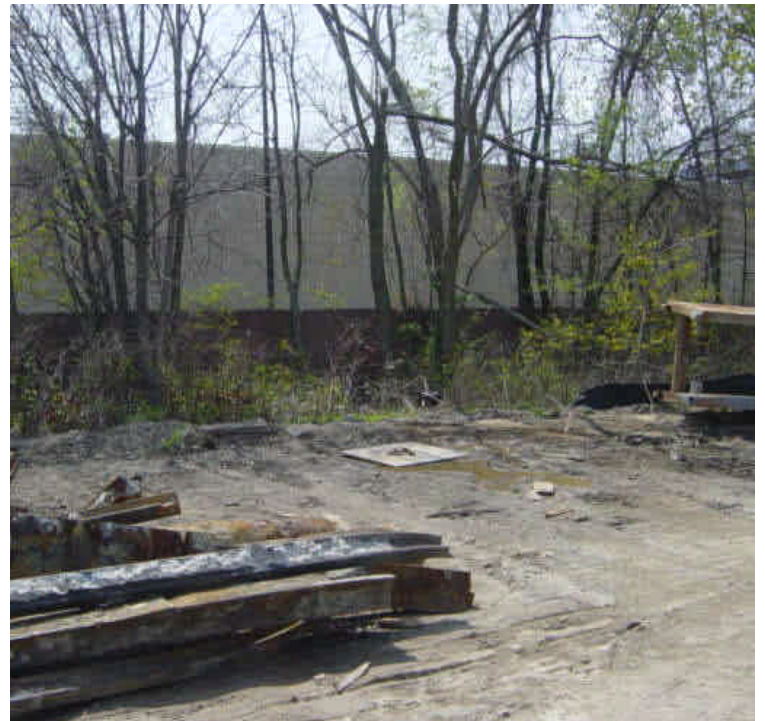
Areas of Inspection	Observation	Recommended Action	Corrected Action
	<p>Perimeter controls remain in place but some sections need repair. 3/20-5/1/08</p>	<p>near controls. 5/1/08  Controls need maintenance. 3/20-5/1/08</p>	<p>Needs attention</p>
<p><b>Inland Wetland and Watercourse encroachment and mitigation</b></p>	<p>The Kings Highway lay-down yard is located adjacent to potential resource areas and a concrete lined waterway. 5/1/08</p> <p>Ruts and some exposed soil were observed near the drainage swale (near sta. #480) along the roadway. Crushed stone remains piled near the edge of the swale. 4/24-5/1/08</p>	<p>See Erosion and Sediment Controls section. 5/1/08</p> <p>Spread crushed stone over areas of exposed soil at the roadway shoulder. Re-grade rutted areas. 4/24-5/1/08</p>	<p>NA</p> <p>Needs attention.</p>
<p><b>Staging, Storage, and Parking Areas</b></p>	<p>A contractor lay-down yard is located off of Kings Highway near the Rt. 1 rotary. Reserve spill kits are located near the equipment trailers. Debris material and old railroad ties, which have been stored within the yard, are being sorted and processed for disposal. 4/3-5/1/08</p>	<p>See Erosion Control and Spills and Material Storage sections. 5/1/08</p>	<p>NA</p>

**A small section of silt fence needs repair along the perimeter of the Kings Highway lay down yard.**
