Docket No. 272 – Development and Management Plan Inspection

Segment 4a Underground Line

Date: May 29, 2008

Location: Singer Substation to Fairfield/Westport Town Line

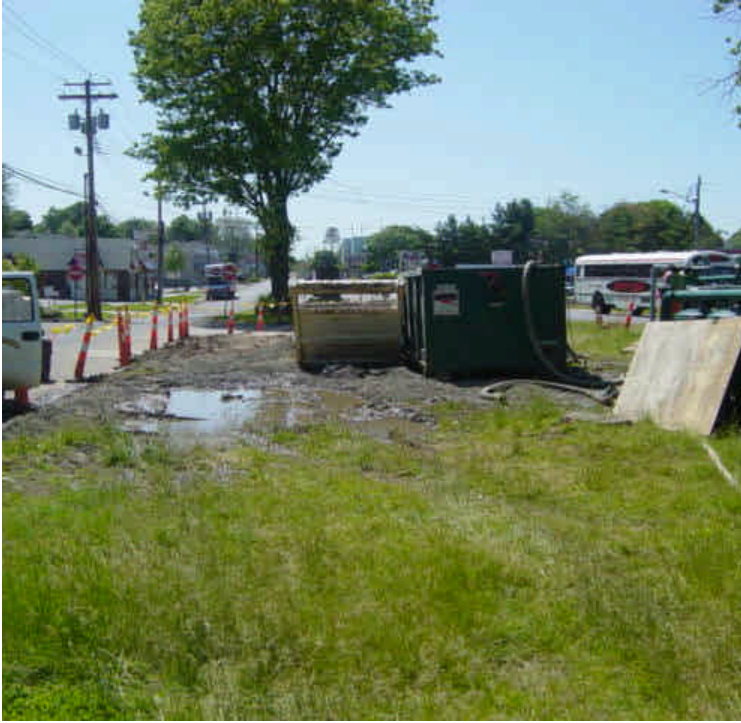
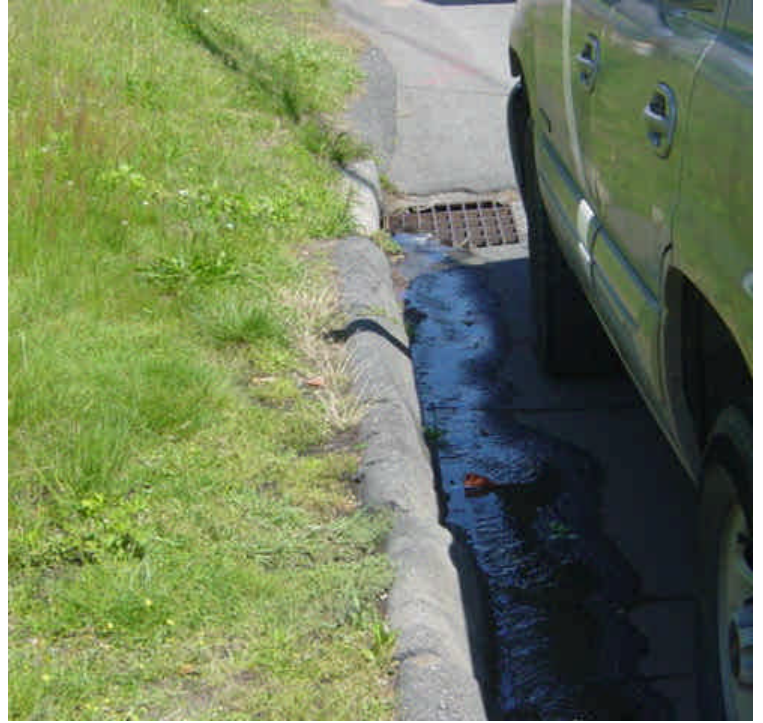
<p>Dewatering</p>	<p>Dewatering was observed during this week's inspection at sta. #463. Filters appear to have clogged and an overflow occurred to the street. A small amount of turbid water entered the catch basin. 5/29/08</p>	<p>Continue to properly contain and/or filter discharge water when dewatering is required. Consider proactive controls in adjacent catch basins when dewatering is scheduled. 5/29/08</p>	<p>Continue to address this area.</p>
<p>Spills and Material Storage</p>	<p>Spill cleanup materials/kits were observed in the storage yards. 5/29/08</p>	<p>Ensure that spill kits are also present with each vehicle during active construction 5/29/08</p>	<p>NA</p>
<p>Additional Observations</p>	<p>Sidewalk has been restored near sta. #481. 5/29/08</p>	<p>None. 5/29/08</p>	<p>NA</p>

Crews were dewatering near sta. #462-464 in preparation for trenching work to realign the conduit. During dewatering activities, the filters appear to have clogged and an overflow occurred. A small amount of turbid runoff was flowing along the curbline and into the downstream catch basin.

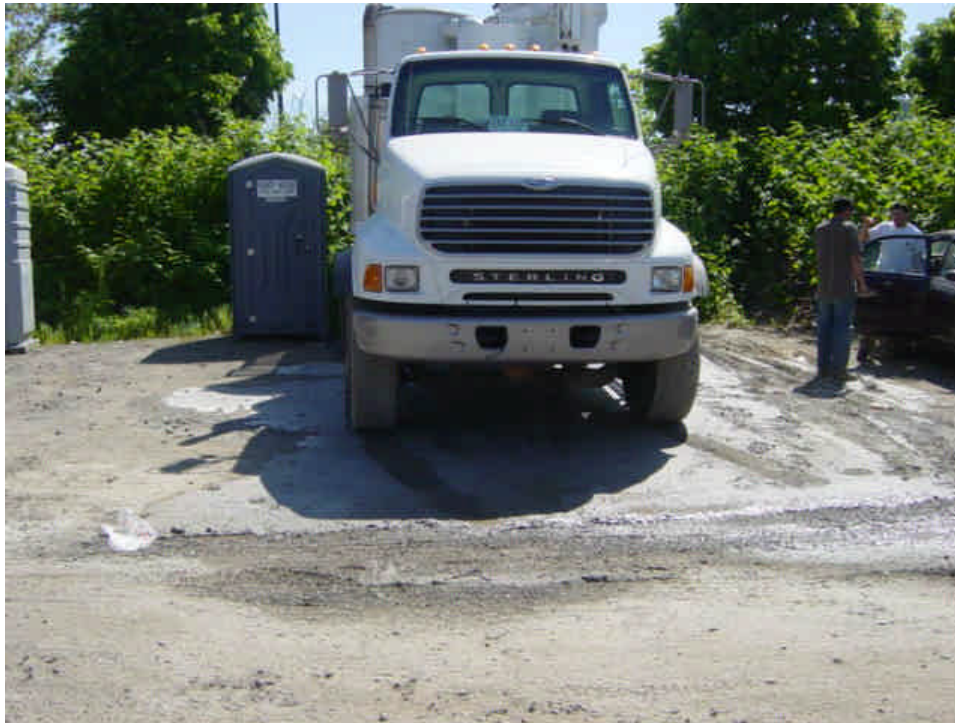
Spilled slurry material was observed underneath a vac truck in the Kings Highway lay-down yard.
