Docket No. 272 – Development and Management Plan Inspection

Segment 4a Underground Line

Date: June 6, 2008

Location: Singer Substation to Fairfield/Westport Town Line

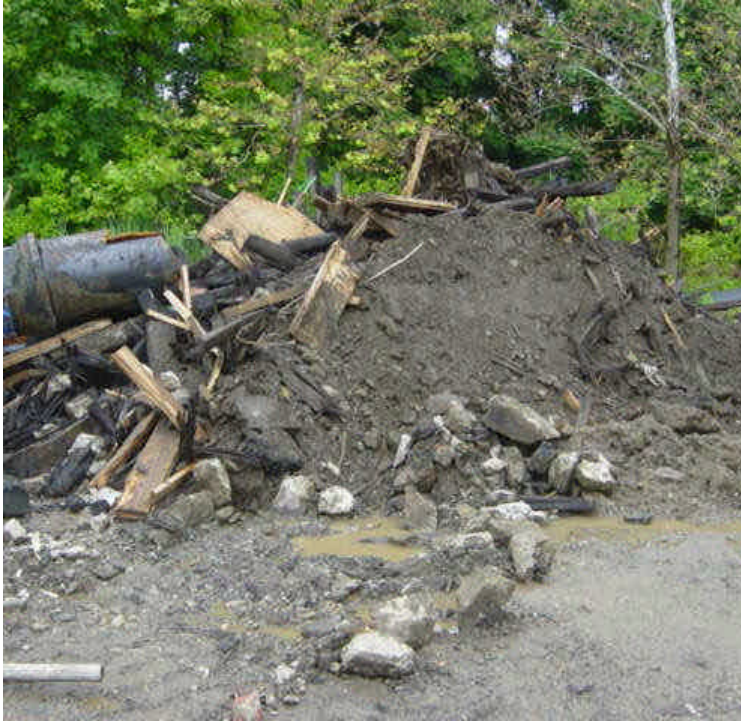
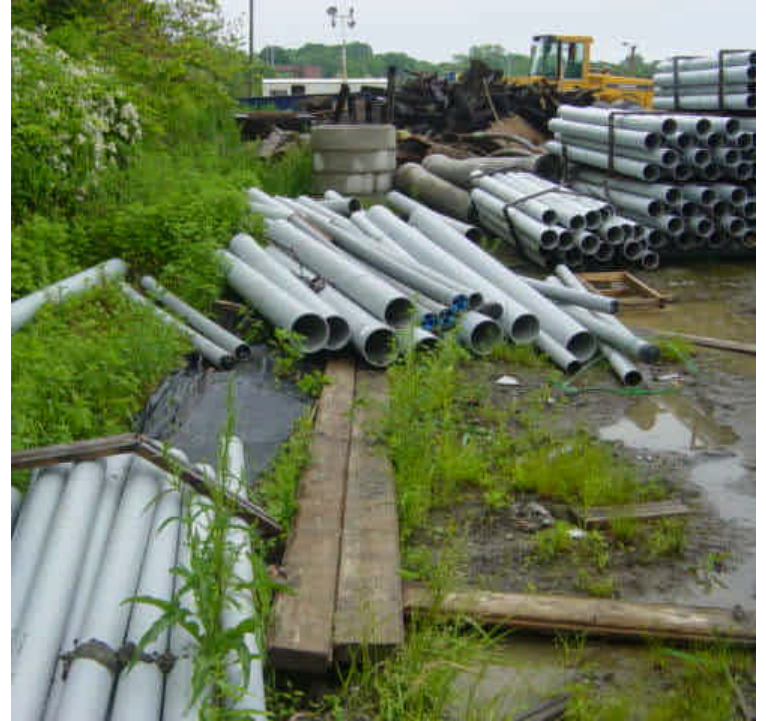
<p>Some sections of the perimeter silt fence are in need of repair in area where materials have been placed/spilled on the fence. The small stockpile that was dumped on top of the silt fence in one area near the NW corner of the yard has been removed but the silt fence still needs to be restored. 6/6/08</p>	<p>Maintain crushed stone throughout the yard to reduce the potential for tracking, dust migration, and limit the amount of material piled near controls. 6/6/08</p>	<p>Crushed stone was added but still needs regular attention.</p>
	<p>Crushed stone has been spread in several areas throughout the yard to reduce tracking. However, sediment tracking was still a minor issue. 6/6/08</p> <p>Spilled slurry material that was observed under a vac truck near the west side of the yard appears to have been cleaned. 6/6/08</p>	<p>None at this time. 6/6/08</p>	<p>The spilled slurry material appears to have been cleaned.</p>

Areas of Inspection	Observation	Recommended Action	Corrected Action
Staging, Storage, and Parking Areas	<p>A contractor lay-down yard is located off of Kings Highway near the Rt. 1 rotary. Reserve spill kits are located near the equipment trailers. A pile of old railroad ties stored within the yard was being sorted for disposal. Additional soil and debris material has been mixed with the previously sorted railroad tie debris. 6/6/08</p>	<p>See Erosion and Sediment Controls section for more information. 6/6/08 Watch encroachment of materials beyond the perimeter controls in the yard. 6/6/08</p>	<p>See erosion control section.</p>
Soils	<p>Soils are exposed as part of the excavation for trench, vault, and utility work. 6/6/08</p> <p>An area of exposed soil remains near sta. #596 (vault #36) near the new sidewalk and parking lot. 3/13-6/6/08</p> <p>An area of exposed soil is adjacent to the work zone near sta. #649-650. Sediment tracking was not observed this week. A temporary sidewalk is in place. 6/6/08</p>	<p>Most areas are temporarily stabilized. Soils appear to be handled appropriately. 6/6/08</p> <p>Re-grade and appropriately restore the area. 3/13-6/6/08</p> <p>Work is complete in this area. Stabilize and seed the area when feasible. 6/6/08</p>	<p>NA</p> <p>Needs attention.</p> <p>Needs attention when feasible Continue to monitor.</p>

In the King's Highway lay-down yard soil and additional debris material has been mixed with the railroad tie debris which had been previously sorted for disposal. Conduit and other materials have been piled or spilled on the perimeter silt fence which needs repair in several areas.

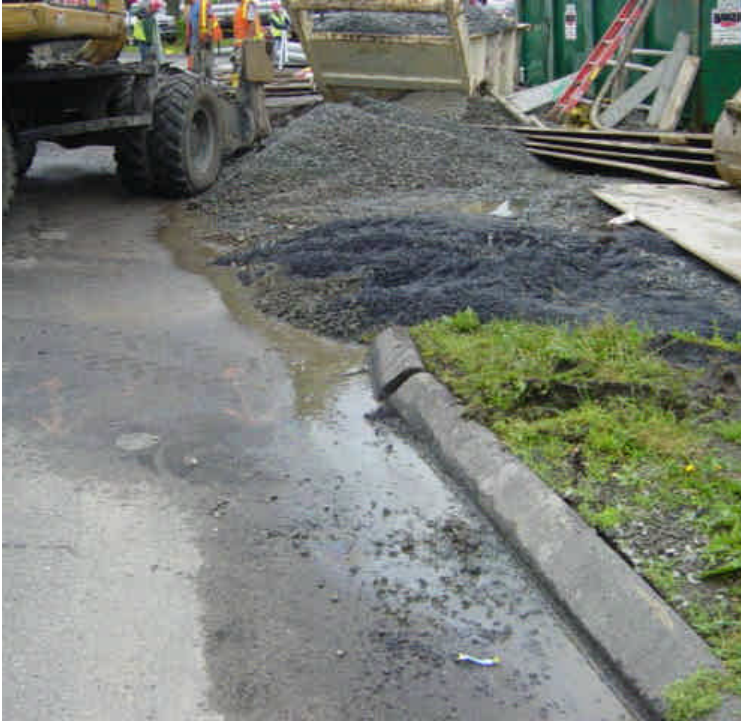
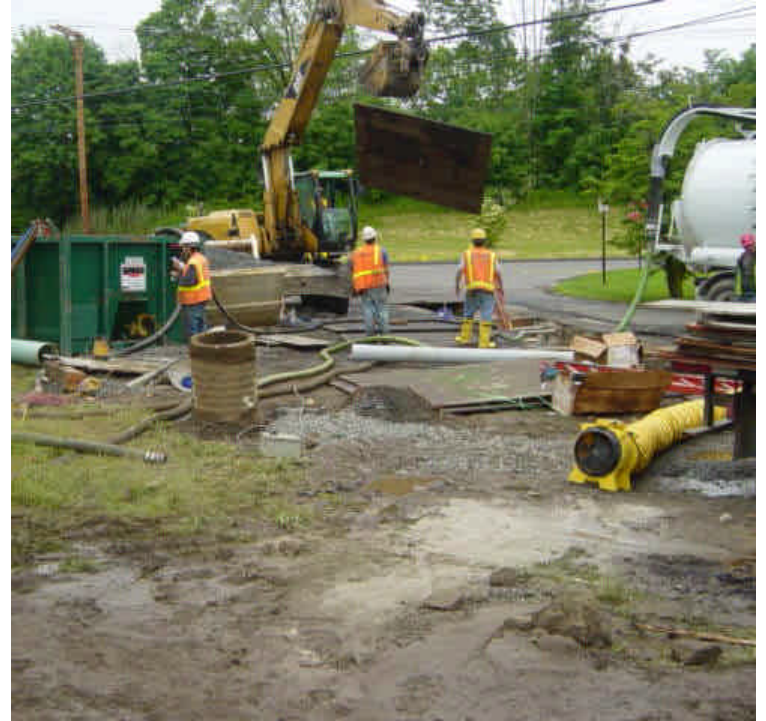
<p>Crews were trenching near sta. #462-464 to realign the conduit. The site was very muddy but generally well contained. A minor amount of sediment was being tracked onto Old Post Road (Rte 1) from vehicles as they exited the median area. A minor amount of turbid runoff was flowing along the curblin and into the downstream catch basin. 6/6/08</p>	<p>Sweep roadways as necessary to minimize tracking. Install erosion controls measures to reduce the potential for sediment-laden runoff to enter the catch basin. Continue to monitor the area. 6/6/08</p>	<p>Needs attention</p>
Bridgeport	<p>A minor amount of gravel/ cold mix has accumulated in the area of the steel plates near sta. #716-718. 6/6/08</p>	<p>Sweep roadway to remove granular material from the roadway. 6/6/08</p>	<p>Needs attention.</p>
	<p>The work area near the intersection of Railroad Ave and Fairfield Ave (sta #719-720) has been backfilled with process material. Cones were</p>	<p>Continue to monitor and provide final cover/ restoration when feasible. 6/6/08</p>	<p>Temporary barriers were placed in efforts to prevent ruts here</p>

Crews were trenching near sta. #462-464 to realign the conduit. Deawtering activities were ongoing. The site was very muddy but generally well contained. A minor amount of sediment was being tracked onto Old Post Road (Rte 1) from vehicles as they exited the median area. A small amount of turbid runoff was flowing along the curbline and into the downstream catch basin.
