Docket No. 272 – Development and Management Plan Inspection

Segment 4a Underground Line

Date: June 27, 2008

Location: Singer Substation to Fairfield/Westport Town Line

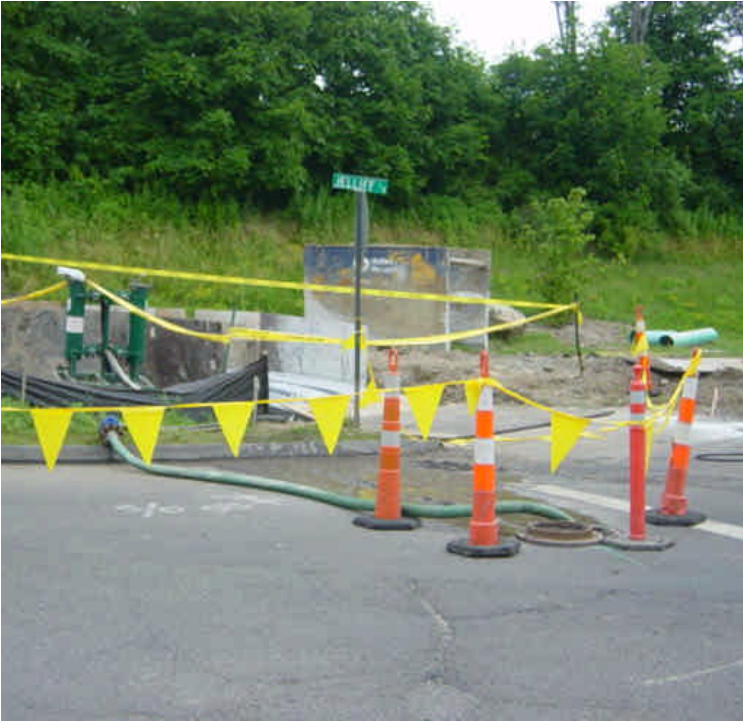
Gravel and sediment has accumulated along the curb line near sta. #647. Crews were later observed sweeping the area.

Bridgeport	<p>A minor amount of gravel and sediment was again observed along the curb line near sta. #647. Crews were observed sweeping the area later. 6/27/08</p>	<p>Sweep roadway to remove material. Continue to monitor the area and proactively sweep the roadway as necessary. 6/27/08</p>	<p>Roadway was swept following the observation.</p>
	<p>The work area near the intersection of Railroad Ave and Fairfield Ave (sta #719-720) has been backfilled with process material. Cones remain in place to prevent vehicles from pulling off road and creating ruts. However, minor tracking was newly observed near the edge of the trench. 6/20-6/27/08</p>	<p>Continue to monitor and provide final cover/restoration within timelines. Sweep roadway as necessary to remove sediment from the roadway. 6/27/08</p>	<p>Needs attention. <i>The city of Bridgeport is concerned about any areas of tracking along Railroad Ave and crews should be sweeping this area.</i></p>

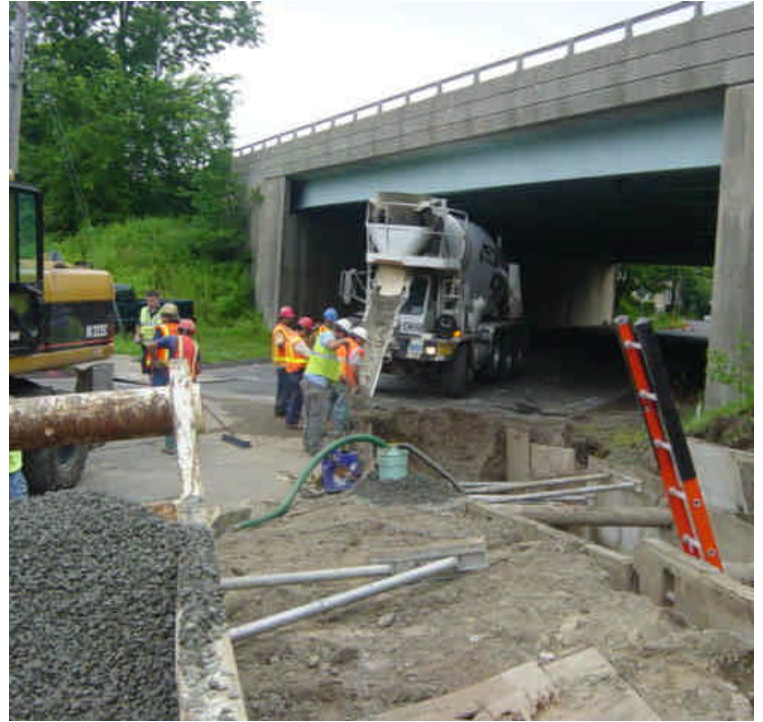
The area near sta. #719 has been partially backfilled. Minor tracking was observed along the edge of the trench.

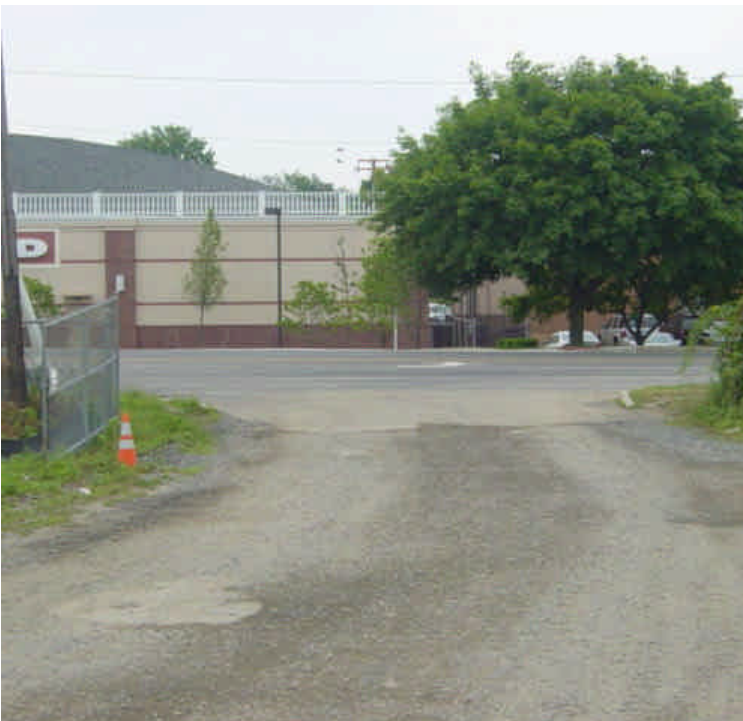
Minor tracking was observed near the entrance to the Kings Highway laydown yard. Sweep as needed.

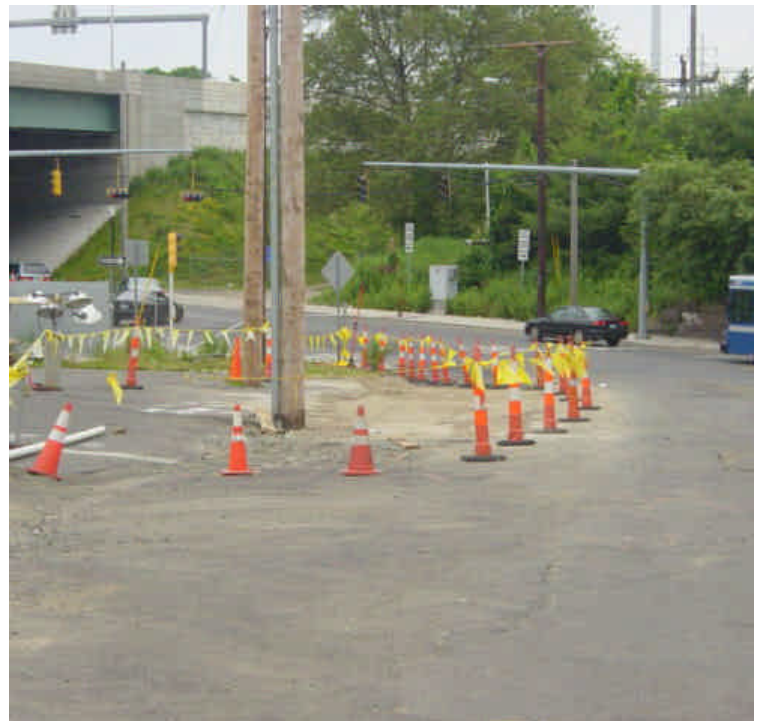
The work area near the intersection of Railroad Ave and Fairfield Ave (sta #719-720) has been backfilled with process material. Cones remain in place to prevent vehicle from pulling off road and creating ruts. Minor tracking was observed near the edge of the trench. Sweep as needed.
