Docket No. 272 – Development and Management Plan Inspection

Segment 4a Underground Line

Date: July 2, 2008

Location: Singer Substation to Fairfield/Westport Town Line

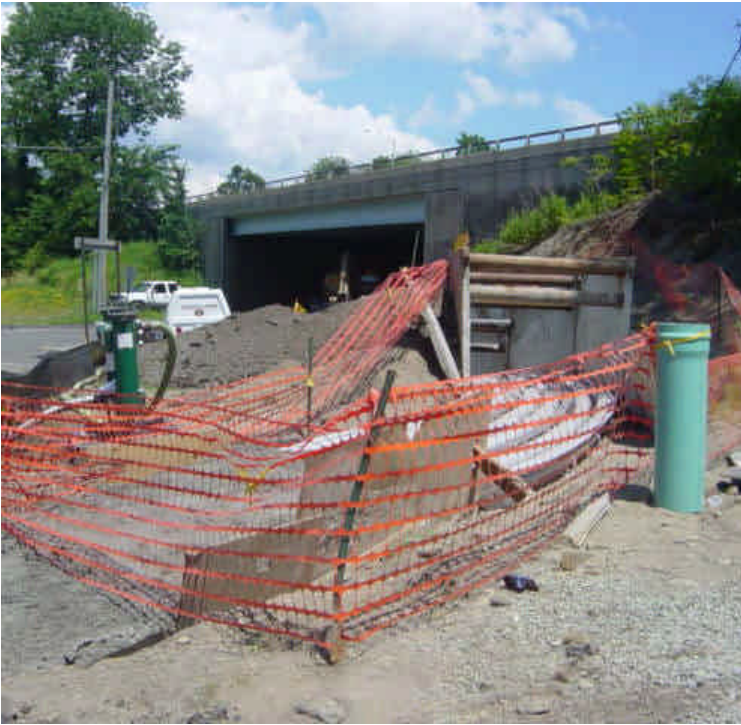
Trenching continues near sta. #462-465. Steel plates covered parts of the trench. Dewatering was ongoing at the time of the inspection.

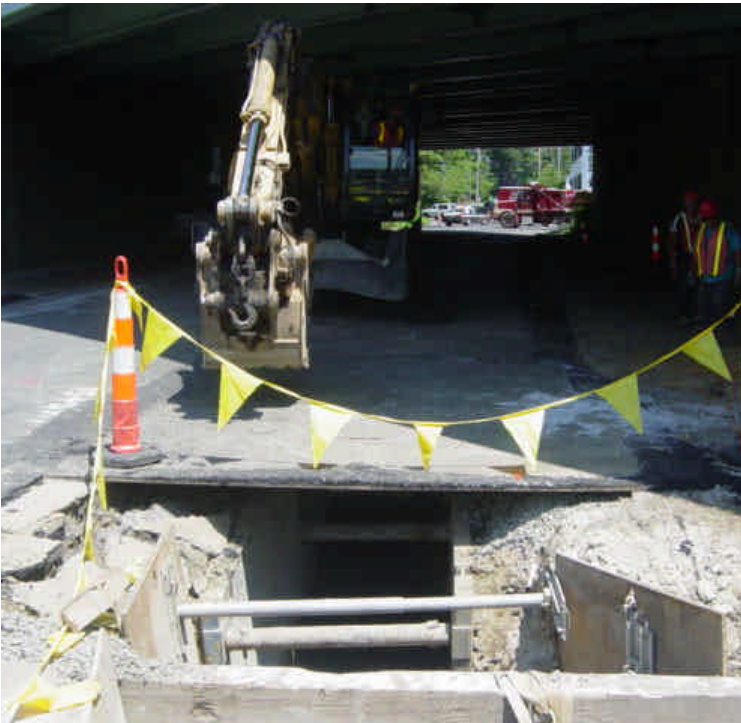
Trenching continues near sta. #466.

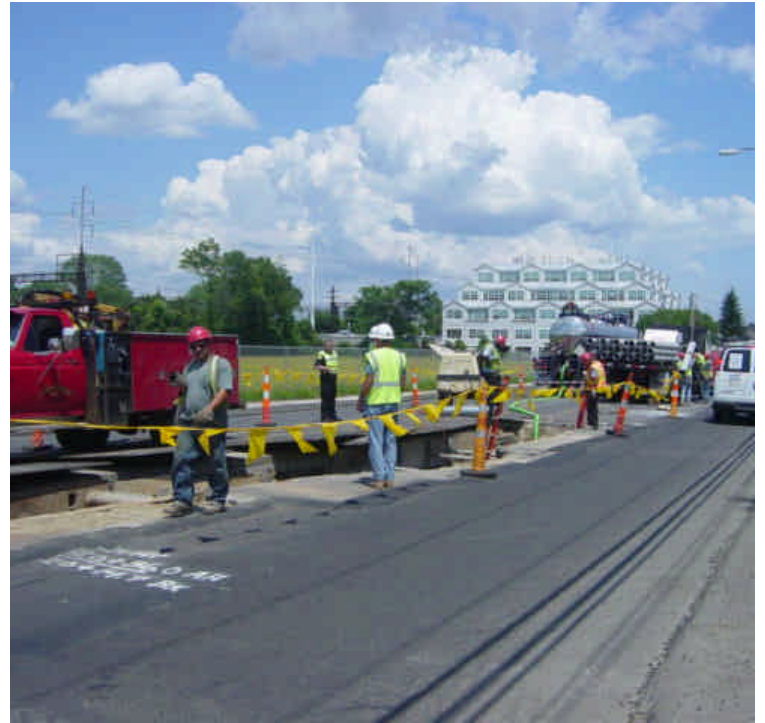
Conduit repair work was ongoing at sta. #519-520.
