Docket No. 272 – Development and Management Plan Inspection

Segment 4a Underground Line

Date: July 17, 2008

Location: Singer Substation to Fairfield/Westport Town Line

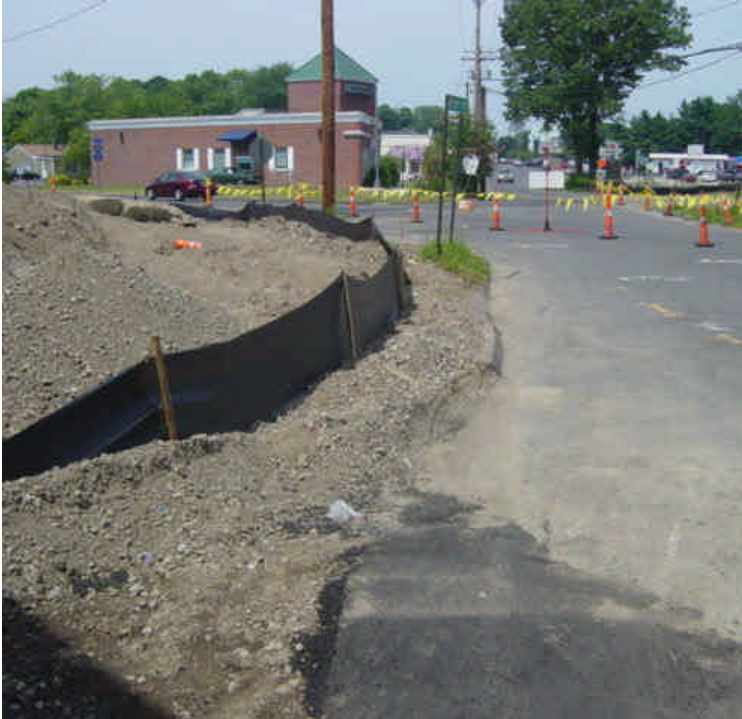
Bridgeport	Trenching has been completed near sta. #465. A large sloped area of exposed soil remains near the bridge abutment. Silt fence has been installed at the base of the slope since last week. 7/17/08	Continue to monitor the area. Continue to sweep roadways as necessary to minimize tracking. Clean the catch basin due to observed run-off from previous weeks. 7/17/08	Silt fence was installed. Catch basin will also need attention.
	<p>The work area near the intersection of Railroad Ave and Fairfield Ave (sta. #719-720) has been backfilled with process material. Cones were placed to prevent vehicle from pulling off road and creating ruts. However, minor tracking was observed near the edge of the trench. 6/20-7/17/08</p> <p>Some ruts were observed along the shoulder of Railroad Ave between Hancock Ave. and</p>	<p>Continue to monitor and provide final cover/restoration when feasible. Sweep roadway as necessary to remove sediment from the roadway. 7/17/08</p> <p>Refresh/add gravel or hard-pack along the shoulders of the roadway in this area to reduce the potential for</p>	<p>Needs attention.</p> <p><i>The city of Bridgeport is concerned about any areas of tracking along Railroad Ave and crews should be sweeping this area.</i></p> <p><i>The city of Bridgeport is concerned about the condition here and crews were being requested to evaluate</i></p>

Trenching work is complete near sta. #465. Silt fence has been installed along the curbline. Soil has been stockpiled against the fabric which is stressing it and causing it to rip in some areas.

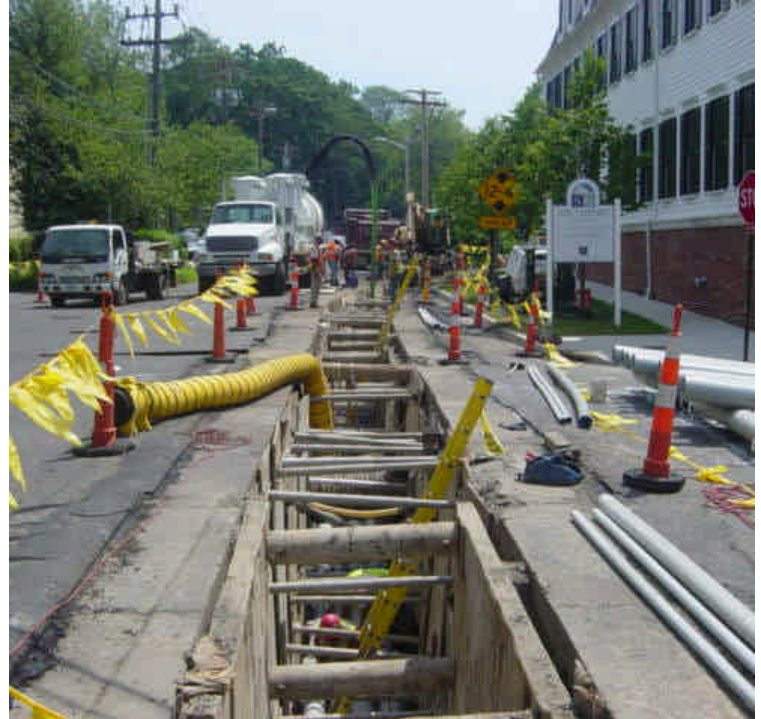
Trenching continues near sta. #468. A vac truck was on site to dewater the trench. Conduit was also being installed in some areas.

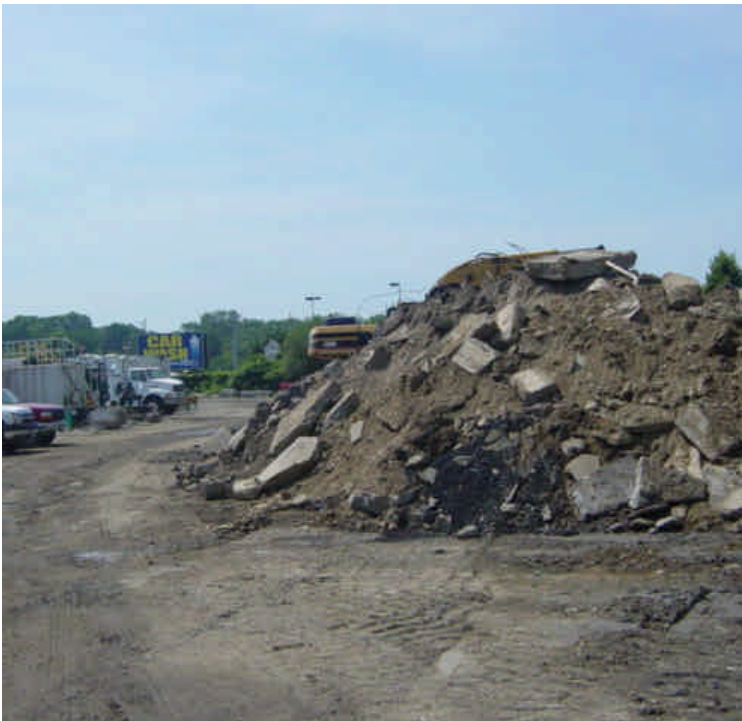
Debris pile in the Kings Highway yard has grown considerably since the previous inspection. Continue to keep material contained until it can be removed.

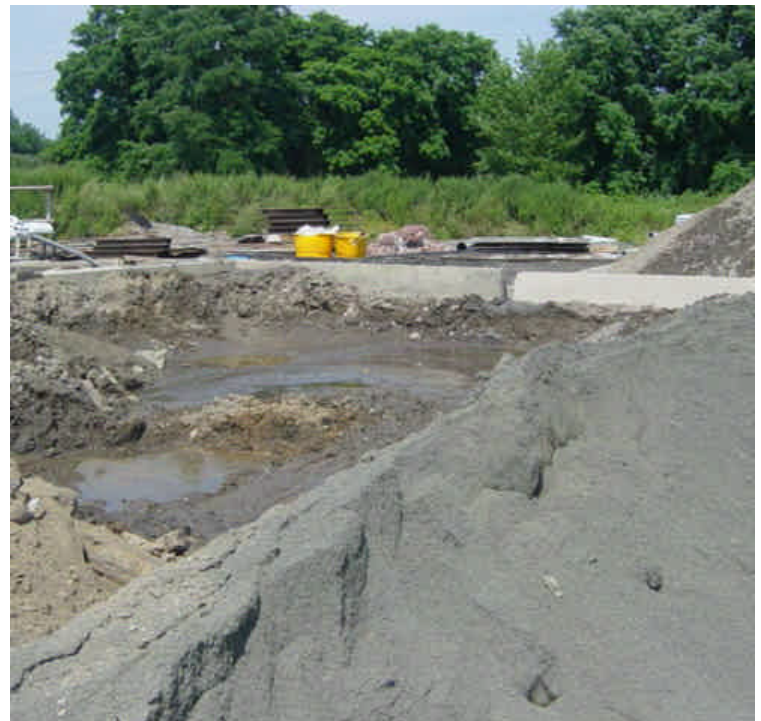
Frac tank washout water has been emptied into a containment area within the Kings Highway laydown yard. The soil berm was adequately containing the material in preparation for disposal.
