Docket No. 272 – Development and Management Plan Inspection

Segment 4a Underground Line

Date: August 14, 2008

Location: Singer Substation to Fairfield/Westport Town Line

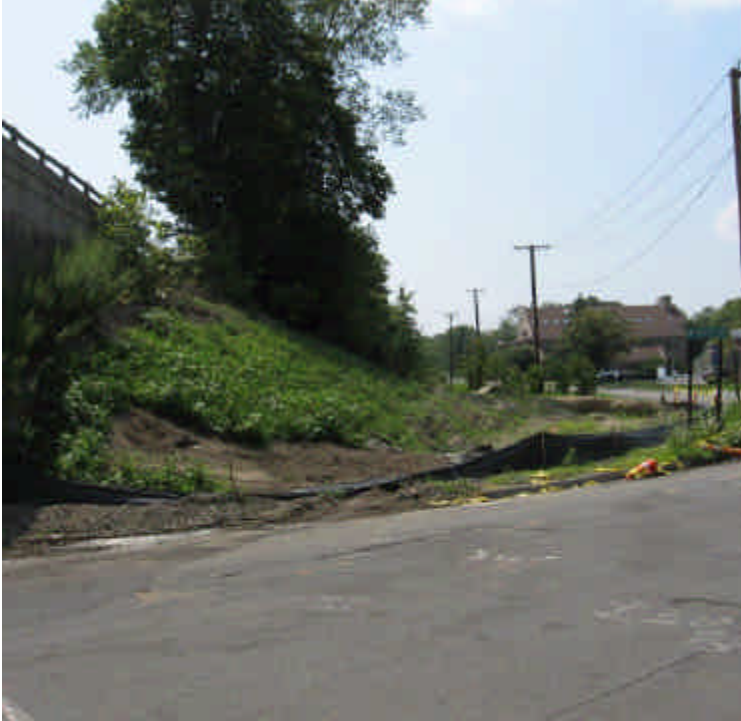
| Areas of Inspection | Observation | Recommended Action | Corrected Action |
|---|---|--|---|
| | <p>Exposed soil remains along the base of the sloped area near the bridge abutment at sta. #465. Silt fence is starting to deteriorate. 8/14/08</p> | <p>Continue to monitor the area. Provide final stabilization. Clean the catch basin due to observed run-off from previous weeks. 8/14/08</p> | <p>Catch basin will also need attention.</p> |

Exposed soil remains along the base of slope near the bridge abutment at sta. #465. Silt fence is falling into disrepair. Provide **final stabilization**.

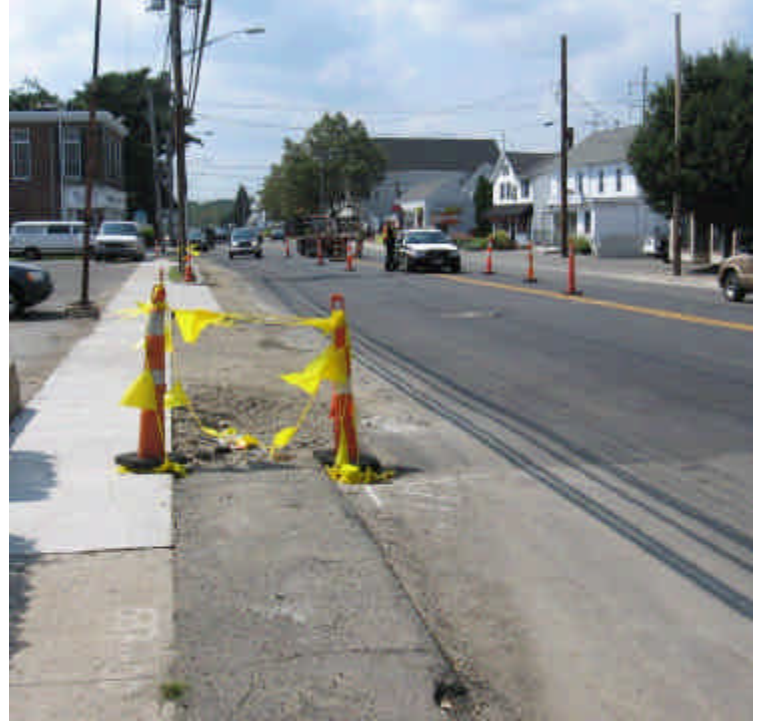
| Areas of Inspection | Observation | Recommended Action | Corrected Action |
|---|--|--|---|
| <p>Soils</p> | <p>Soils are exposed as part of the excavation for trench, vault, and utility work. 8/14/08</p> <p>Sidewalk restoration work was ongoing at sta. #535-537. Areas of exposed soil were not contained. Soil has accumulated along the edge of the roadway. 8/14/08</p> <p>An area of exposed soil near sta. #596 (vault #36) has started to naturally vegetate near the new sidewalk and parking lot. 8/14/08</p> <p>An area of exposed soil is adjacent to the work zone near sta. #649-650 (for several months). Sediment tracking was not observed this week. A temporary sidewalk is in place. 8/14/08</p> | <p>Most areas are temporarily stabilized. Soils appear to be handled appropriately. 8/14/08</p> <p>Sweep roadway. Provide erosion control measures as necessary to contain areas of exposed soils. 8/14/08</p> <p>Continue to monitor until the area has grass cover. 8/14/08</p> <p>Work is complete in this area. Stabilize and seed or provide final surfacing at the area when feasible. 8/14/08</p> | <p>NA</p> <p>Needs attention.</p> <p>Some vegetation was starting to grow.</p> <p>Needs attention/ final restoration.</p> |

Sidewalk restoration work was ongoing at sta. #535-537. Areas of exposed soil were not contained. Soil has accumulated along the edge of the roadway and needs to be swept.

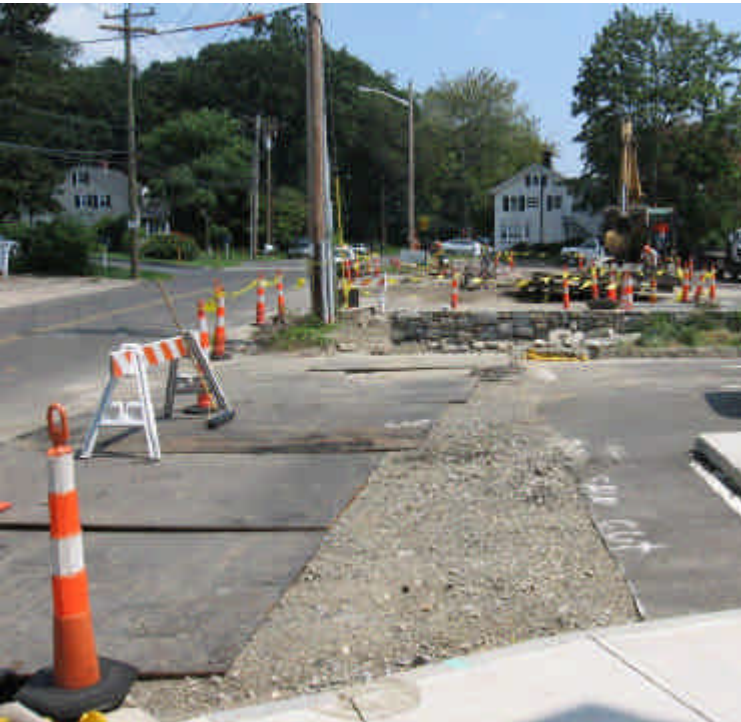
| Areas of Inspection | Observation | Recommended Action | Corrected Action |
|---|---|--|---|
| <p>Bridgeport</p> | <p>Cold mix/ granular material was observed along the roadway near sta. #511-514. Sediment was also noted near sta #535-537 and vault #28. 8/14/08</p> | <p>Continue to monitor the areas. Sweep roadways as necessary to minimize tracking. 8/14/08</p> | <p>Needs attention.</p> |

Trenching and tie-in work continues at vault #28. Sweep the Roadway as necessary to prevent tracking.

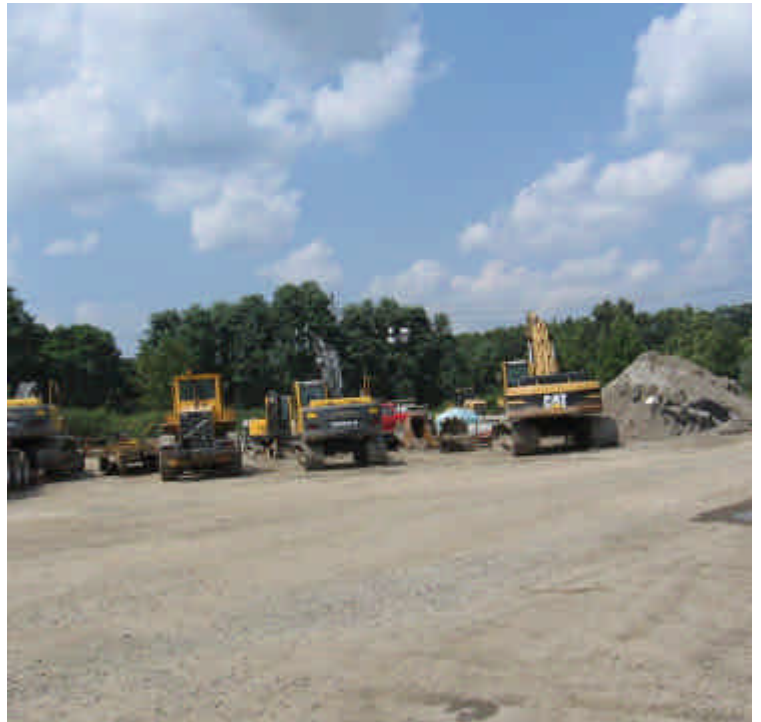
Crushed stone remains throughout the Kings Highway yard to reduce tracking. Sediment tracking and dust migration issues were not observed at the time of the inspection.
