**Docket No. 272 – Development and Management Plan Inspection**

**Segment 4a Underground Line**

**Date:** August 29, 2008

**Location:** Singer Substation to Fairfield/Westport Town Line

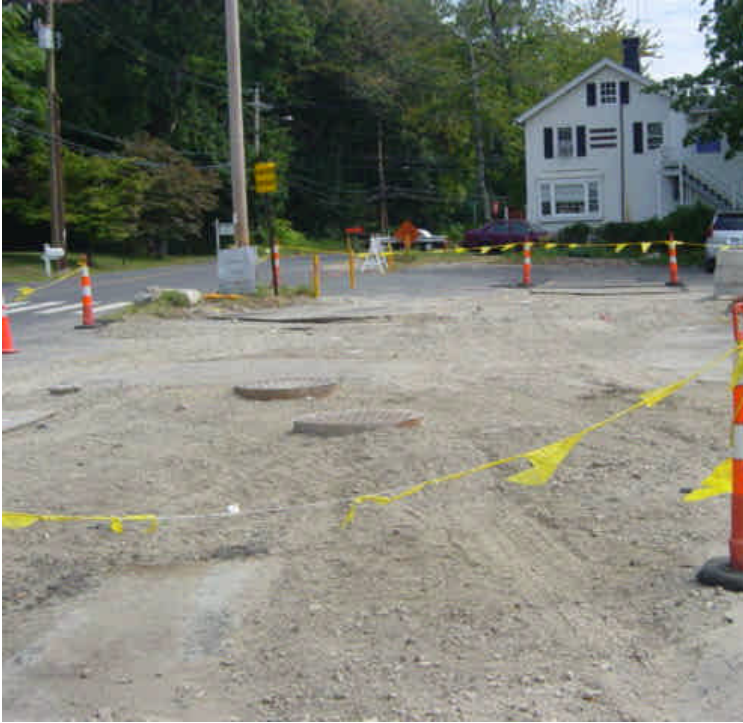
**Tie-in work appears to have been completed and vault #28 has been backfilled. The surface remains exposed and should be finalized**

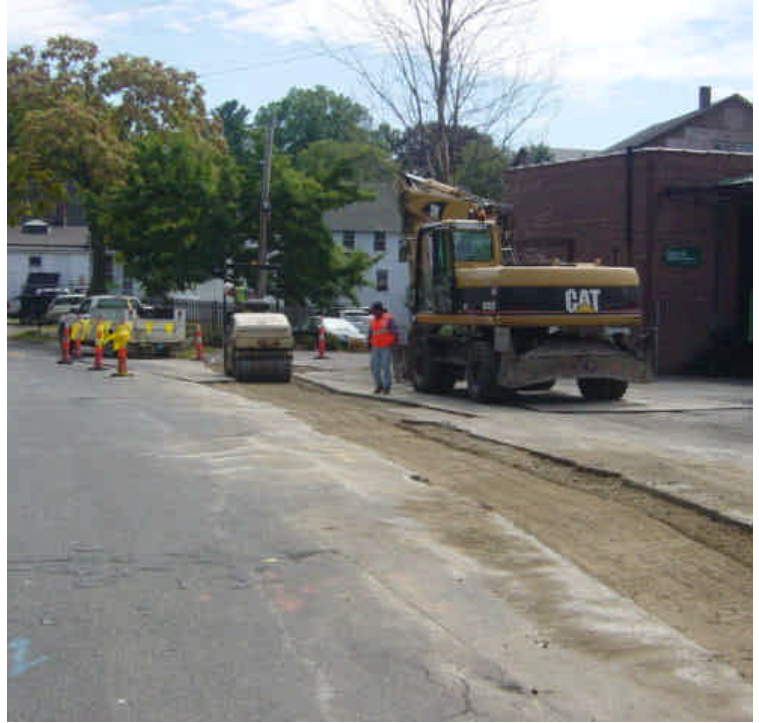
**Backfilling and paving operations were underway near sta. #480-482.**

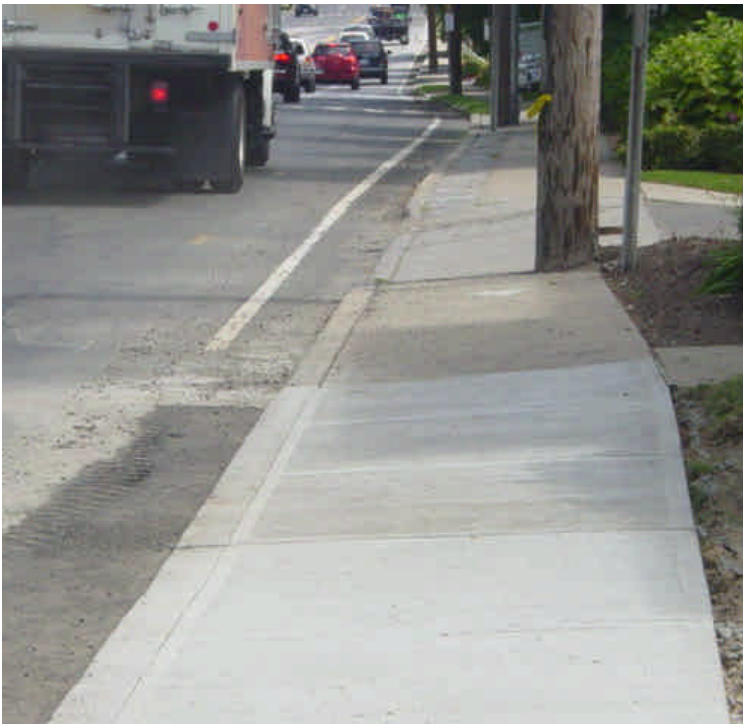
Curbing and sidewalk has been restored near vault #30. A minor amount of cold mix and granular material was observed along the edge of the roadway.

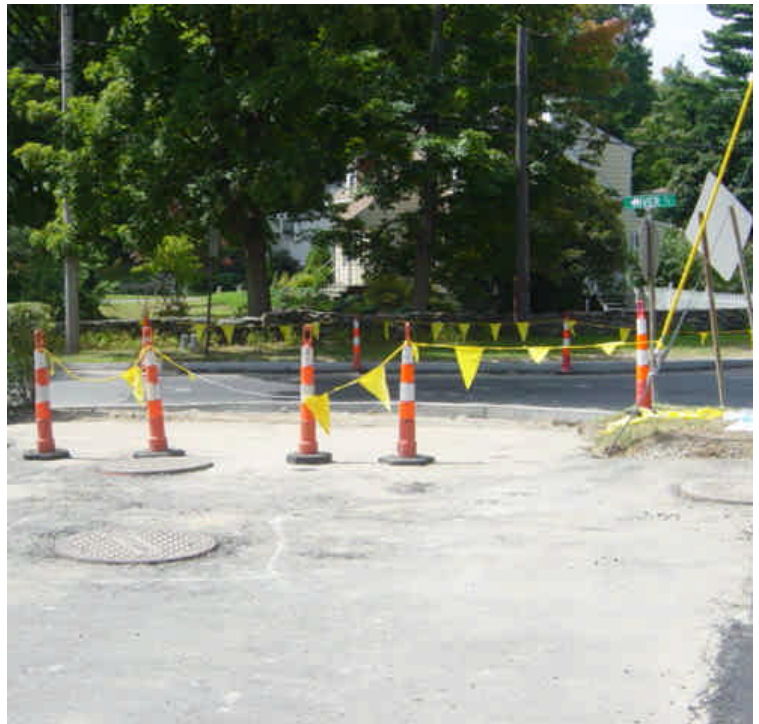
Curbing had been restored near sta. #504-505. near vault #30.
