Docket No. 272 – Development and Management Plan Inspection

Segment 4a Underground Line

Date: September 12, 2008

Location: Singer Substation to Fairfield/Westport Town Line

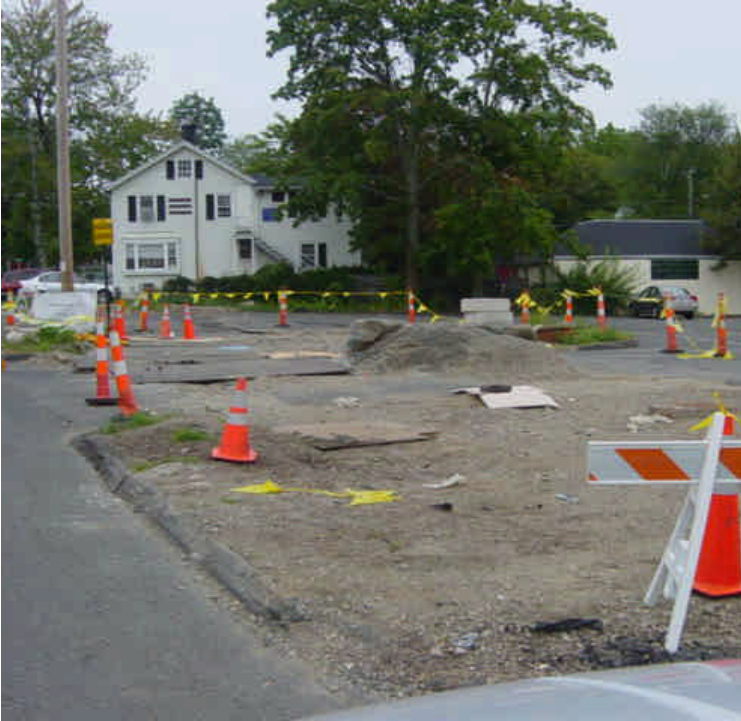
Tie-in work continues near vault #28.

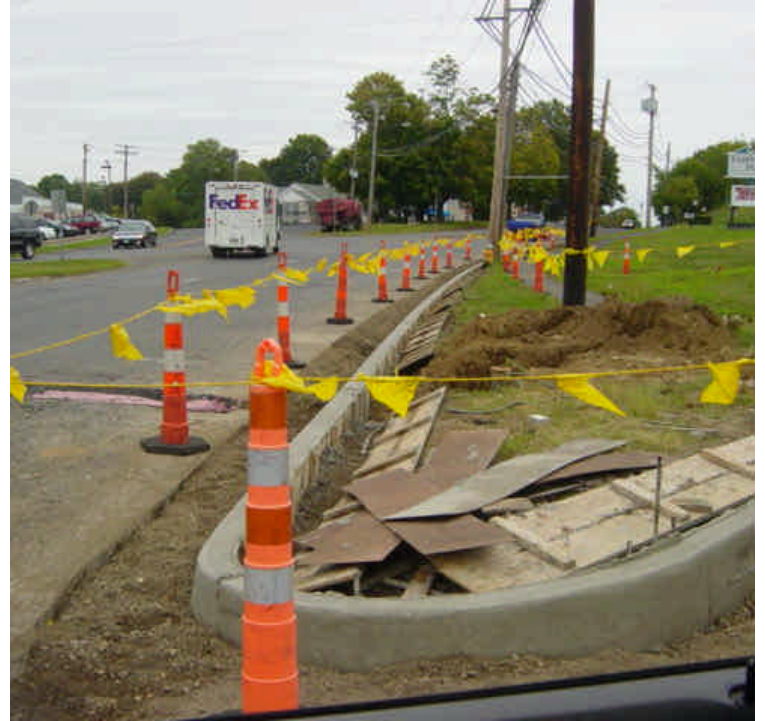
Concrete curbing has been restored near sta. 611 (vault #37). Provide stabilization measures (mulch/stone) to adjacent soil.

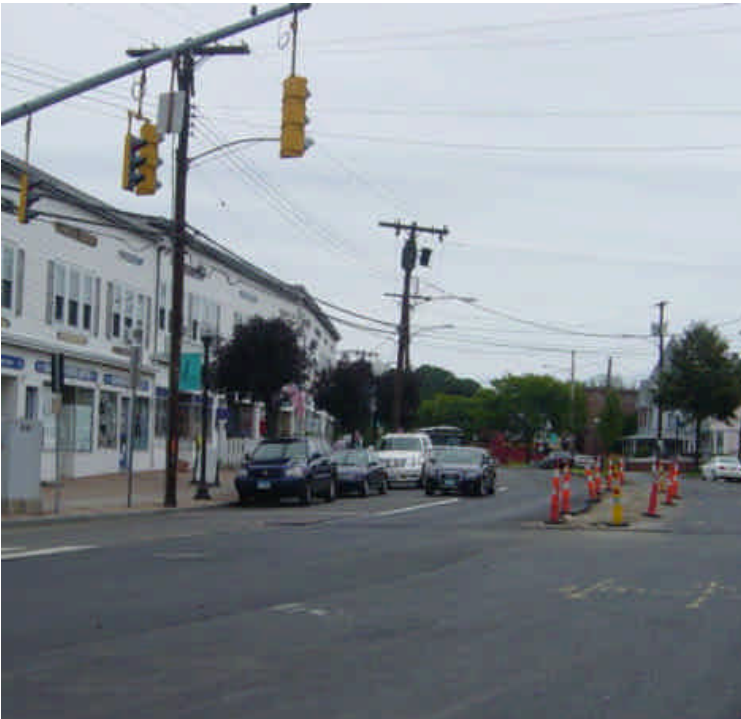
Various portions of Fairfield Ave have been milled in preparation for resurfacing as part of final restoration. Median restoration was also ongoing.

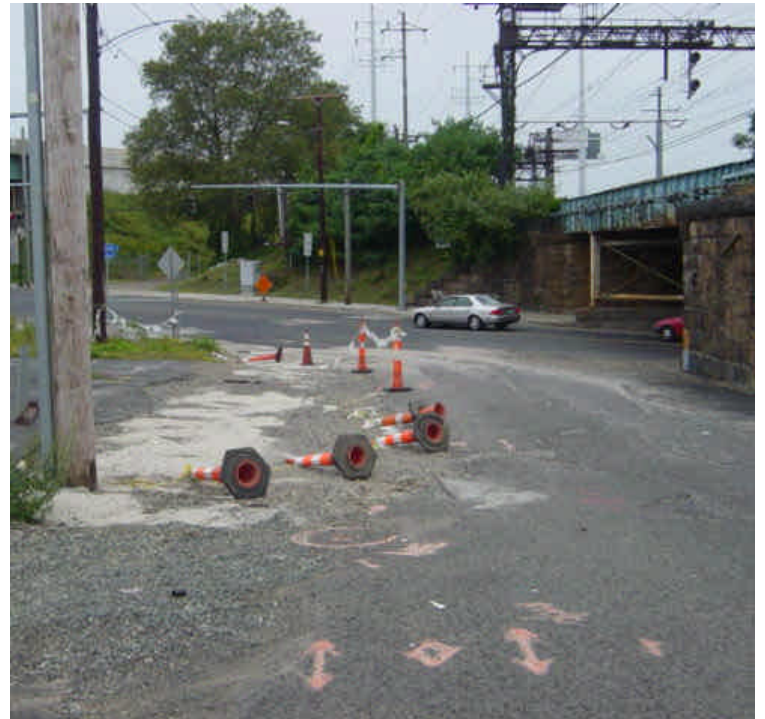
Bridgeport	<p>The work area near the intersection of Railroad Ave and Fairfield Ave (sta. #719-720) remains backfilled with process material. A small stockpile of sandy material was observed in this area. Some residual dusty material was washing into the roadway and catch basin. This may be partially related to utility pole relocation. 9/12/08</p> <p>Some ruts were observed along the shoulder of Railroad Ave between Hancock Ave. and Howard Ave. (sta #737) likely due to regular traffic, not construction vehicles. This area remains backfilled with</p>	<p>Continue to monitor and provide final cover/restoration as soon as feasible. Sweep roadway to remove sediment run-off and clean the catch basin. 9/12/08</p> <p>Refresh/add gravel or hard-pack along the shoulders of the roadway in this area to reduce the potential for rutting and tracking. Continue to monitor so crews can address specific problem areas as they arise. 1/31-</p>	<p>Area needs additional attention. Catch basin needs to be cleaned.</p> <p><i>The city of Bridgeport is concerned about the condition here and crews were being requested to evaluate this area.</i></p> <p>Needs regular attention.</p>

The area near sta. #719-720 remains backfilled with processed material. Some of the material and residual dusty tracking was beginning to be washed onto the roadway and into the catch basin. This may be partially related to utility pole relocation. Sweep, Stabilize, and clean the catch basin.
