Docket No. 272 – Development and Management Plan Inspection

Segment 4a Underground Line

Date: September 26, 2008

Location: Singer Substation to Fairfield/Westport Town Line

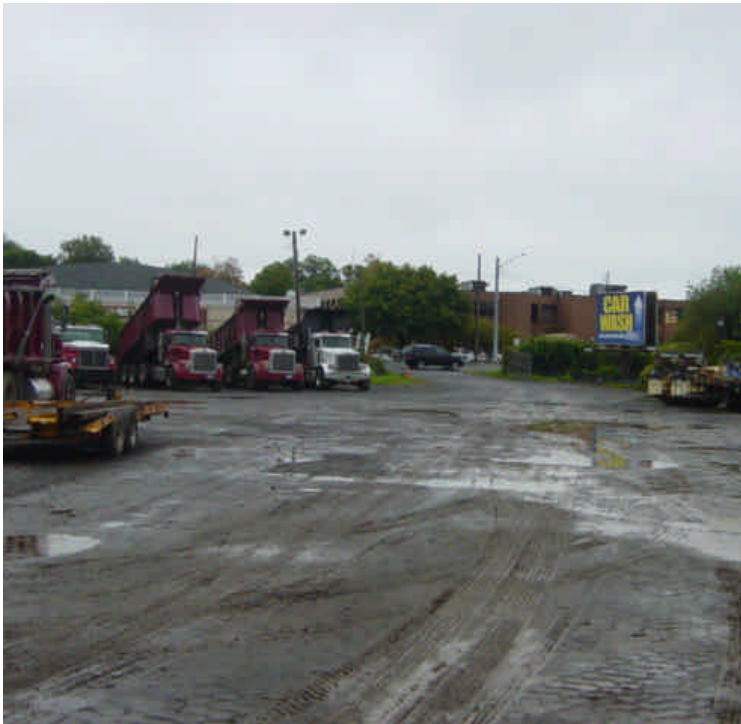
Kings Highway Lay-down Yard (Off Kings Highway, near Rt. 1 rotary)	<p>Perimeter controls around the yard were starting to deteriorate in places (since 9/12). Crushed stone remains throughout</p>	<p>Continue to monitor and maintain controls as necessary. Maintain crushed stone throughout the yard to reduce the potential for tracking</p>	<p>Perimeter silt fence needs attention in some areas.</p>

The Kings Highway yard remains in use, but materials and equipment are beginning to demobilize. Portions of the perimeter fence are deteriorating and need maintenance.

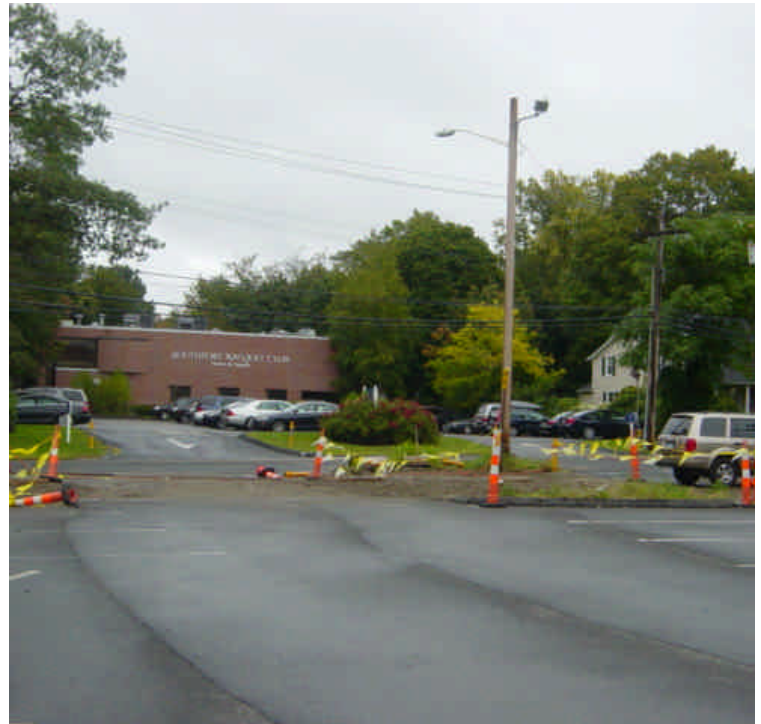
Tie-in work appears to be complete near sta. #28. The area needs to be restored and stabilized.

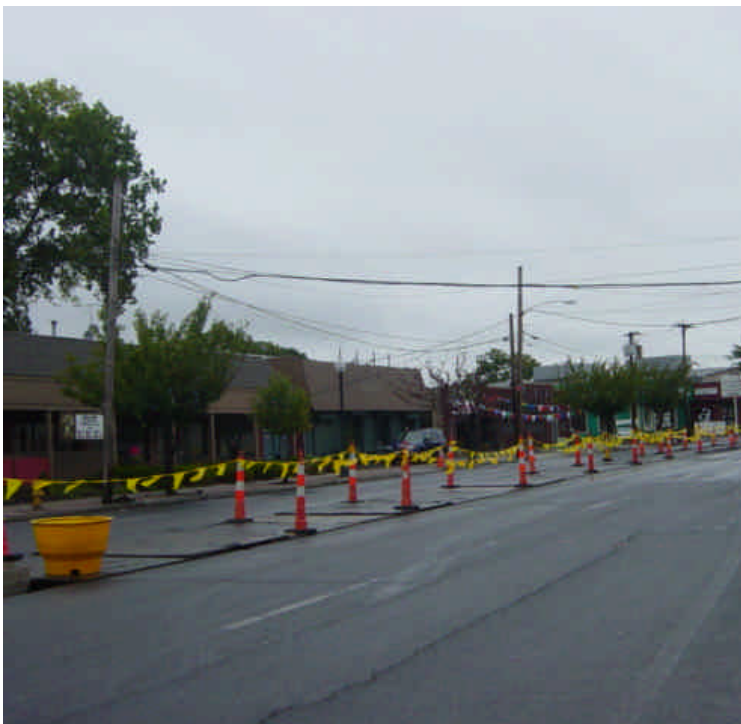
Median and sidewalk restoration was observed in numerous locations along Fairfield Ave.

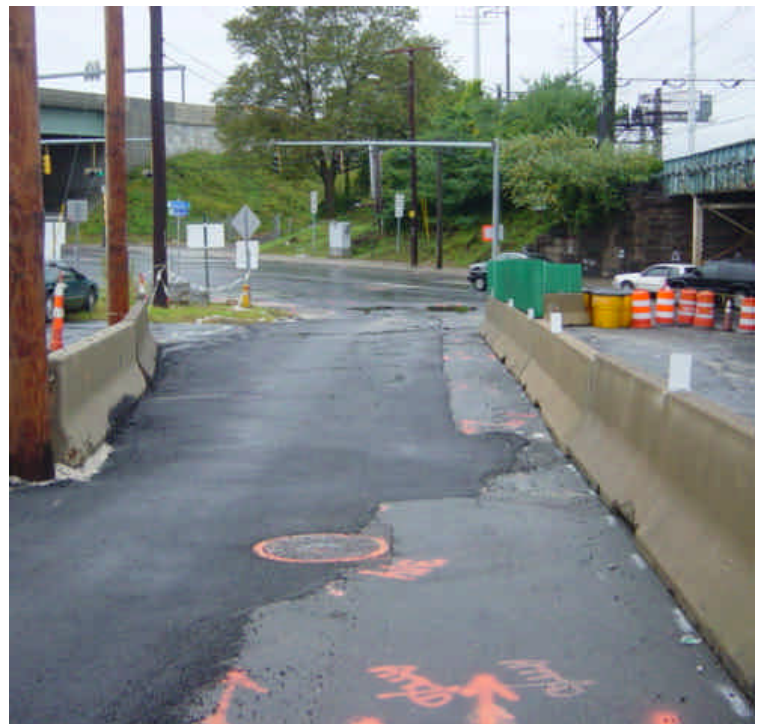
The work area near the intersection of Railroad Ave and Fairfield Ave (sta. #719-720) remains backfilled with process material. Concrete barrier curbs have been placed in the area and the stockpile of sandy material was removed. This work does not appear to be project related. The catch basin should be cleaned.
