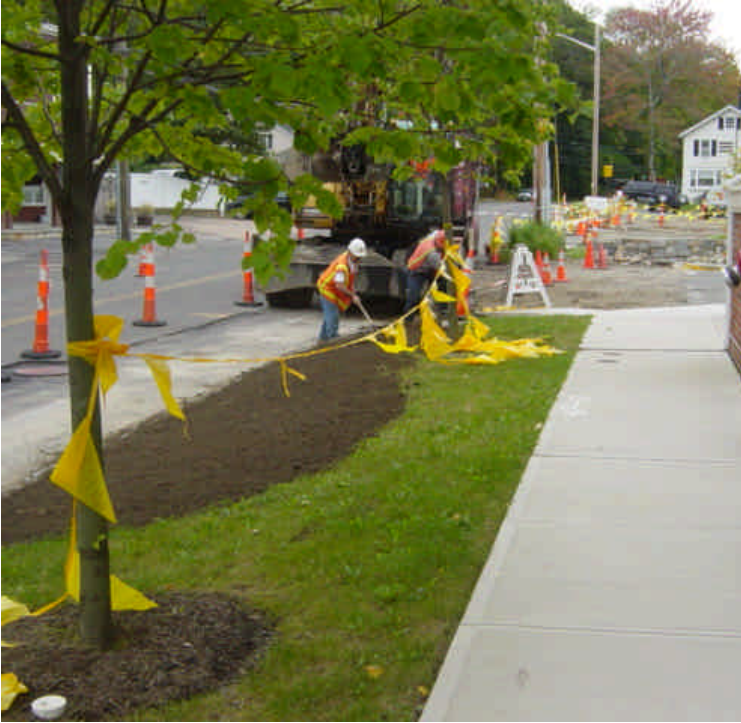
Restoration efforts were observed near sta. #469-470.

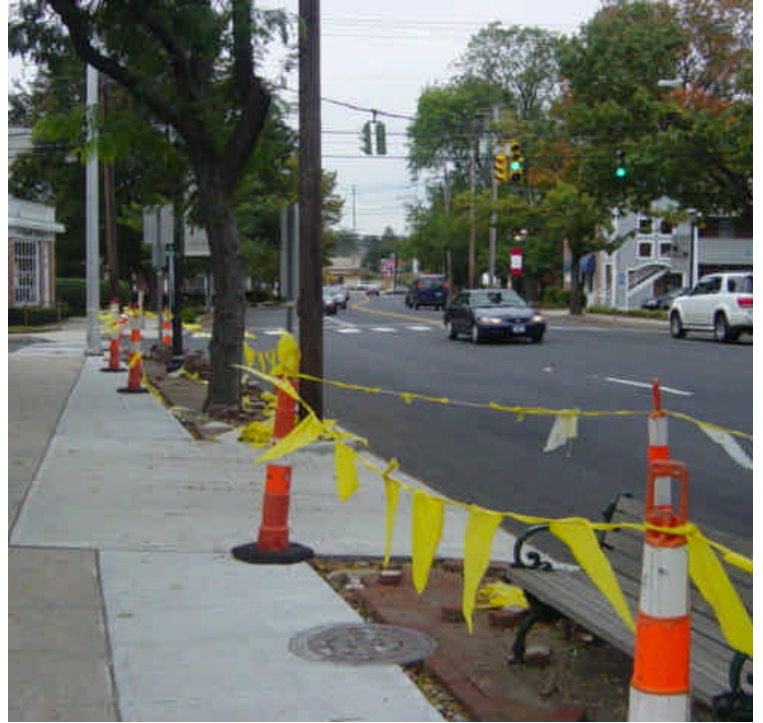
Sidewalk and brick banding pavers have been restored in various locations along Fairfield Ave.

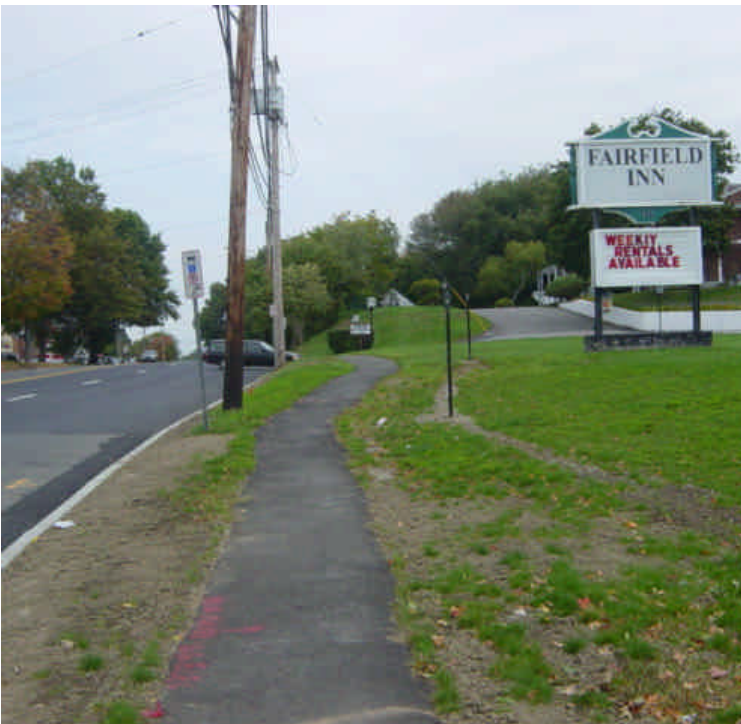
Area near sta. #612 and vault #37 has been re-graded and the area is beginning to vegetate.

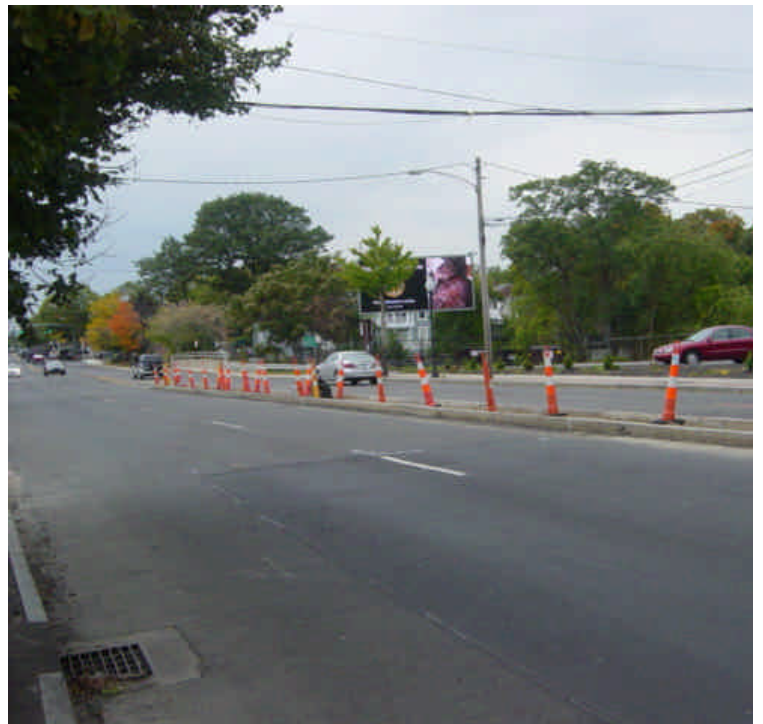
The median was in the process of being restored near sta. #646 along Fairfield Ave.
