**Docket No. 272 – Development and Management Plan Inspection**

**Segment 4a Underground Line**

**Date:** October 10, 2008

**Location:** Singer Substation to Fairfield/Westport Town Line

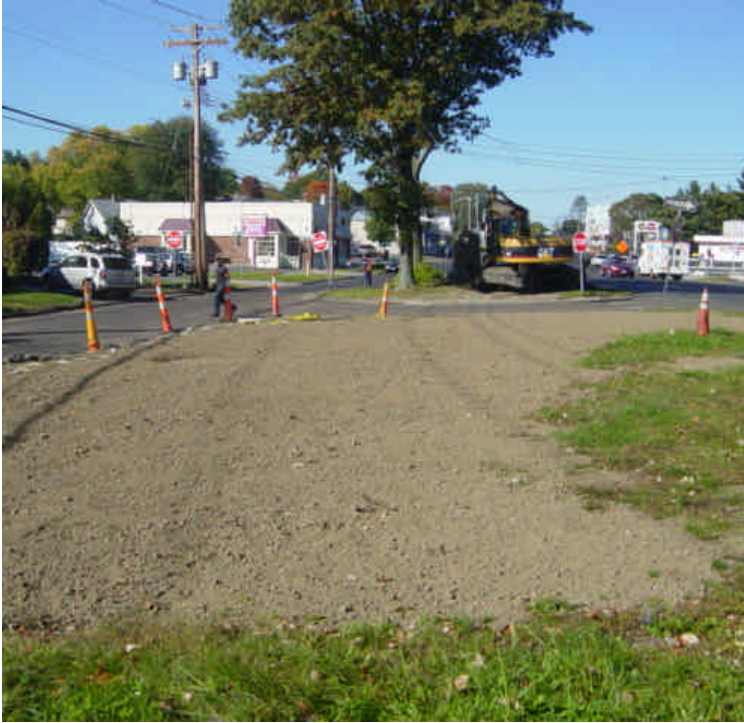
Topsoil has been spread near sta. #463. Ensure the area is properly seeded and mulched to reduce potential for erosion.

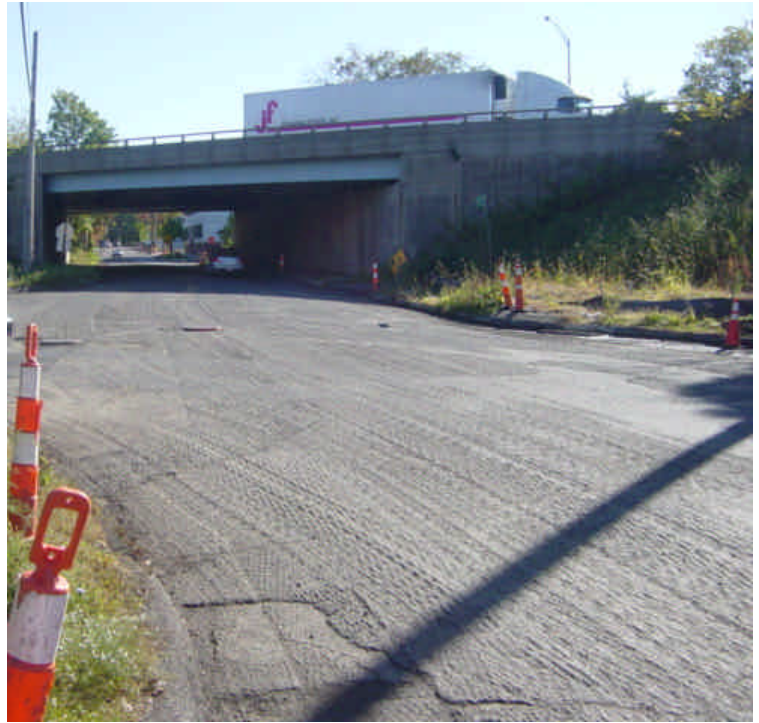
Various portions of Old Post Road have been milled in preparation for final restoration.

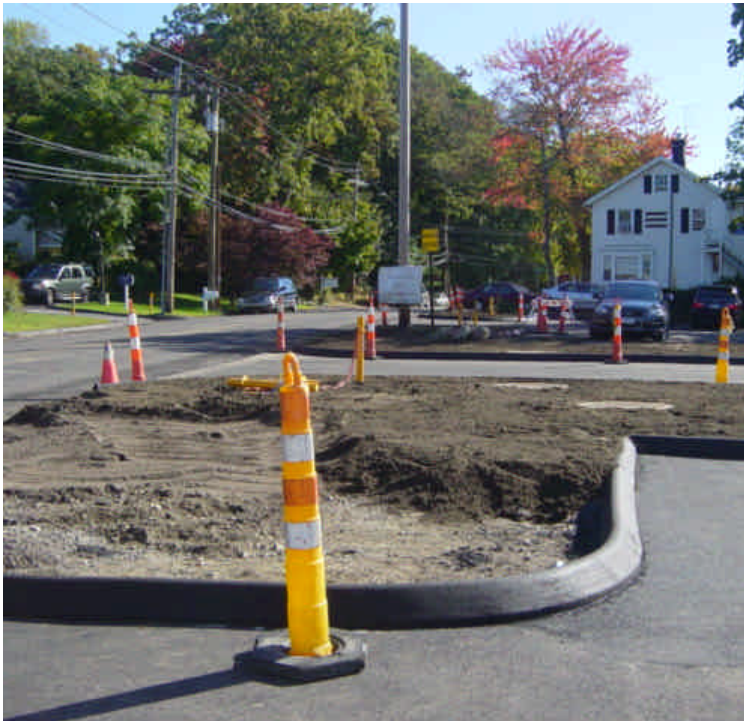
Restoration efforts are underway near vault #28. Ensure topsoil is properly seeded and mulched to reduce potential for erosion.

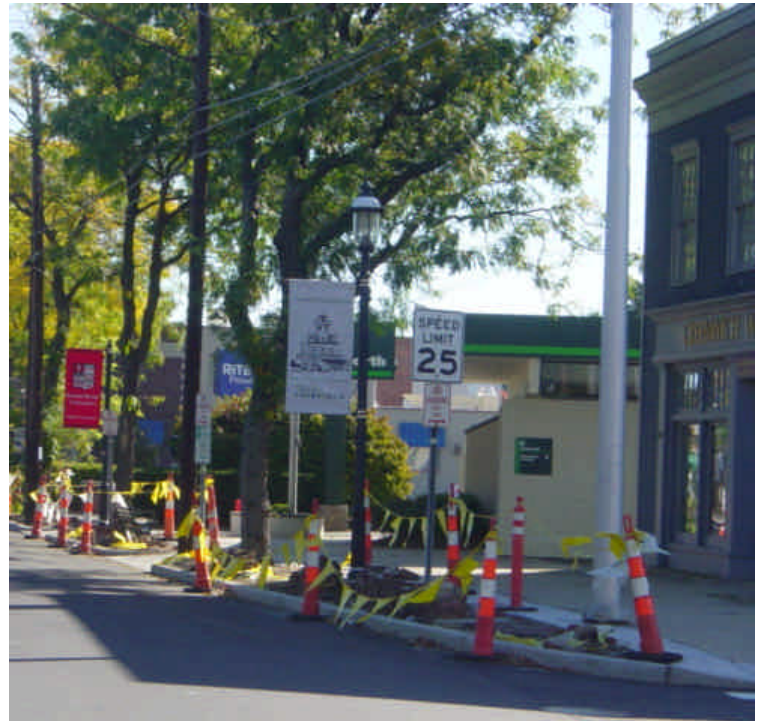
Sidewalk and brick paver restoration was observed in various locations along Fairfield Ave.
