Docket No. 272 – Development and Management Plan Inspection

Segment 4a Underground Line

Date: October 16, 2008

Location: Singer Substation to Fairfield/Westport Town Line

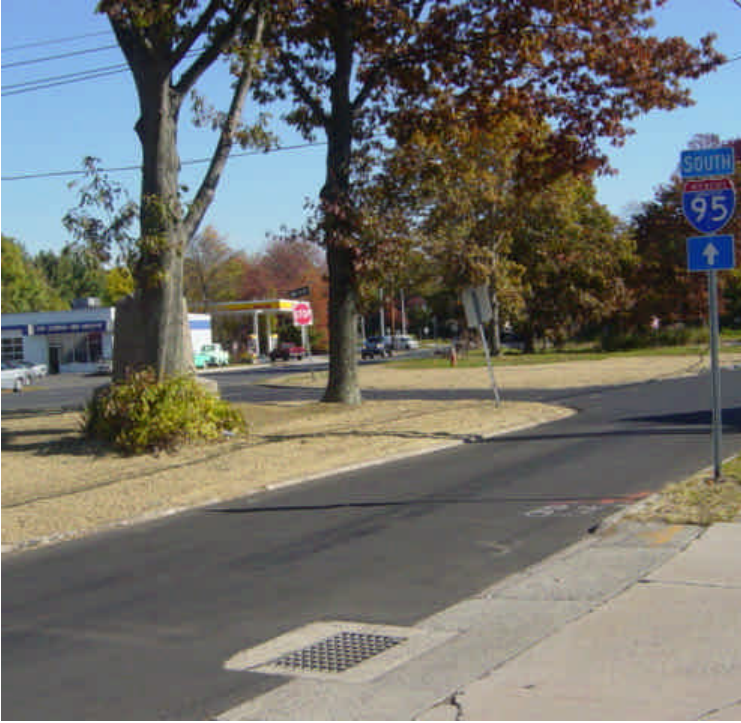
The area near sta. #463 remains restored and hydroseeded. Monitor for grass cover.

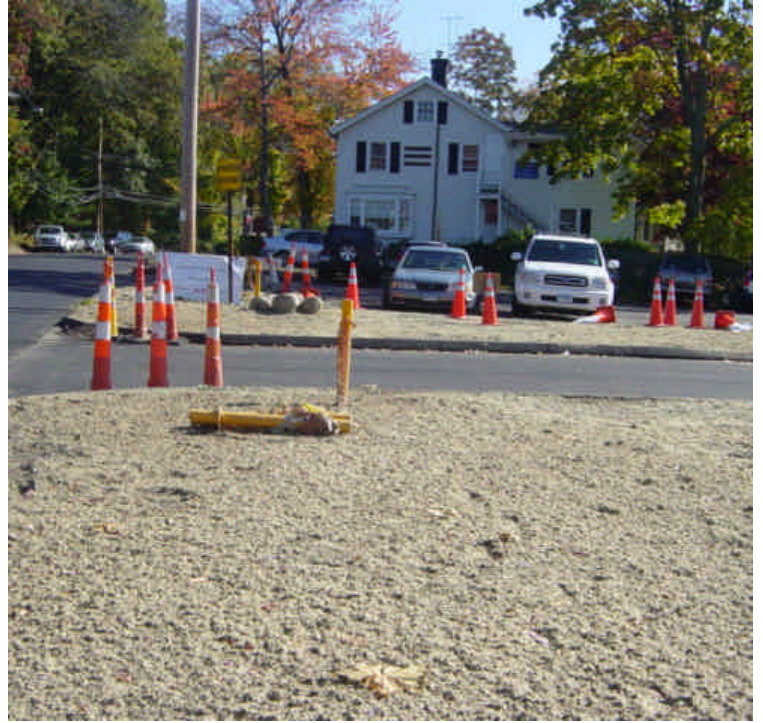
Restoration efforts have been completed near vault #28. The area remains hydroseeded. Monitor for grass cover.

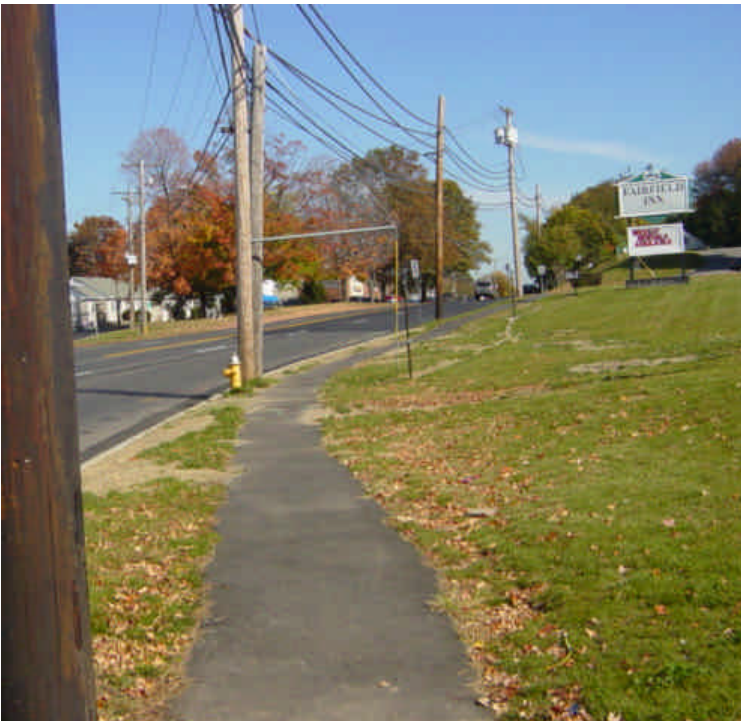
The area near sta. #611 (vault #37) has been partially restored. Small remaining areas of exposed soil have been seeded.

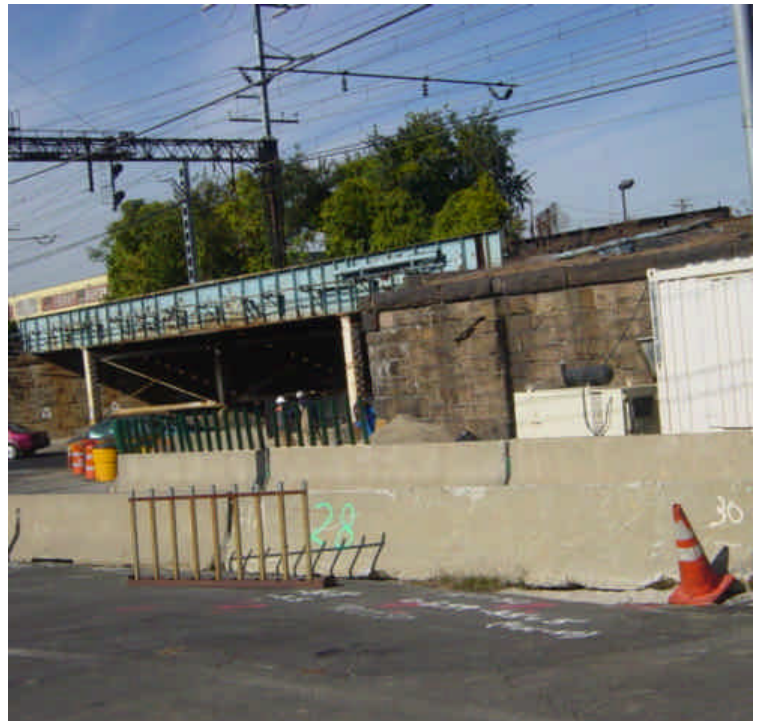
Bridge work, which is not project related, continues near sta. #719. However, the catch basin downgradient should be cleaned as part of the M/N project work.
