Docket No. 272 – Development and Management Plan Inspection

Segment 4a Underground Line

Date: October 24, 2008

Location: Singer Substation to Fairfield/Westport Town Line

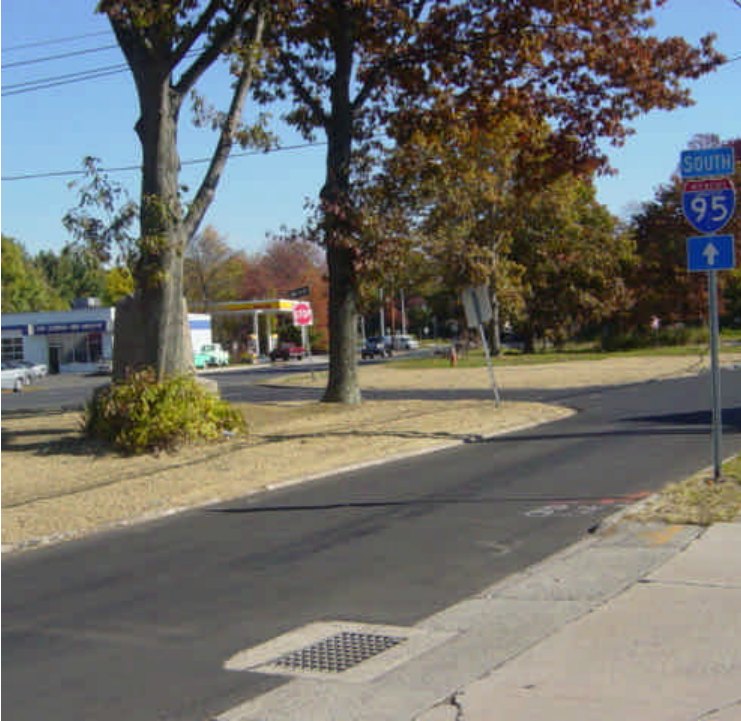
The area near sta. #463 remains restored and hydroseeded. Monitor for grass cover.

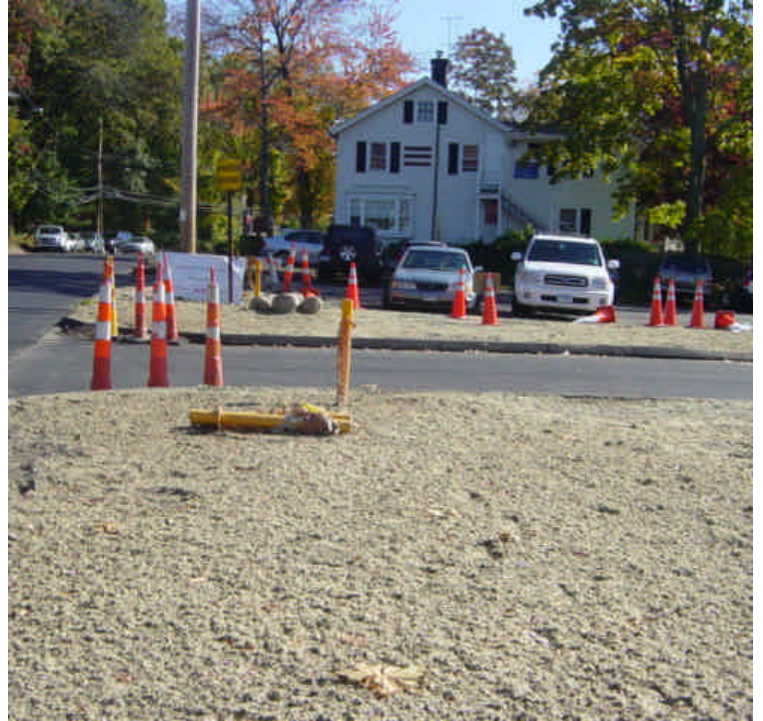
Restoration efforts have been completed near vault #28. The area remains hydroseeded. Monitor for grass cover.
