Docket No. 272 – Development and Management Plan Inspection

Segment 4a Underground Line

Date: October 30, 2008

Location: Singer Substation to Fairfield/Westport Town Line

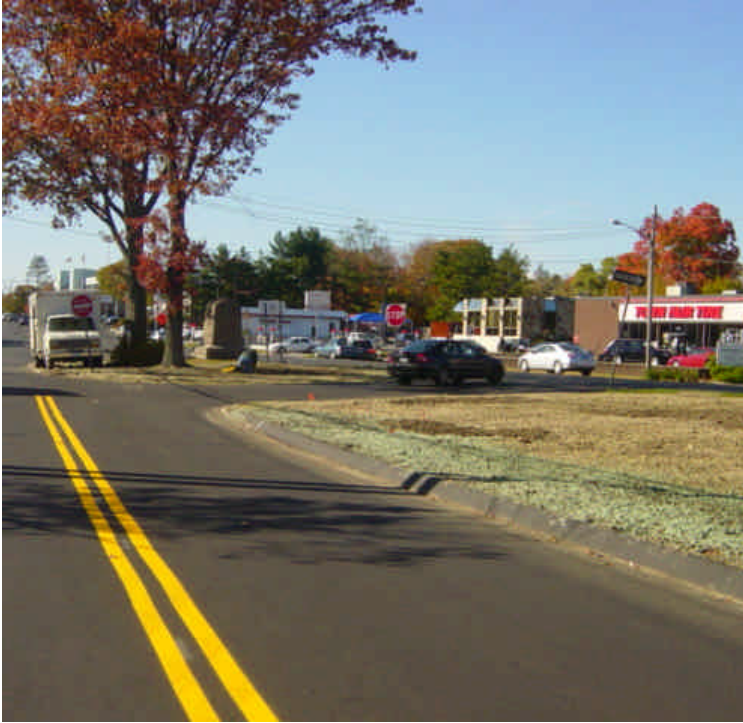
Topsoil has been spread near sta. #463 and the area has been hydroseeded. Bulbs were also being planted in the area.

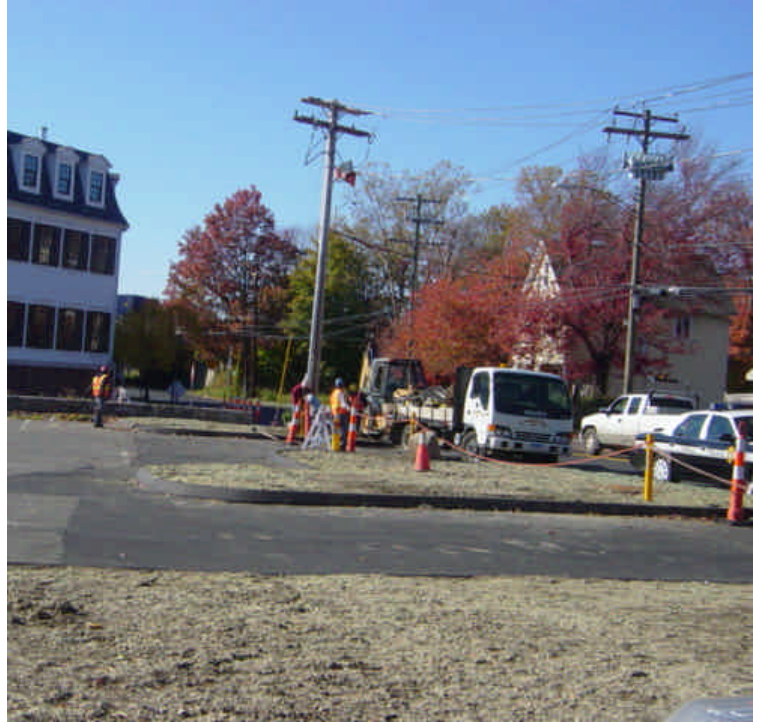
Restoration efforts have been completed near vault #28. The area has been hydroseeded.

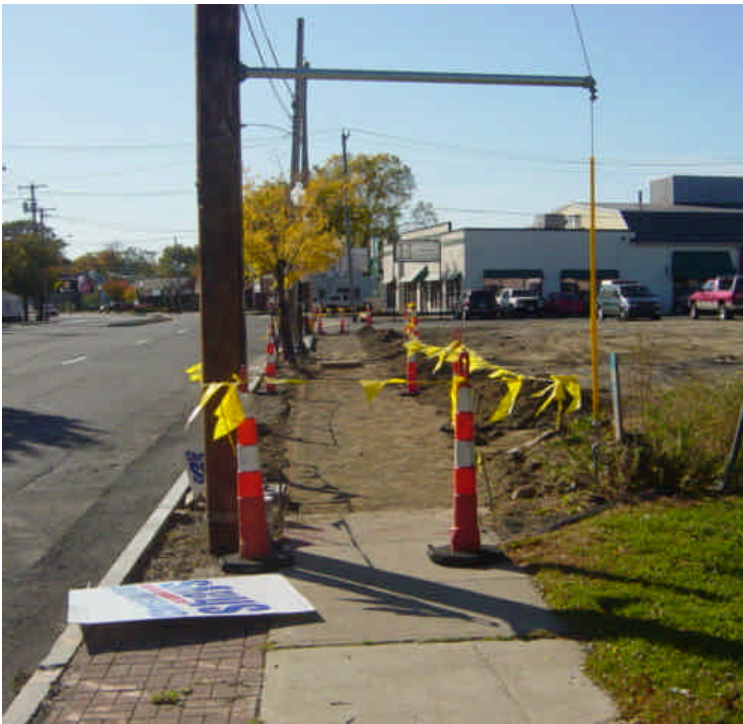
The area near sta. #649 has been prepped for sidewalk restoration. Determine if the vacant lot has been returned to its pre-construction condition. Provide further stabilization if necessary.

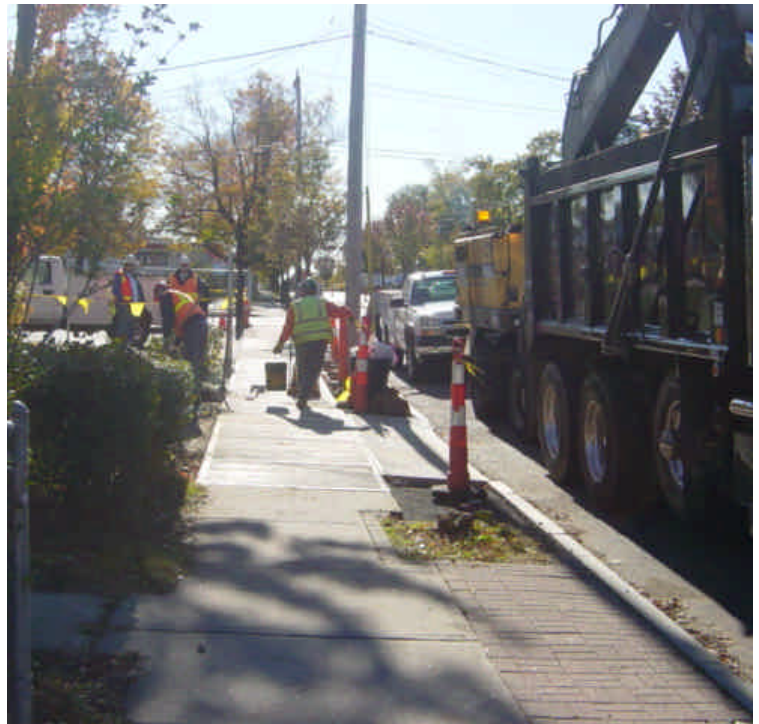
Sidewalk restoration was ongoing near sta. #695.
