**Docket No. 272 – Development and Management Plan Inspection**

**Segment 4b Underground Line**

**Date:** January 18, 2008

**Location:** Westport Avenue to the Norwalk Substation in the City of Norwalk

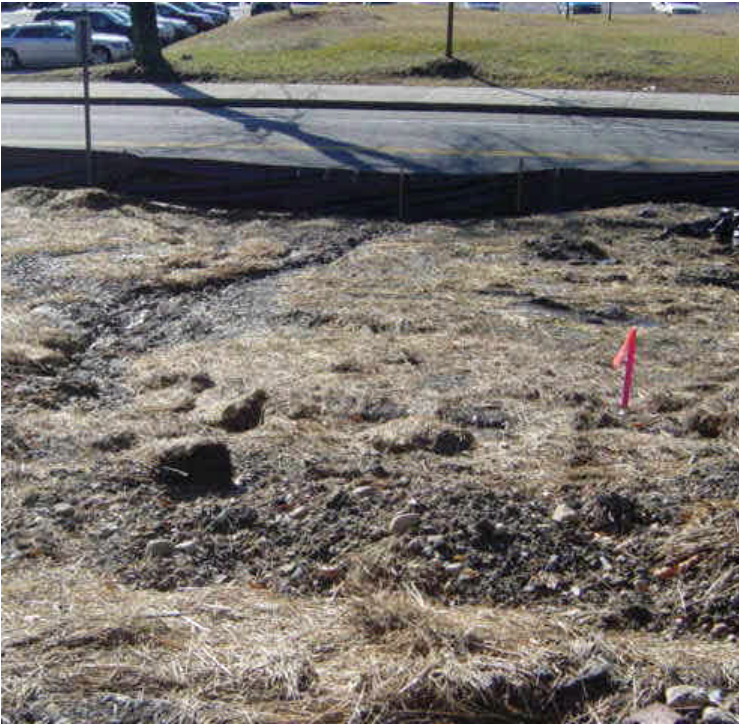
| Areas of Inspection | Observation | Recommended Action | Corrected Action |
|---|--|--|---|
| | <p>Silt fence near sta. #81 (vault #5) has been reinstalled. Portions of the area remain mulched but the exposed soil is susceptible to rill erosion. 1/18/08</p> | <p>Continue to stabilize exposed soils sufficiently for the winter. Maintain the silt fence as necessary and sweep the roadway. Also consider installing temporary curbing downgradient if this will help. 1/18/08</p> | <p>Silt fence was repaired but the area still needs additional stabilization.</p> |

**Silt fence was re-installed along Route 1, down gradient from the exposed soil at station #81. The partially mulched soils are susceptible to rill erosion caused by precipitation and surface runoff.**

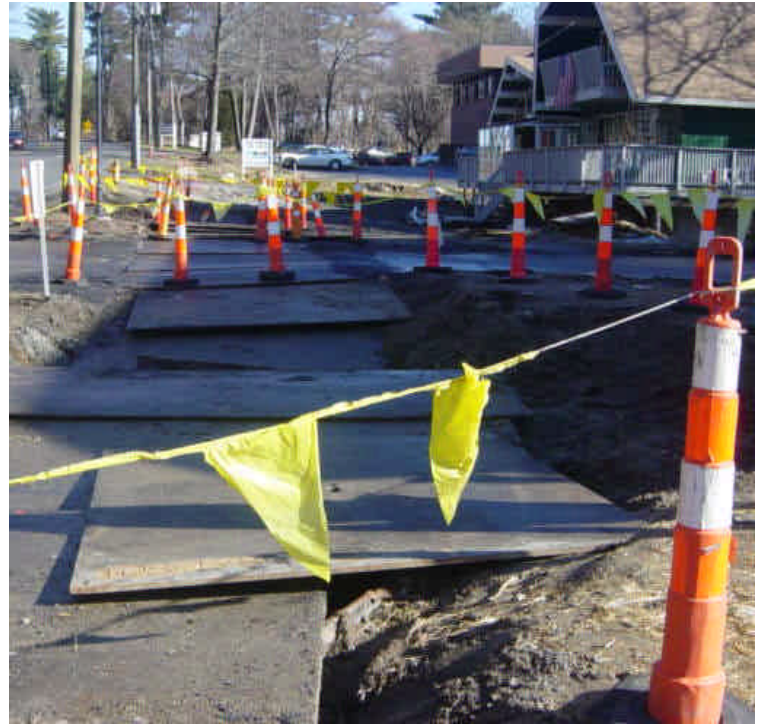
| <b>Areas of Inspection</b> | <b>Observation</b> | <b>Recommended Action</b> | <b>Corrected Action</b> |
|--|--|--|--|
| <b>Vault Openings and Trench Construction Westport/Norwalk</b> | <p>Steel road plates were observed at the time of the inspection along the shoulder/sidewalk areas near sta. #81, Vault 8, #145-148, #184-185, #200-201 (vault tie-in), #260-262, and #431-433. 1/18/08</p> | <p>See erosion and sediment control section of this report for additional details. 1/18/08</p> | <p>NA</p> |

**Steel plates are in use at the tie-in to vault 11 (stations #184-185).**

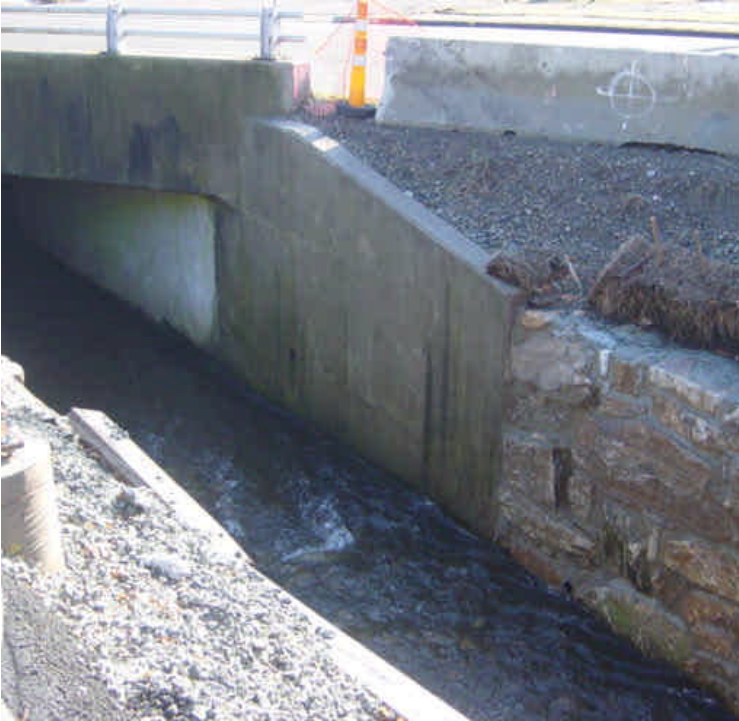
| Areas of Inspection | Observation | Recommended Action | Corrected Action |
|---|--|--|---|
| | <p>Erosion controls remain in place between the hard-pack material and Stony Brook at sta #217. However, some areas appear to have the potential to run-off. 1/18/08</p> | <p>Continue to monitor and maintain controls as necessary. Ensure that all gravel material remains contained. See Inland Wetlands section for more details. 1/18/08</p> | <p>Continue to monitor.</p> |

**At Stony Brook, the channel remains free of debris. Ensure that soil and gravel at the top of the walls are stable and contained. Work out the final restoration plan.**

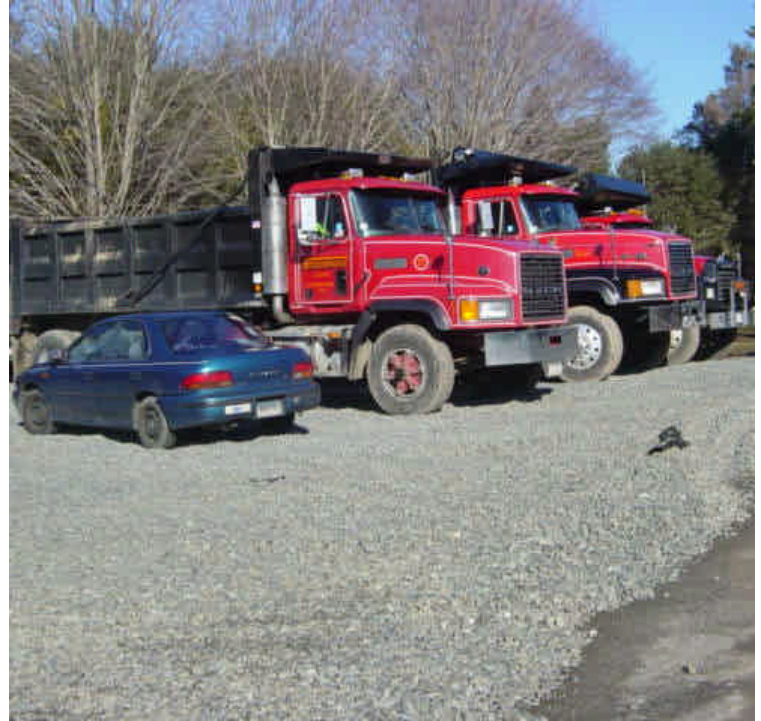
| Areas of Inspection | Observation | Recommended Action | Corrected Action |
|--|--|---|--|
| | <p>Minor sediment tracking was noted from the shoulder of the access road to the Sherwood Island yard. Turbid run-off is reaching catch basins during rain events. 1/18/08</p> <p>Heavy equipment was parked outside the fenced limits of the yard on rutted, exposed soil. Some areas are stabilized with crushed stone. 1/18/08</p> | <p>Continue to sweep the roadway and stabilize at the source. Also, see erosion control section. 1/18/08</p> <p>The contractor has previously stated that the vehicles are stored within an area covered under the lease. Full restoration will be needed when access needs are complete. 1/18/08</p> | <p>Needs regular attention.</p> <p>Additional crushed stone was applied to the disturbed soil.</p> |

**Along the sides of the Sherwood Island access road, more crushed stone has been installed in the area where heavy equipment has been stored, reducing ruts and tracking. Ensure that pre-construction conditions/surfaces are restored when the area is no longer in use.**
