Docket No. 272 – Development and Management Plan Inspection

Segment 4b Underground Line

Date: February 27, 2008

Location: Westport Avenue to the Norwalk Substation in the City of Norwalk

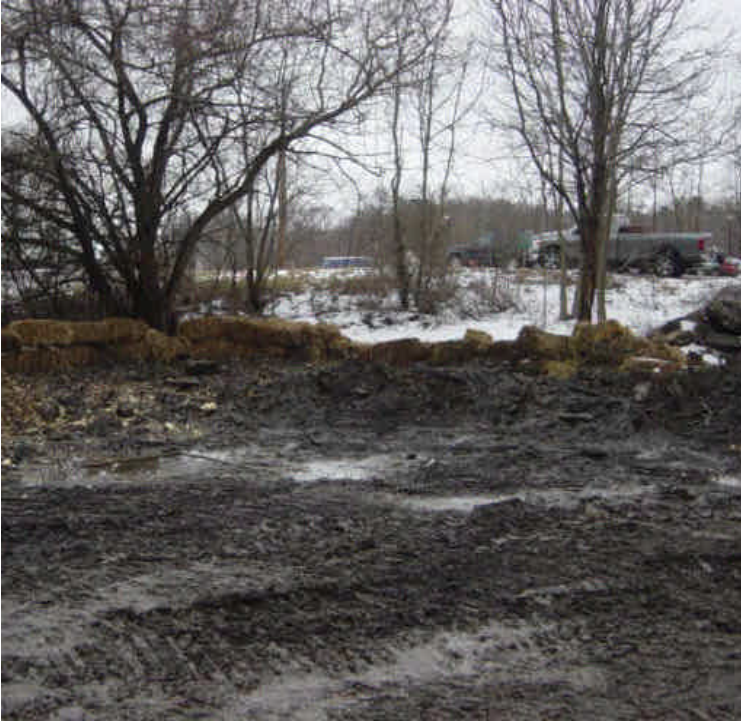
On the east side of the Saugatuck River, excavated soil has been temporarily stockpiled on-site and contained with hay bales. Most of the soil has been transported off site.

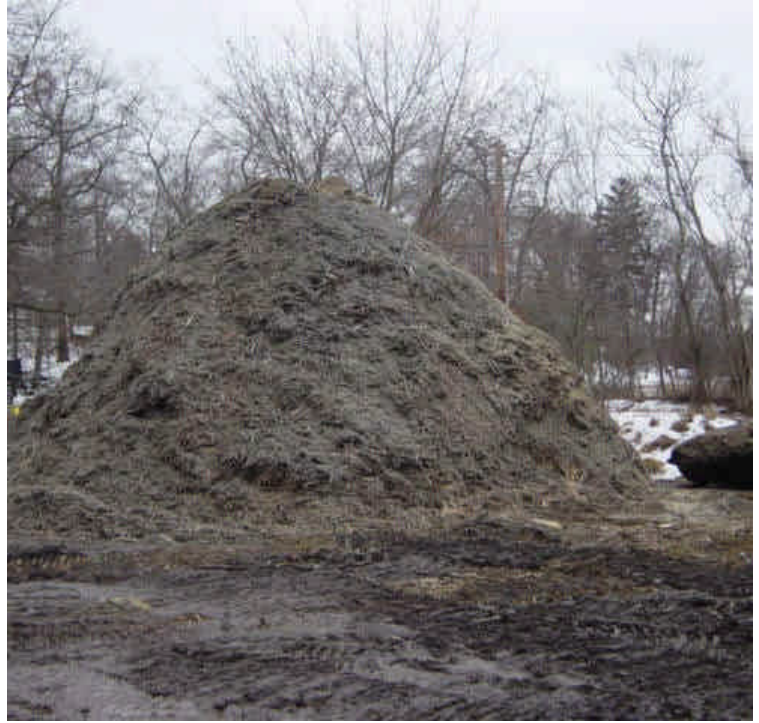
The buried logs that were uncovered during excavation work for vault #15, near sta. #251 have been ground into mulch and stockpiled. A soil stockpile was also noted within the yard.

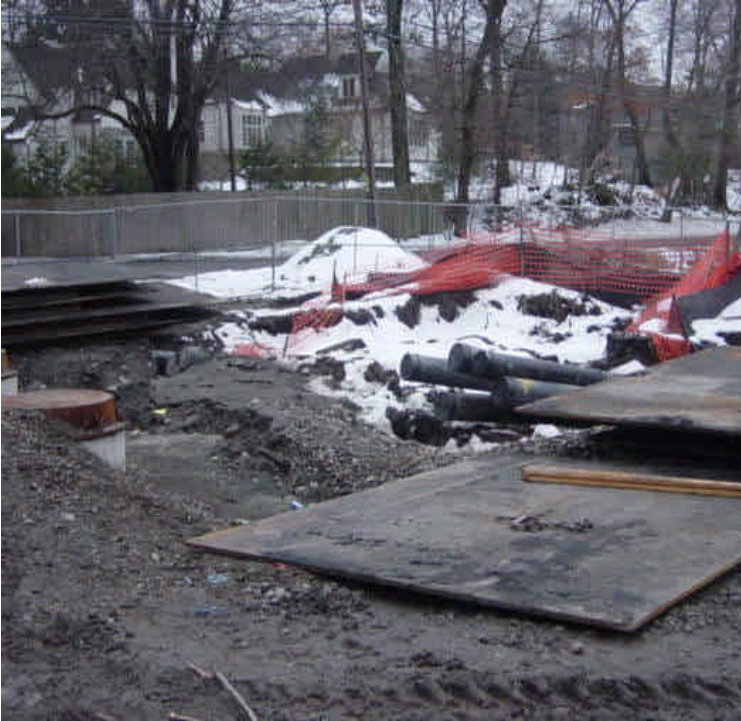
Vault #15 has been installed along Imperial Ave., near sta. #251.

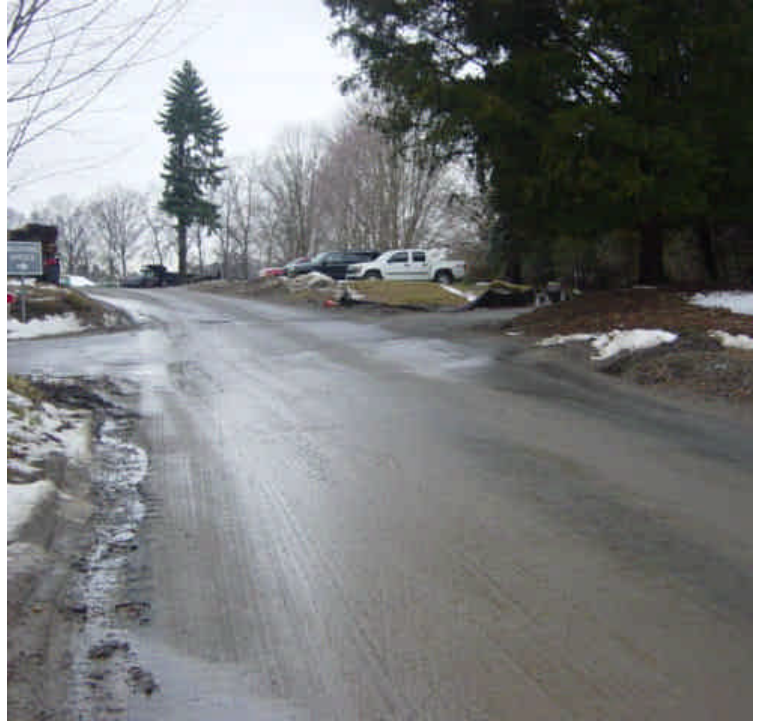
Sediment tracking continues to be noted along the access road to the Sherwood Island yard.
