**Docket No. 272 – Development and Management Plan Inspection**

**Segment 4b Underground Line**

**Date:** March 6, 2008

**Location:** Westport Avenue to the Norwalk Substation in the City of Norwalk

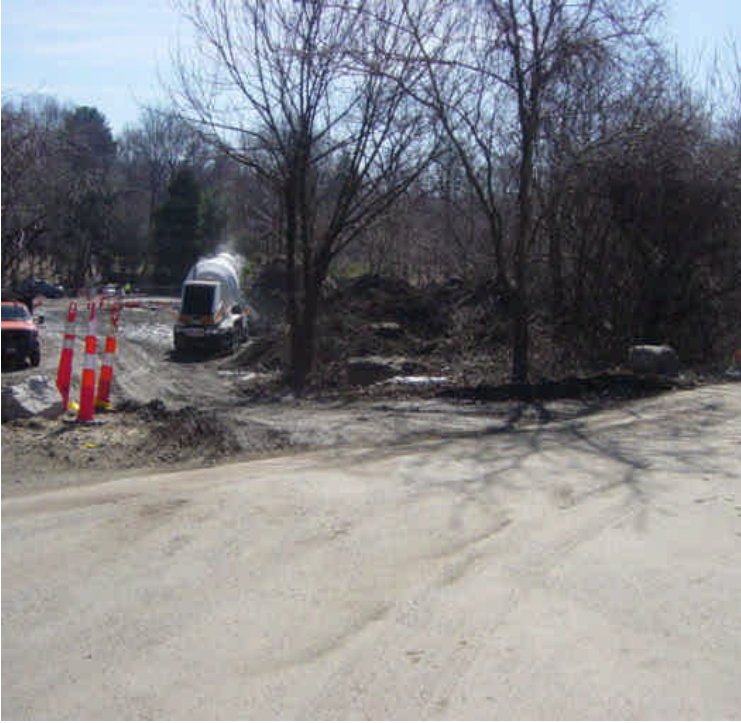
**On the east side of the Saugatuck River, vault work continues. Sediment tracking was observed along the parking lot area and the stone construction entrance needs to be refreshed.**

Westport	<p>Erosion controls are deteriorating between the hard- pack material and Stony Brook at sta. #217 and don't provide complete coverage. Some areas of process material and soil appear to have the potential to run-off (since 1/24). 3/06/08</p> <p>Tie-in work for vault #15 was ongoing in the staging area on the east side of the Saugatuck River near sta. #251. Adjacent catch basin was protected. The area was very muddy from heavy vehicle traffic. Dump trucks were accessing the site via the existing stone construction entrance, which has become covered with mud and needs to be refreshed. Tracking was observed</p>	<p>Continue to monitor and maintain controls as necessary. Ensure that all material remains contained. See Inland Wetlands section for more details. 1/24-3/06/08</p> <p>Sweep parking lot as necessary. Continue to access area through the existing stone construction entrance and refresh the stone in the pad. 3/06/08</p>	<p>Continue to monitor.</p> <p>Needs attention.</p>

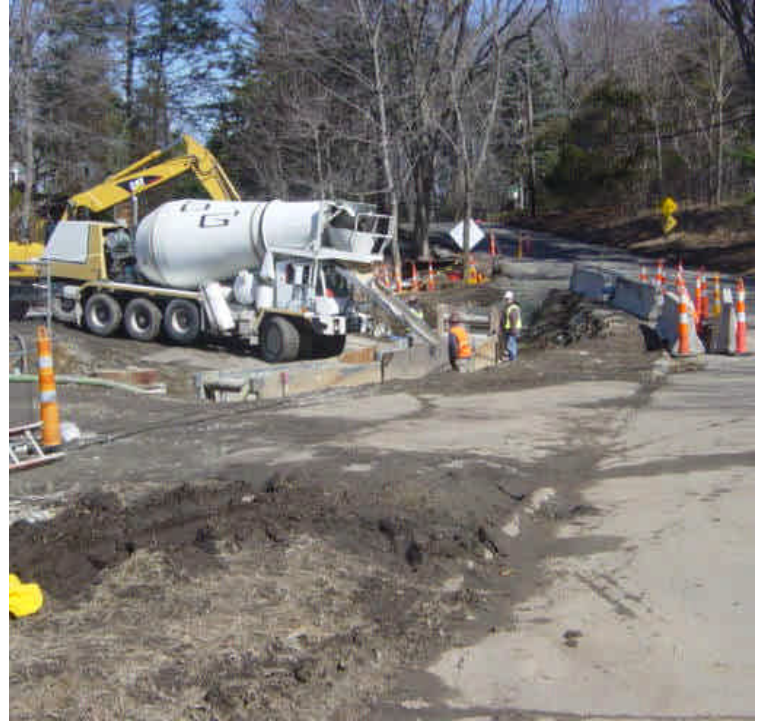
**Crews are backfilling the trench near sta. #252 which ties in to the recently installed vault #15.**

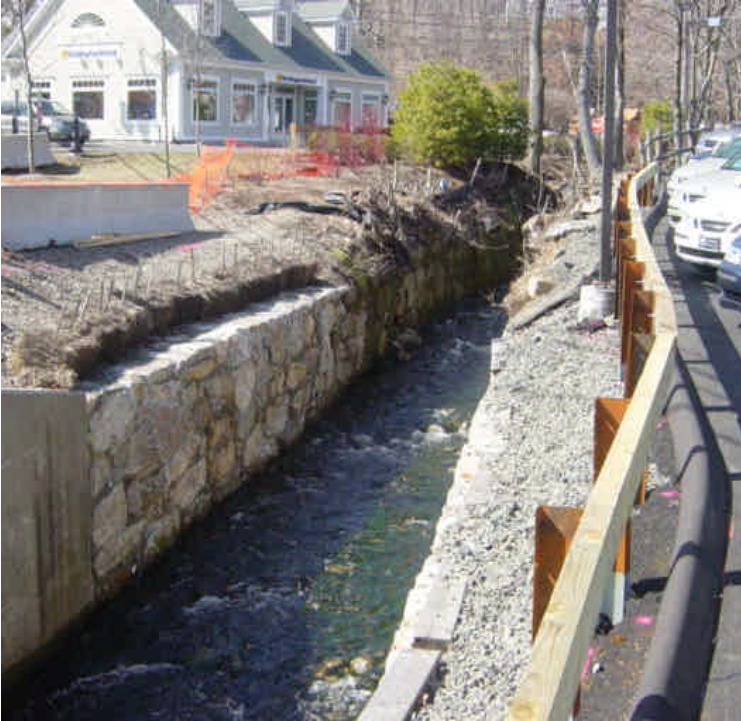
<p><b>Inland Wetland and Watercourse encroachment and mitigation</b></p>	<p>The Kings Highway lay-down yard is located adjacent to potential resource areas and a concrete lined waterway. 3/06/08</p> <p>Some concrete work on the Stony Brook bridge was noted last week. Adjacent areas have been seeded but not mulched. Grass cover is present in some areas while other areas adjacent to the walls are still bare/ gravel material. (since 9/11/07) A new wooden fence is in place between the auto dealer parking lot and Stony Brook. 3/06/08</p>	<p>See Erosion and Sediment Controls section. 3/06/08</p> <p>Continue restoration/ stabilization efforts and monitor until vegetation is fully restored. See Erosion and Sediment Controls section for additional details. Exposed material appears to have the potential to wash into the stream. 3/06/08 Consider working out a shrub planting plan with the landowner to provide shading for the brook.</p>	<p>NA</p> <p>Needs evaluation</p>

**A wooden guide rail has been installed along Stony Brook. Gravel material still appears to have the potential to be washed into the channel. Ensure all material and remaining exposed areas are contained. Consider working with the landowner here to provide shrub plantings for shading.**

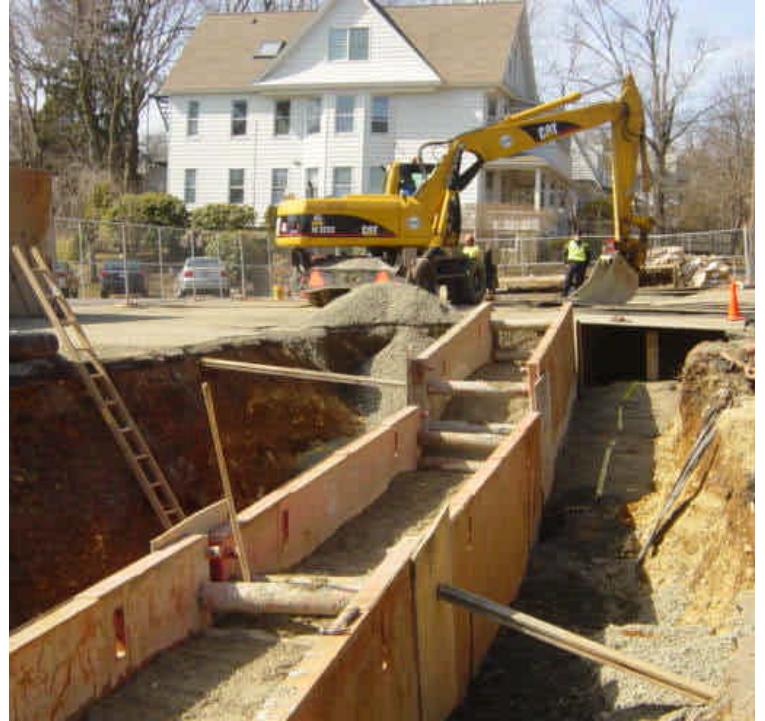
**The trench is being backfilled along the west side of the Saugatuck River near sta. #232. The HDD drilling pit remains open.**
