**Docket No. 272 – Development and Management Plan Inspection**

**Segment 4b Underground Line**

**Date:** March 13, 2008

**Location:** Westport Avenue to the Norwalk Substation in the City of Norwalk

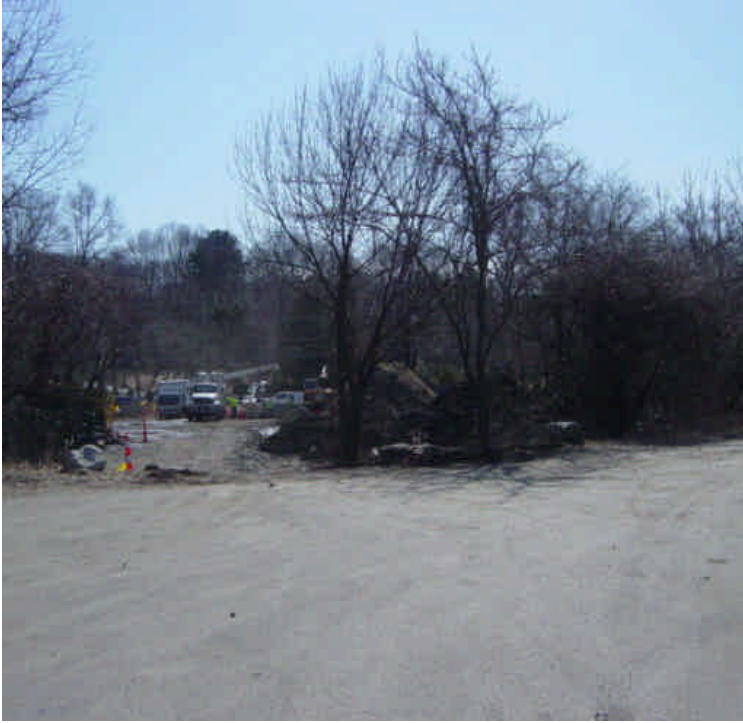
**On the east side of the Saugatuck River, vault work continues. Sediment tracking was observed along the parking lot area and the stone construction entrance needs refreshing.**

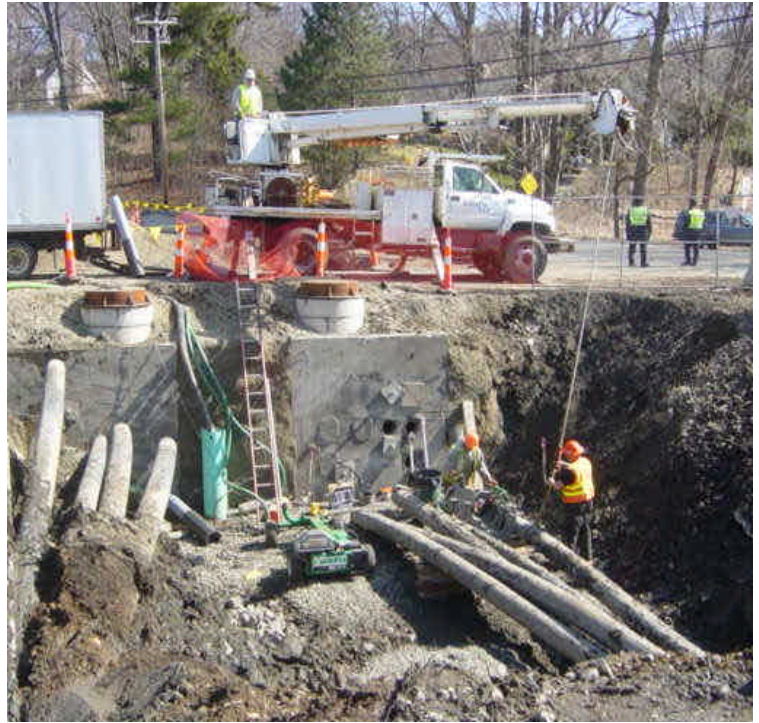
**Crews are fusing sections of conduits to complete the tie-in work at the vault near sta. #252.**

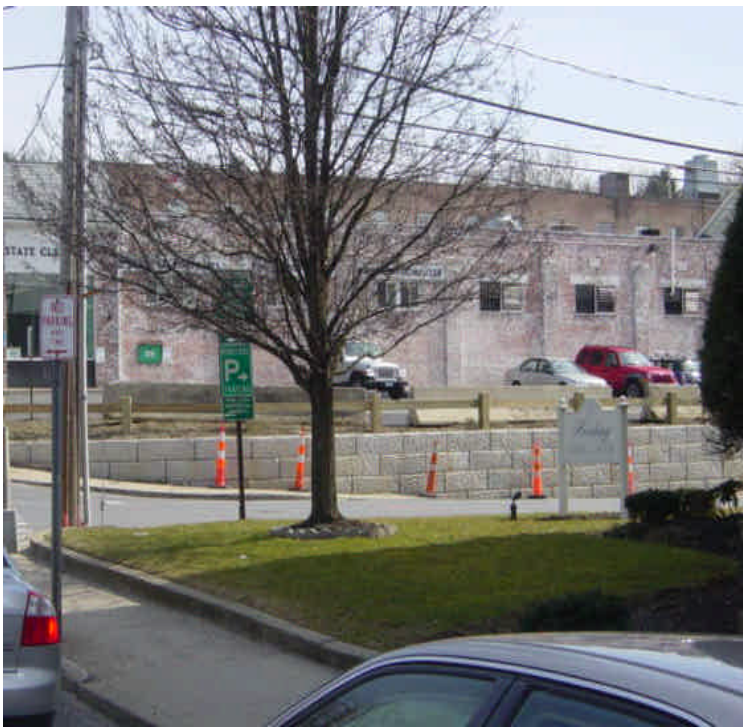
**A wooden guide rail has been installed along the top of the retaining wall near sta. #264.**

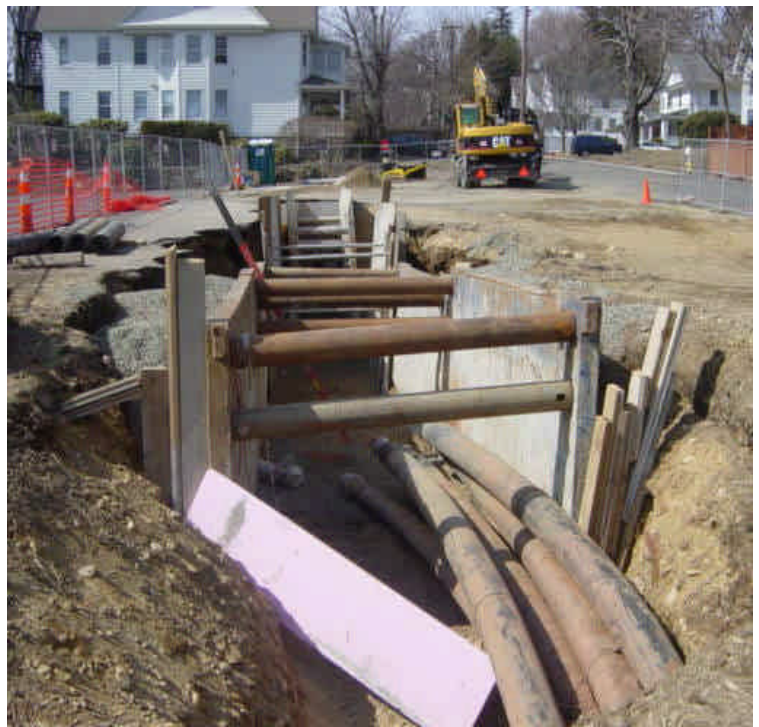
**Vault tie-in work continues on the west side of the Saugatuck River near sta. #232. One of the two circuits has already been backfilled.**
