Docket No. 272 – Development and Management Plan Inspection

Segment 4b Underground Line

Date: March 20, 2008

Location: Westport Avenue to the Norwalk Substation in the City of Norwalk

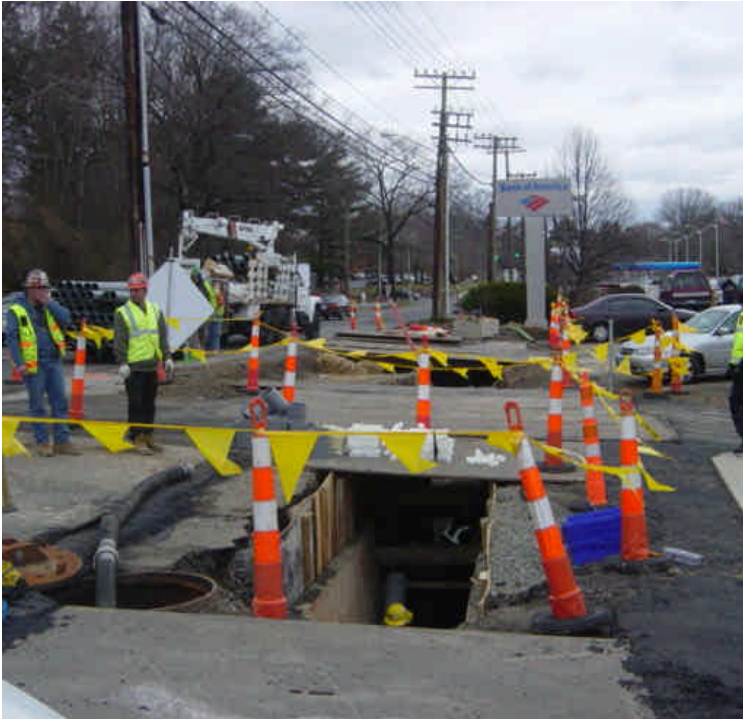
Vault tie-in work continues at sta. #163-166. Conduit was being installed at the time of the inspection. Steel plates remain over portions of the trench.

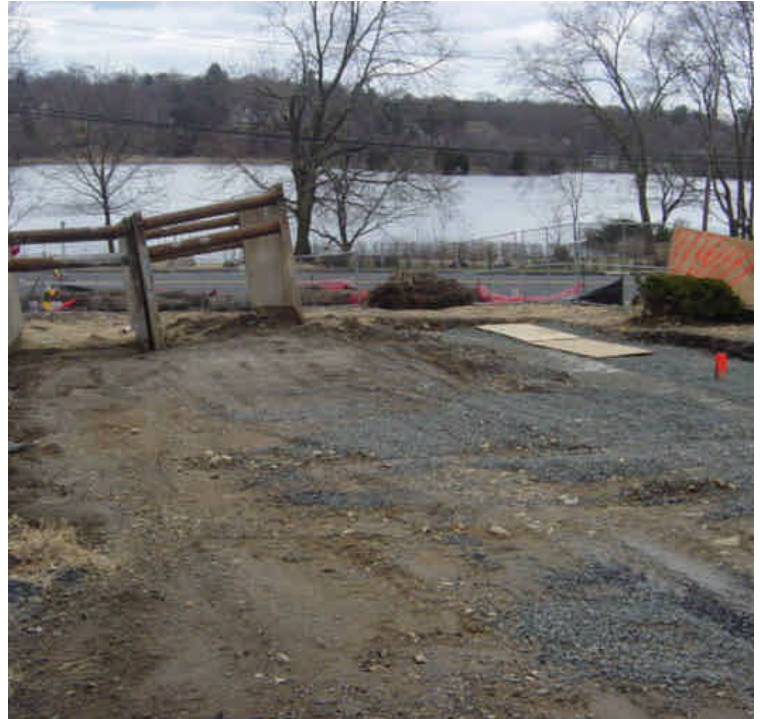
On the west side of the Saugatuck River vault tie-in work is complete and the area has been backfilled. Exposed soil remains stabilized with hay mulch and/or stone. The area is expected to be paved within the next few weeks.

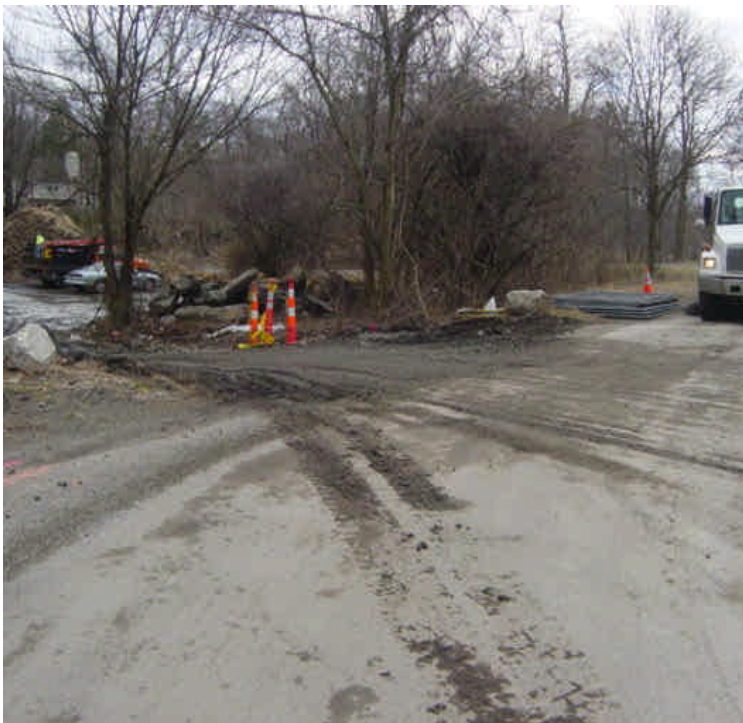
The construction entrance near the staging area on the east side of the Saugatuck River near sta. #251 is covered with mud and sediment and no longer functions. Sediment tracking was observed throughout the adjacent parking area. Heavy ruts have also formed near the corner of the access drive and Imperial Ave. The adjacent catch basin was not protected. Minor tracking was observed along Imperial Ave. but the area was being swept during the inspection. The entrance pad should be refreshed.
