Docket No. 272 – Development and Management Plan Inspection

Segment 4b Underground Line

Date: April 3, 2008

Location: Westport Avenue to the Norwalk Substation in the City of Norwalk

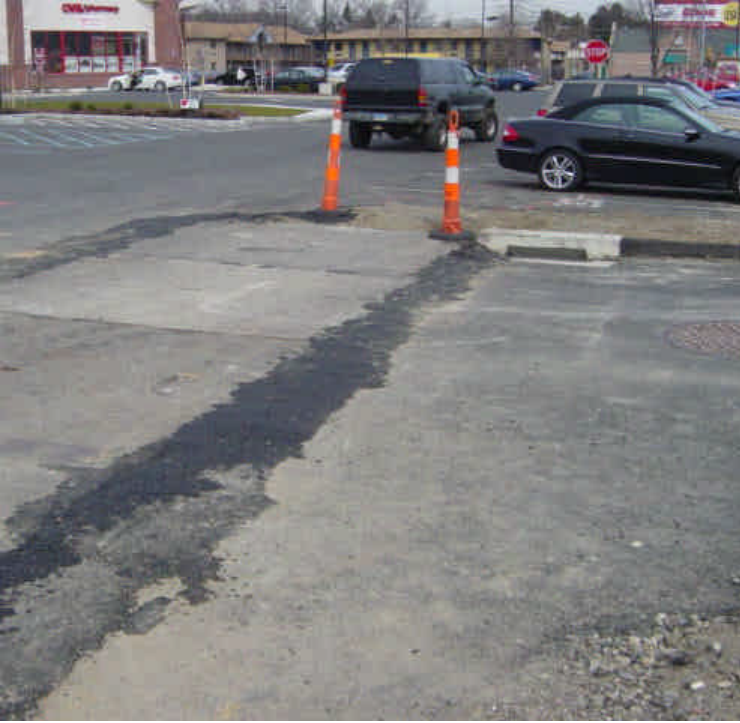
Vault tie-in work continues at sta. #147. The catch basin adjacent to the trench was not protected with controls.

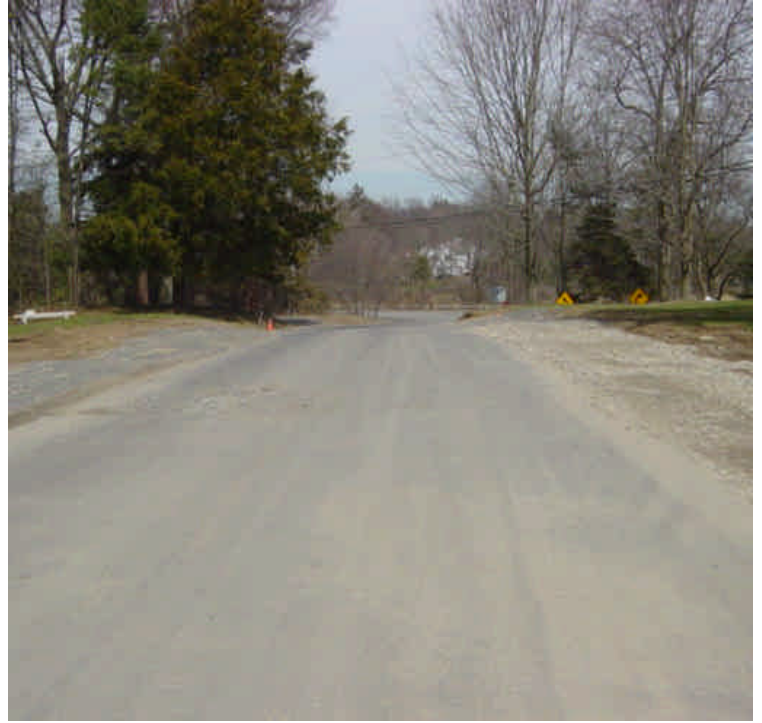
The access drive to the Sherwood Island yard appears to have been recently swept and sediment tracking was not observed this week.

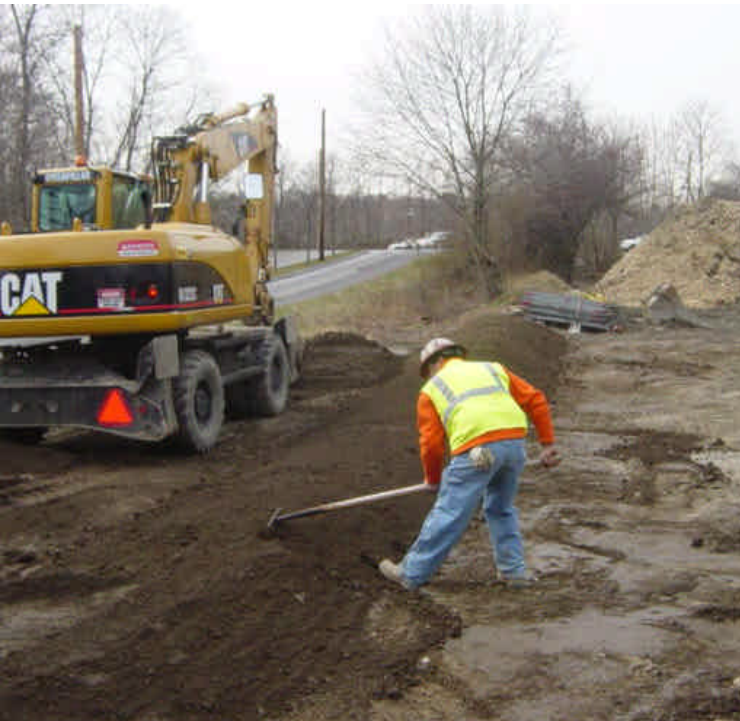
Tie-in work is complete on the east side of the Saugatuck River, near sta. #251. The area is being restored. A dirt berm was being reconstructed near the perimeter of the yard. Ensure that controls are placed adjacent to the berm until the area can re-vegetate.

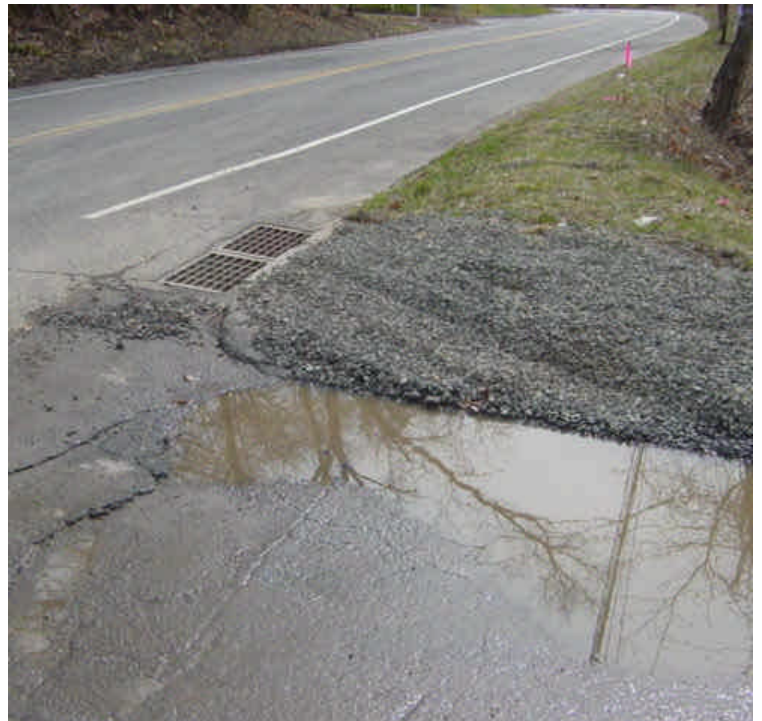
View of the crushed stone in place at the corner of the access drive and Imperial Ave. where the heavy ruts used to be. Ensure that the catch basin here is also protected/controlled.
