Docket No. 272 – Development and Management Plan Inspection

Segment 4b Underground Line

Date: April 10, 2008

Location: Westport Avenue to the Norwalk Substation in the City of Norwalk

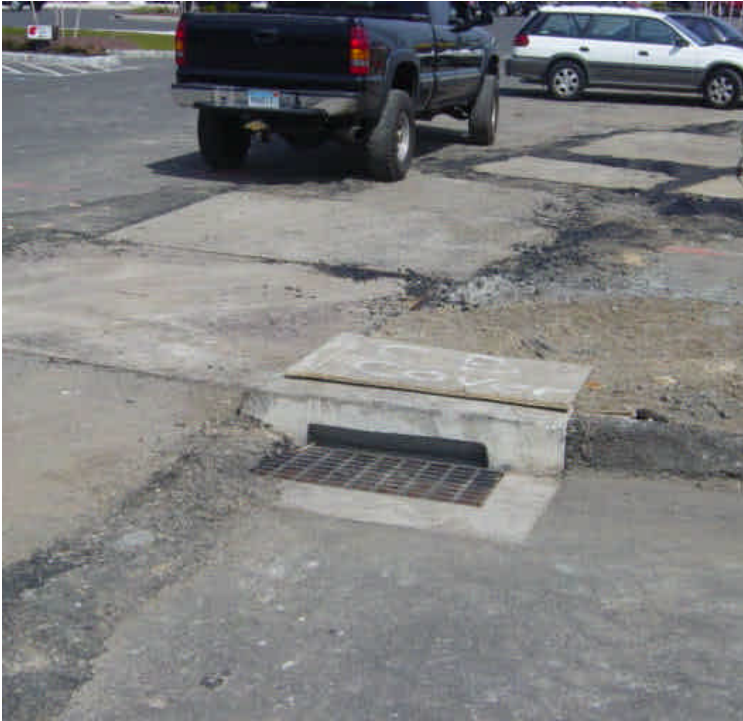
<p>Westport</p>	<p>Minor ponding was previously observed in the parking lot near sta. #147. The silt sack appeared to be plugged (since 3/20). Active trench work is ongoing and steel plates were covering the trench. Plywood was being used to cover the adjacent catch basin during active work. 4/10/08</p>	<p>Clean or remove silt sack to re-establish proper drainage. Clean catch basin if necessary. 3/20-4/10/08</p> <p>Evaluate whether the plywood is an adequate control. 4/10/08</p>	<p>Additional attention needed.</p>
	<p>Portions of the erosion controls are deteriorating between the hard- pack material and Stony Brook at sta. #217 and don't provide complete coverage. Some areas of process material and soil appear to have the potential to run-off (since 1/24). 4/10/08</p> <p>Tie-in work for vault #15</p>	<p>Continue to monitor and maintain controls as necessary. Ensure that all material remains contained. See Inland Wetlands section for more details. 1/24-4/10/08</p> <p>Continue to sweep</p>	<p>Continue to monitor.</p> <p>Needs regular</p>

Trenching continues near sta. #147. Plywood is being used to temporarily cover the catch basin during construction activities.

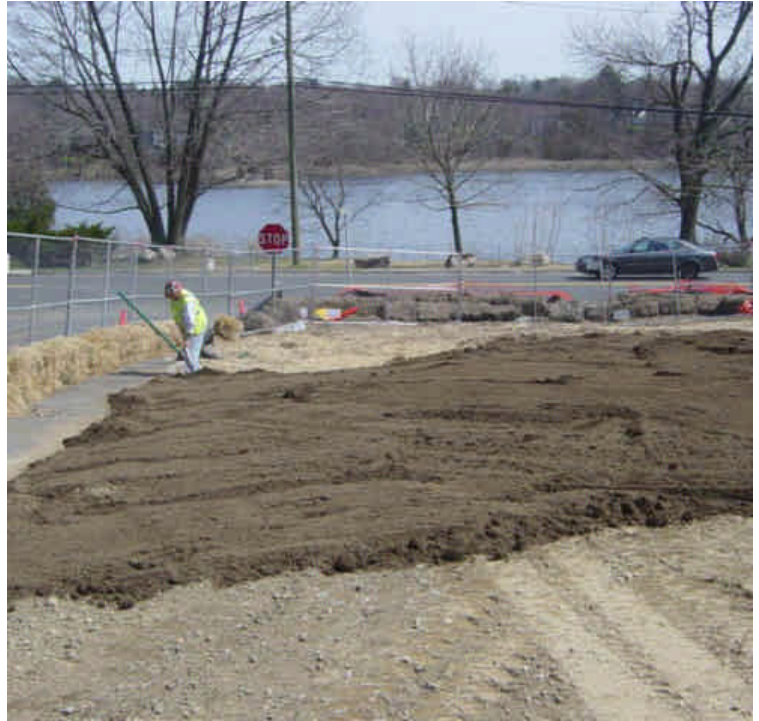
Tie-in work has been completed near sta. #234. The area has been backfilled and topsoil and seed were being applied.

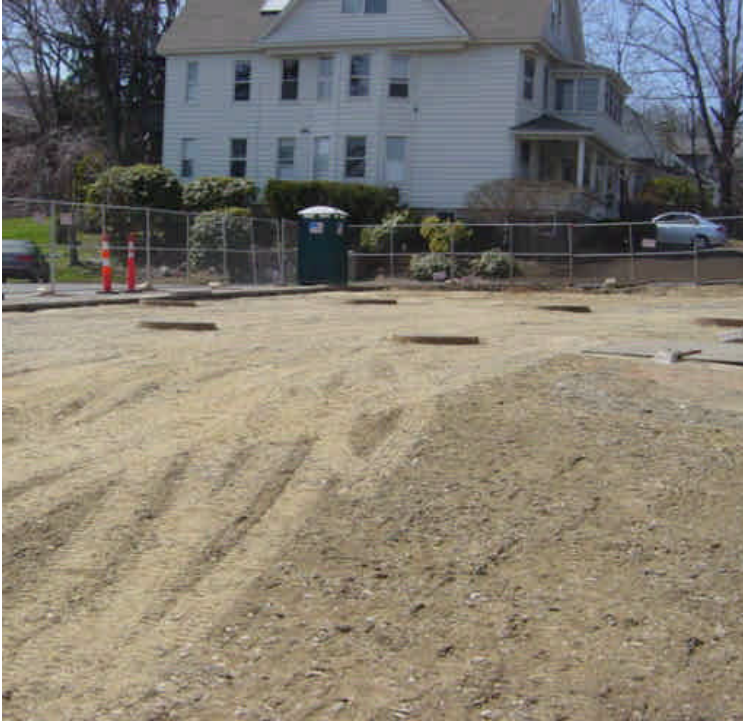
Tie-in work has been completed near sta. #234. The area has been backfilled and this portion is ready to be paved.

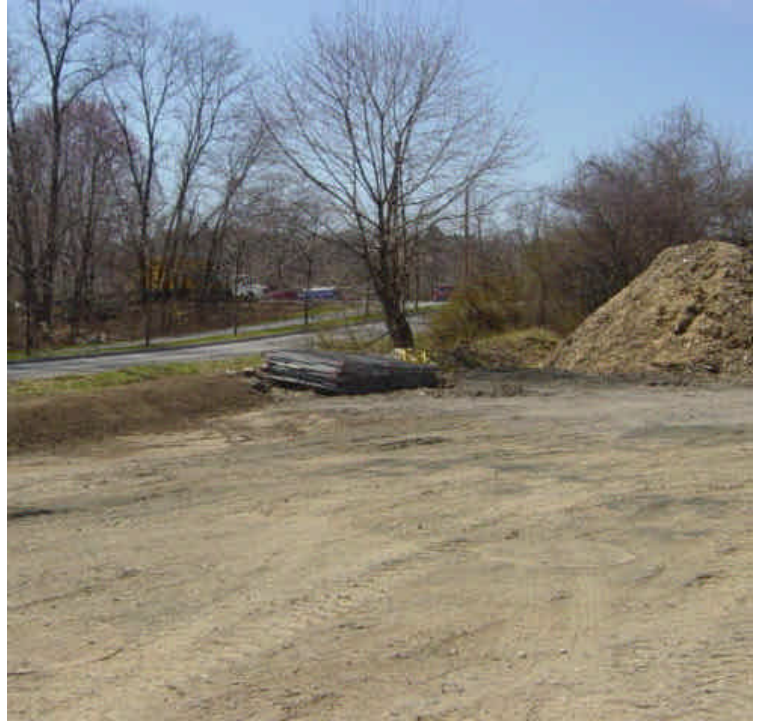
Areas of Inspection	Observation	Recommended Action	Corrected Action
	<p>working to restore the old HDD laydown yard on the east side of the Saugatuck River. Wood chips and chain link fence are still stockpiled here. The dirt berm and some portions of the yard remain exposed. 4/10/08</p>	<p>restoration here, especially in the area of exposed soil and the earthen berm. Stabilization is needed. 4/10/08</p>	<p>stabilization.</p>
<p>Soils</p>	<p>Exposed soils were noted due to excavation for trench, vault, and utility work. 4/10/08</p> <p>Minor amounts of soil have been exposed as part of the vault construction and tie-in activities. Portions of the exposed soil near the vaults remain stabilized with hard-pack material or crushed stone. 4/10/08</p> <p>Vehicles continue to park on the previously seeded areas/exposed soils near sta. #334 (vault #20). The soil is well compacted. Minor rutting and tracking were observed. 4/10/08</p> <p>Vault tie-in work near sta. #234 is completed and the area is backfilled and portions are expected to be paved shortly. Topsoil, seed and mulch have been spread in adjacent areas as part of restoration efforts. 4/10/08</p>	<p>Soils appear to have been handled appropriately. 4/10/08</p> <p>If exposed soils are not to be worked within 21 days, they should be stabilized within 7 days of the last activity. Where work has been completed, the areas should be seeded, and mulched as part of permanent restoration. 4/10/08</p> <p>Continue to monitor the area. Work out the parking situation with the landowner. Install bituminous curbing. 11/21/07-4/10/08</p> <p>Monitor areas of exposed soils for vegetative growth. Pave the remaining area as soon as feasible to permanently restore area. 4/10/08</p>	<p>NA</p> <p>Continue to monitor areas.</p> <p>Contractor is currently working with the landowner to resolve the parking situation.</p> <p>Topsoil and seed were being applied to portions of the area.</p>

Tie-in work is complete near sta. #251. The staging area has been partially restored. Wood chips and chain link fencing remain stockpiled in the staging area. A dirt berm was recently re-graded.
