**Docket No. 272 – Development and Management Plan Inspection**

**Segment 4b Underground Line**

**Date:** April 24, 2008

**Location:** Westport Avenue to the Norwalk Substation in the City of Norwalk

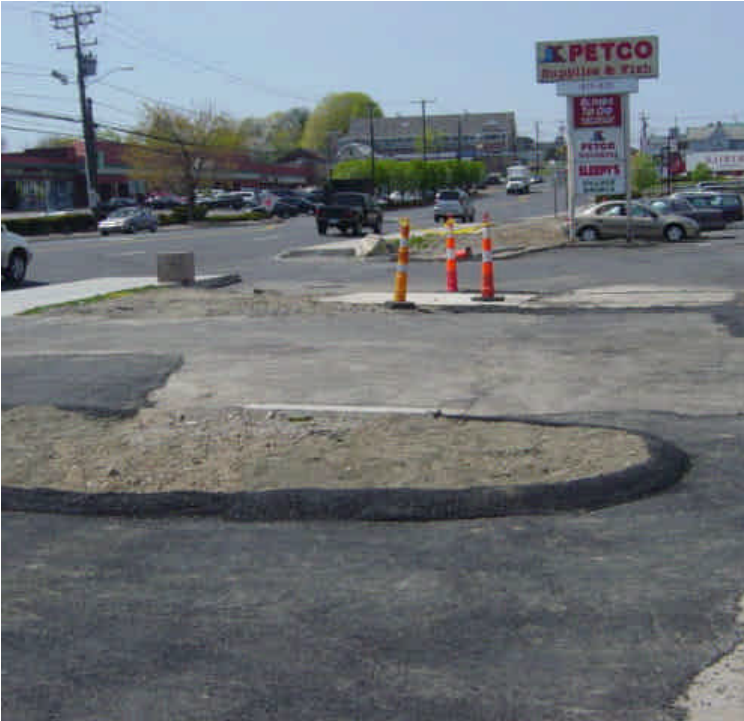
**Trenching continues near sta. #147. Plywood is being used to temporarily cover the catch basin during construction activities. However, evaluate whether this is adequate for control.**

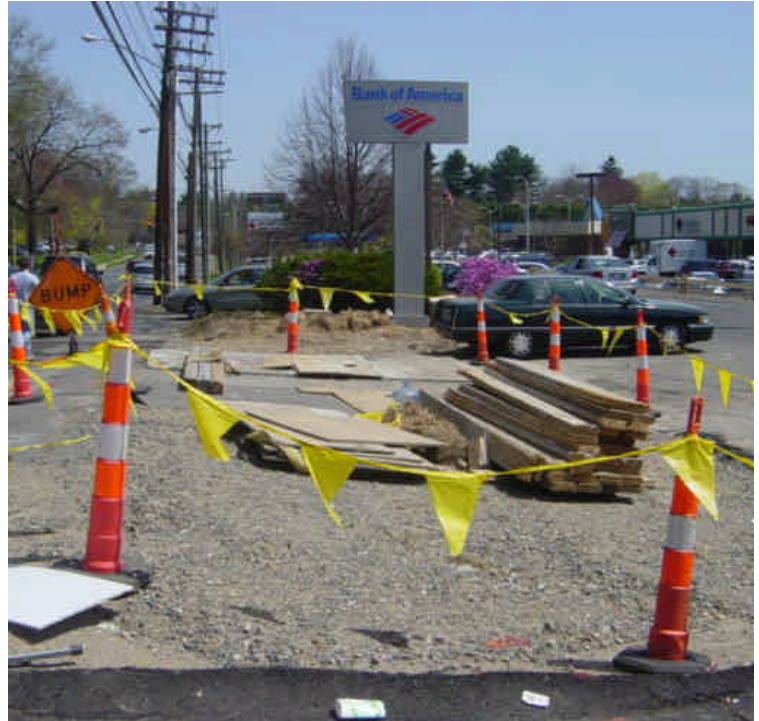
**Vault tie-in work continues near sta. #163-166.**

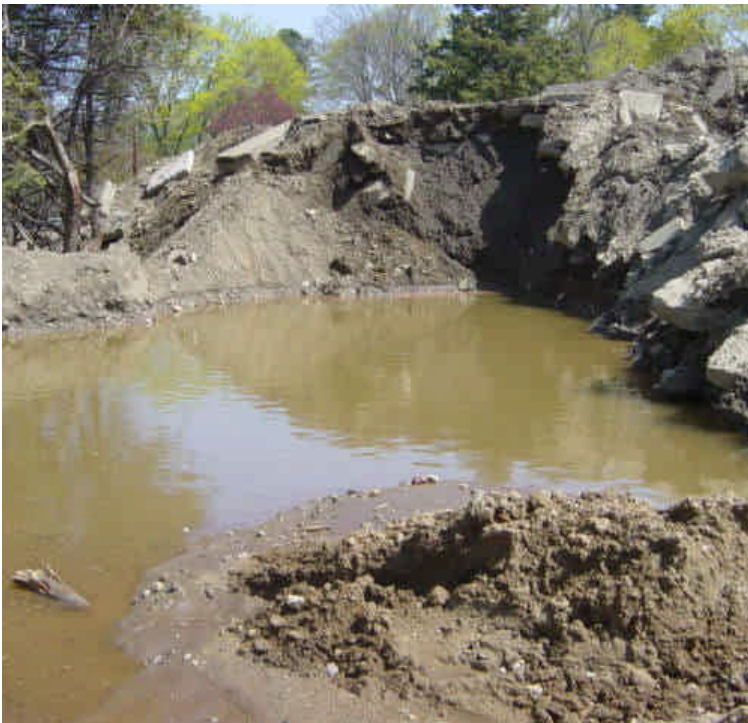
**Frac tank washout water has been mixed with the material stockpile in the Sherwood Island yard to bind the material for disposal.**

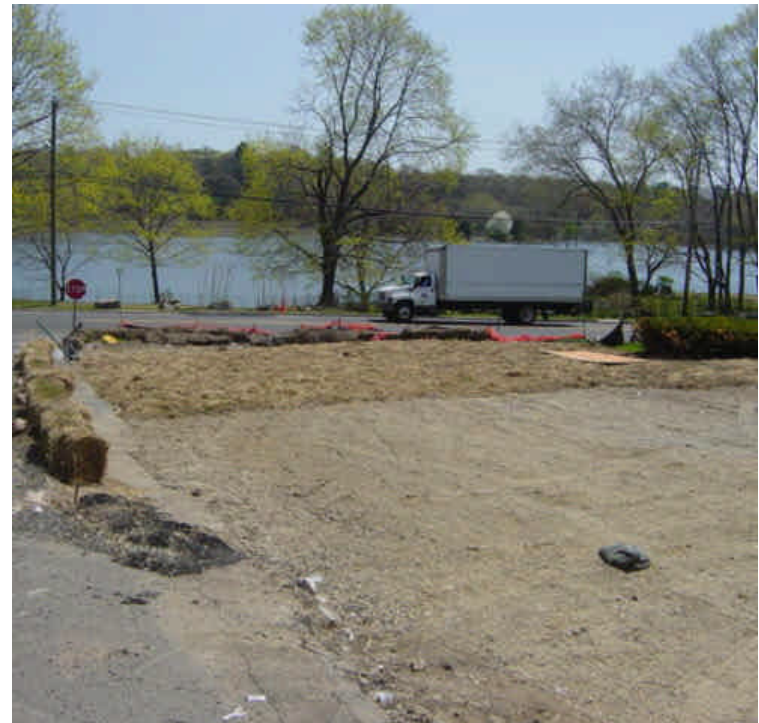
**The area near sta. #231-234 has been prepared for paving for several weeks. Seed and mulch were previously spread over the portion of exposed soil that is not slated for paving.**
